June 27, 2016

Scoping Phase Evaluation of the
Southeast Community Center and Potential Police Station Buildings for the
City of Yakima
Yakima, Washington
Erickson Structural Job No. 160101

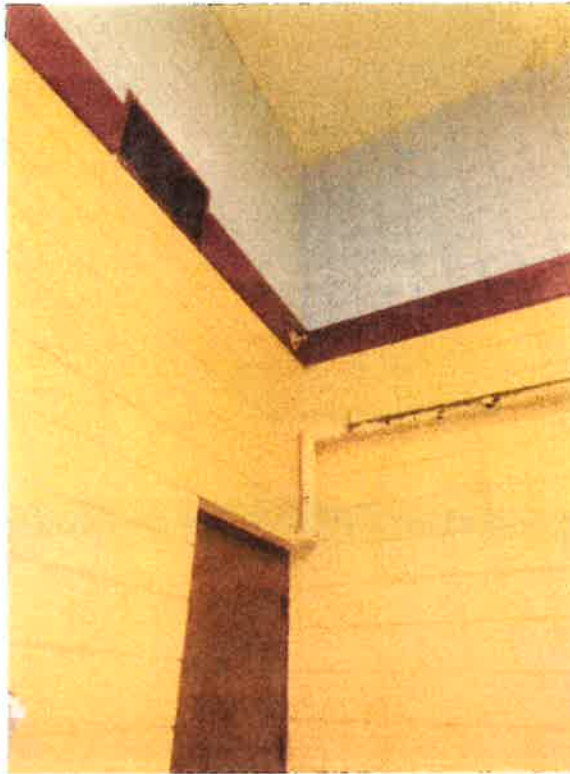
PHOTOGRAPH No. 5

- d) The gymnasium walls are tall and appear vulnerable to a code-level seismic event, especially if the walls are under-reinforced.
- e) The observed CMU walls appear to be in good physical condition, with no visible cracking or similar evidence of distress, as exemplified in Photograph No. 5.

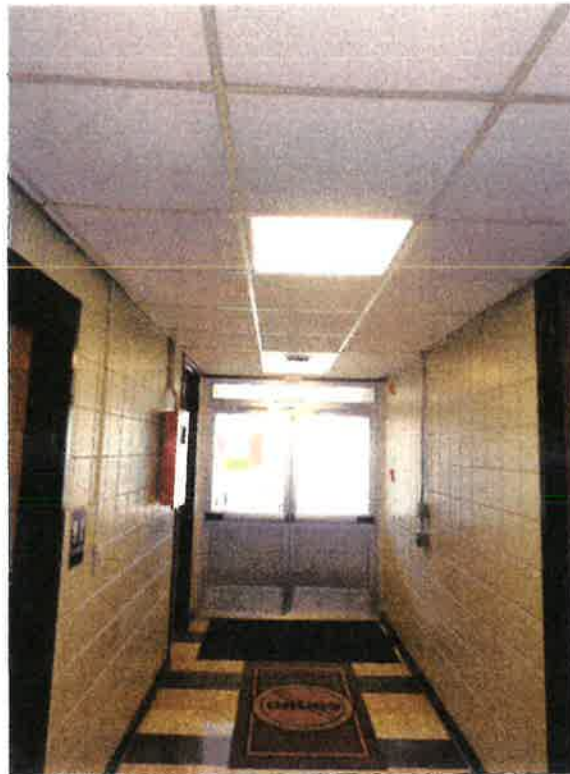
PHOTOGRAPH No. 6

- g) Several of the observed lower ceilings throughout the facility, including corridors, utilize fluorescent lights suspended in the ceiling grid, as shown in Photograph No. 6. These lights should be independently supported by the roof framing to prevent a falling and egress hazard should the ceiling fail.

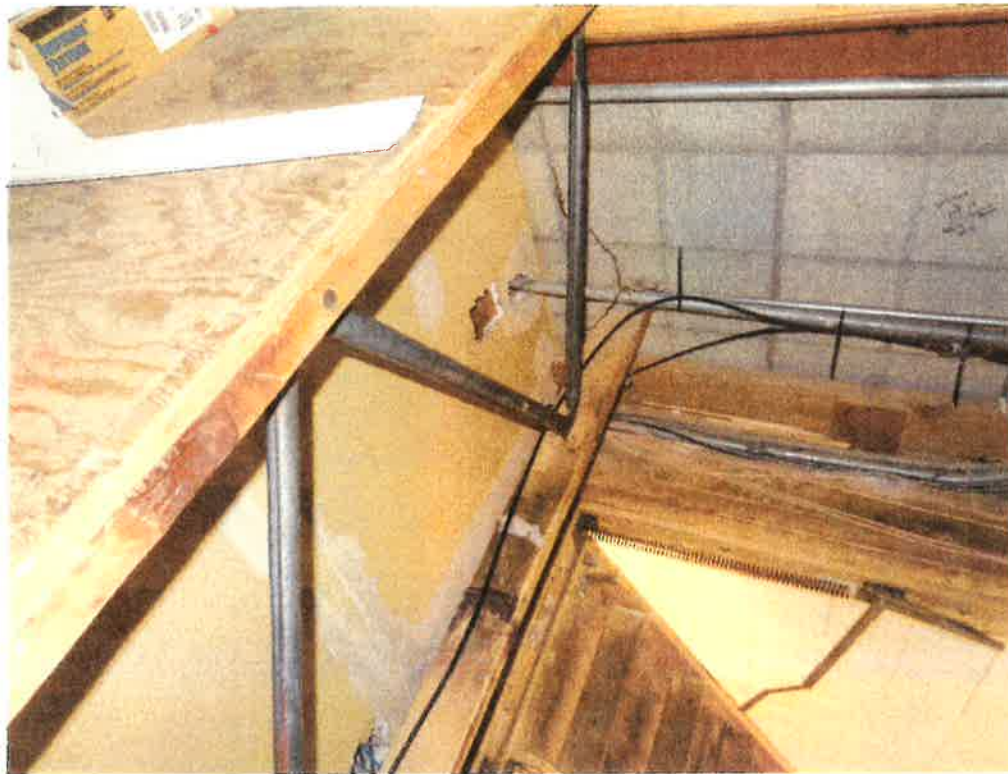
PHOTOGRAPH No. 7

- h) Much of the observed roof framing appears to be comprised of open web, parallel chords joists with wooden chords and steel tube webs. The observed framing appeared to be in good physical condition. See Photograph No. 7.

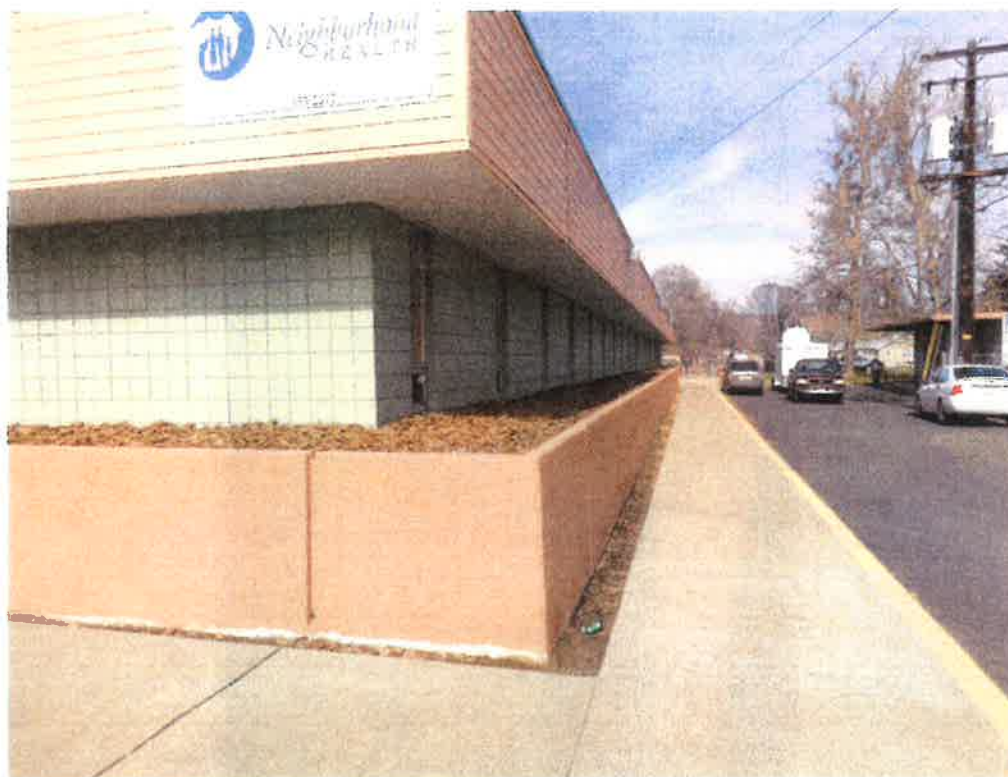
PHOTOGRAPH No. 8

- i) The majority of the building exterior is surrounded by a planter box, as exemplified in Photograph No. 8. The soil and bark dust inside the planters appear to be in direct contact with the exterior faces of the CMU walls of the building. The extent to which the exterior walls are properly waterproofed is unclear. The planter boxes represent a potentially adverse condition for the physical conditions of the exterior walls.

Consideration should be given to the removal of the existing planters around the perimeter of the building to avoid continued chronic moisture exposure to the exterior walls of the building. Once the planters and soil are removed, the exterior walls of the building should be carefully inspected, and damage repaired, as needed.

Erickson Structural also recommends that the existing perimeter planter boxes be removed. Once removed the physical condition of the exterior building walls should be examined and repaired, if needed.

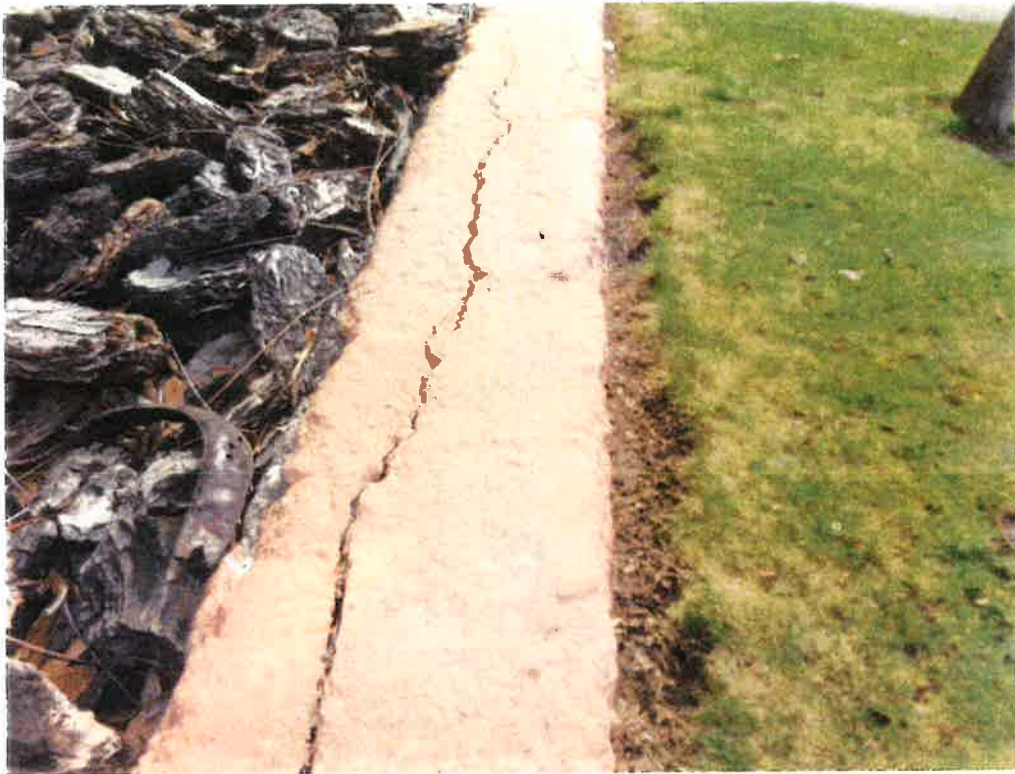
PHOTOGRAPH No. 9

- j) Although weep holes are present in the exterior walls of the planter boxes, some of the observed weep holes appeared non-functional. The resulting consequences of accumulation of moisture in the planter boxes is evident, as demonstrated by portions of the planer box walls that exhibit spalling and cracking, an indication that the reinforcing steel within the walls of the planer box is corroding. See Photograph No. 9.

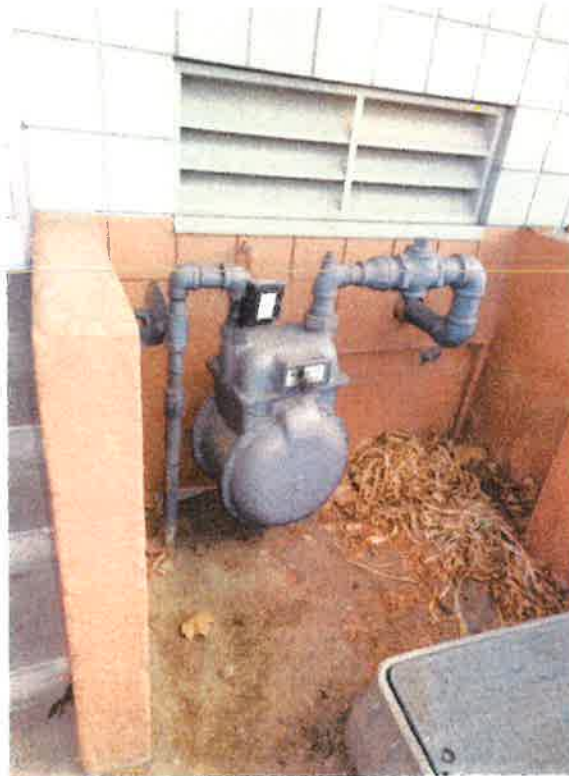
PHOTOGRAPH No. 10

- l) An automatic gas shut off valve was not observed. See Photograph No. 10.

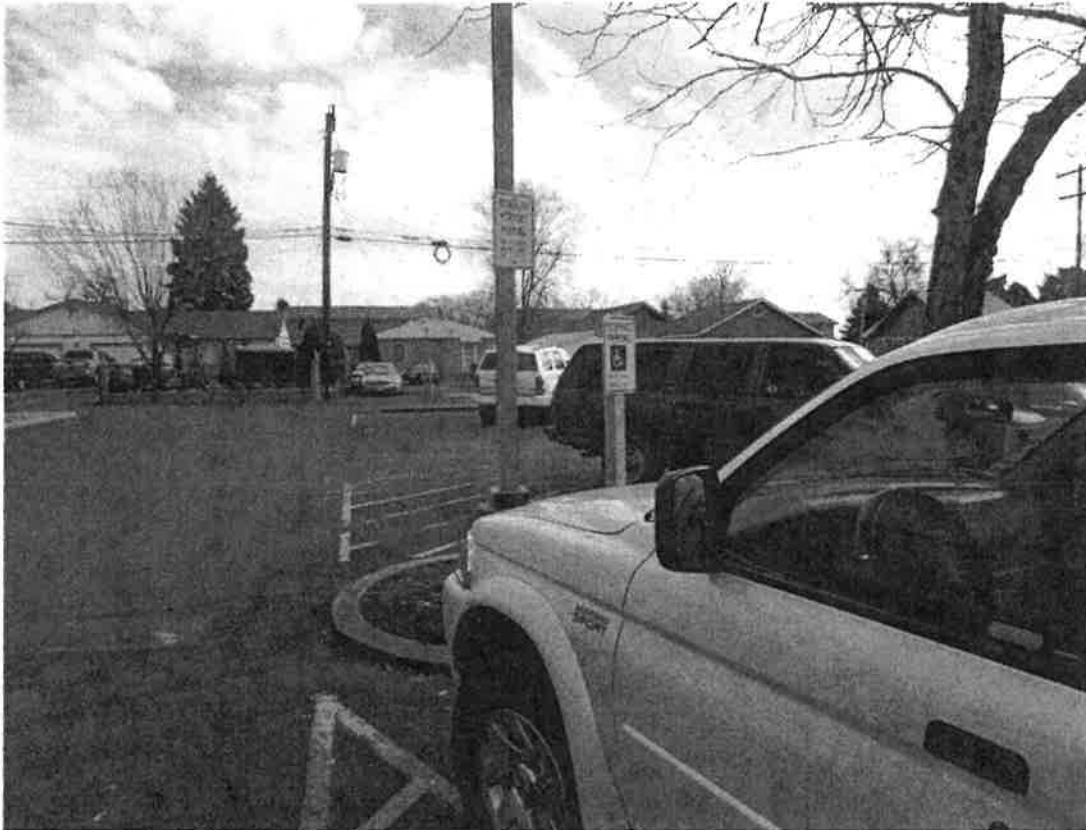
Item	Requirement	Surveyed Condition	Meet Requirement
A.7	Accessible Parking	Access aisles marked to discourage parking ICC/ANSI A117.1/502.4.4	See A.6	No
A.8	Accessible Parking	Accessible parking and access aisles surfaces are stable, firm and slip resistant ICC/ANSI A117.1/502.5	Accessible parking is on asphalt concrete. See also A.6	Yes No
A.8.1	Accessible Parking	Accessible parking and access aisles have surface slopes not steeper than 1:48 (2%) ICC/ANSI A117.1/502.5	Accessible parking has slope less than 2%	Yes
A.8.2	Accessible Parking	Accessible parking access aisle is on the same level as the parking space served ICC/ANSI A117.1/502.5	See A.6	No
A.9	Accessible Parking	Accessible parking spaces identified with signs including the International Symbol of Accessibility complying with ICC/ANSI A117.1/703.6.3.1 ICC/ANSI A117.1/502.7	Accessible car parking spaces have signage appearing to meet MUTCD standards which meet criteria Photo 2	Yes

Photo 2 – View looking east at south parking lot

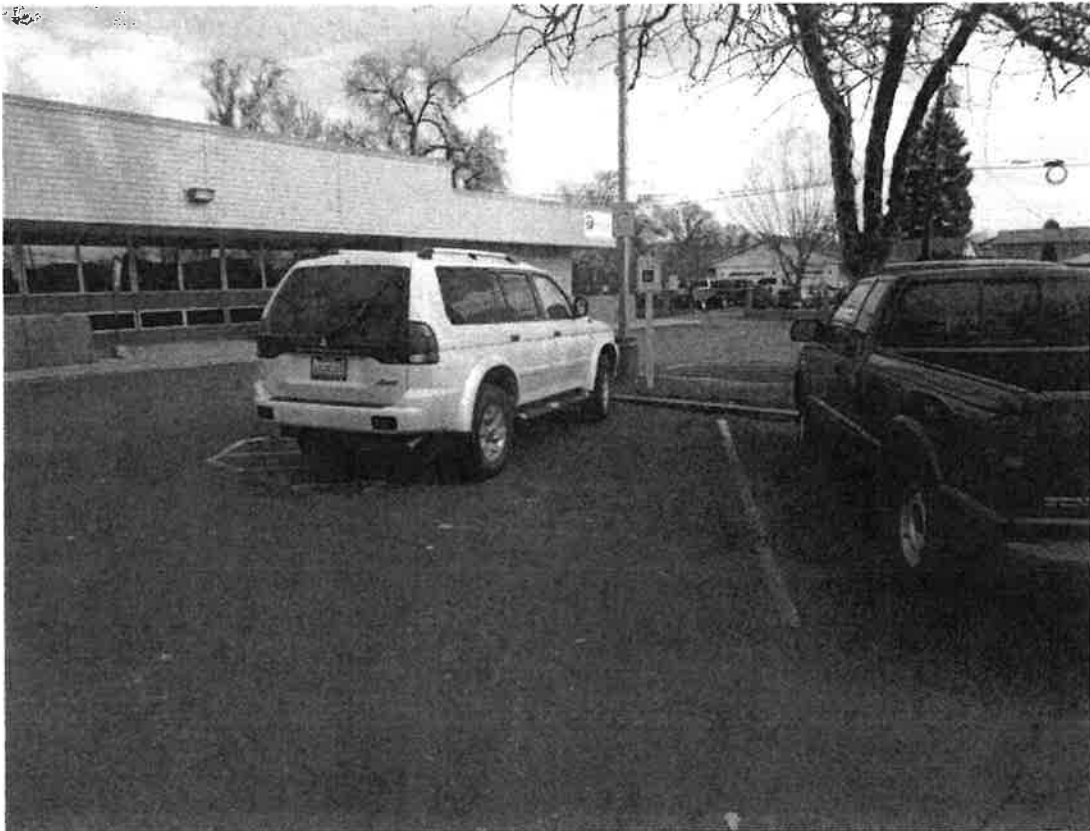
Item	Requirement	Surveyed Condition	Meet Requirement
A.5.1	Van Accessible Parking	Vertical clearance of 98" minimum is provided at parking spaces for vans, access aisles serving them, and vehicular routes from an entrance to the van parking spaces, and from the van parking spaces to a vehicular exit serving them ICC/ANSI A117.1/502.6	See A.4	No
A.6	Accessible Parking	Accessible car parking space minimum 8'-0" wide with adjacent 5'-0" wide access aisle. ICC/ANSI A117.1/502.4.2	All accessible car parking is at least 8'-0" wide with no adjacent access aisle	No
A.6.1	Accessible Parking	Accessible car parking space access aisle extends full depth of parking space ICC/ANSI A117.1/502.4.3	See A.6	No
A.6.2	Accessible Parking	Accessible car parking space access aisle shall not require travel into vehicular way ICC/ANSI A117.1/502.4.1	All accessible spaces require travel into vehicular way due to their locations not adjacent to building sidewalk. Photo 3	No

Photo 3 – Typical accessible parking stall and aisle
