Swimming Pool Assessment

**Lions Indoor Pool
509 West Pine St.
Yakima, WA**

April 22nd, 2015

RE: Lions Indoor Pool
Swimming Pool Assessment

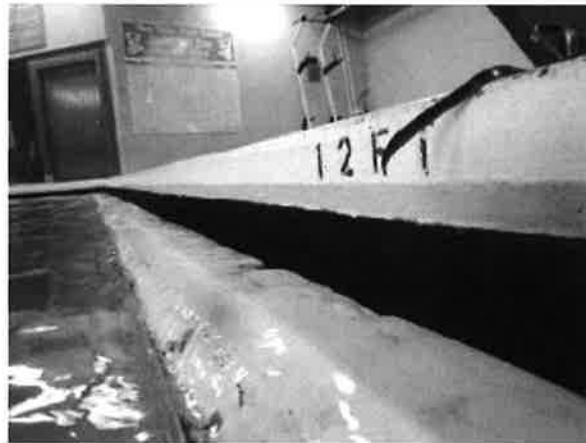
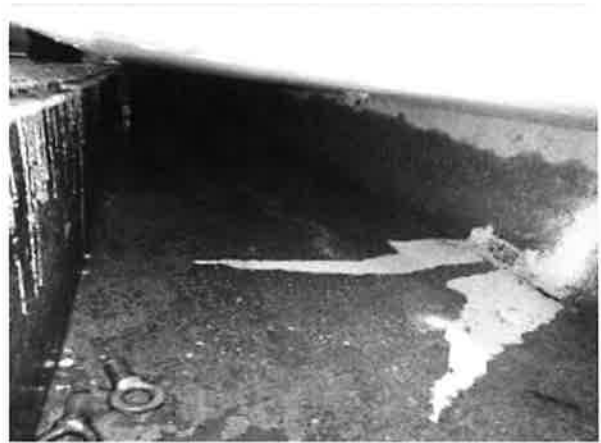
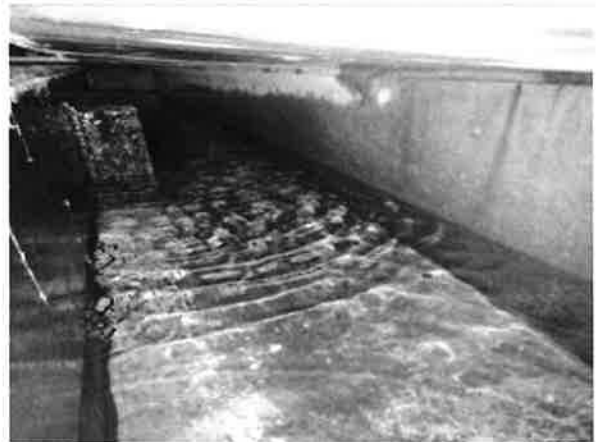
The gutter lip, the coping at the top of the pool wall, was observed to be slightly damaged and stained in some areas. An uneven gutter lip could lead to inconsistent overflow in some areas along the perimeter of the gutter. The bulkhead observed at the facility consisted of four wheels which rolled directly on the wall coping. The direct contact of the bulkhead wheels have damaged the wall coping from years of use.

Immediate: Confirm that the front of the gutter lip is level. In the case that the front of the gutter lip is not level, sections of the gutter lip may need to be removed and replaced as necessary.

Thoroughly clean the gutter trough on a regular basis to cut down on staining and corrosion.

Future: Perform a water tightness test on the gutter system to ensure that it is water tight and does not have any leaks.

Replace the gutter system with either a new stainless steel gutter system or a new concrete gutter system that better captures swimmer surge and is more user friendly for egress similar to a deck level gutter or rollout gutter system. The new gutter system should have 100% capacity of the recirculation flow rate. Recommend selecting a gutter system with PVC grating covering the gutter trough opening for safety reasons.

The gutter coping is currently damaged due to the placement of the bulkhead wheels. A new bulkhead shall be installed that is moved by means of a track and wheel system or is inflatable to eliminate any further coping damage. Refer to *Section 2.5* for further information on the existing bulkhead and suggested replacement.

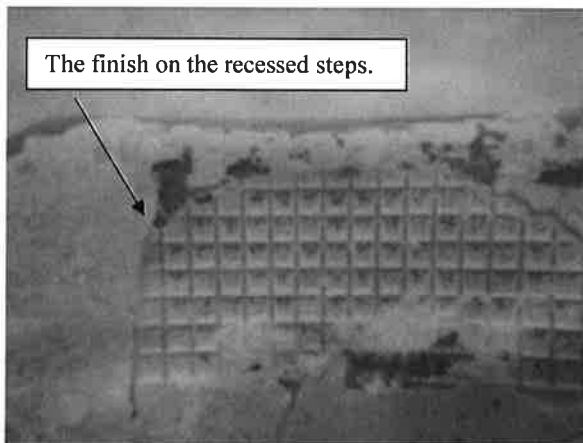
The finish on the recessed steps.

Immediate: The next time the pool is completely drained, replace any missing or damaged tiles.

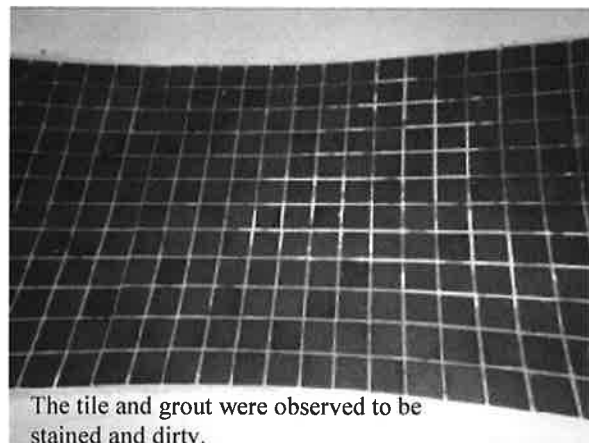
The tile and grout were observed to be stained and dirty.

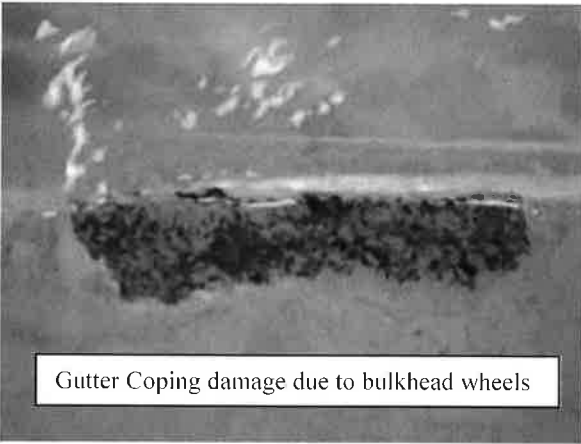
Gutter Coping damage due to bulkhead wheels

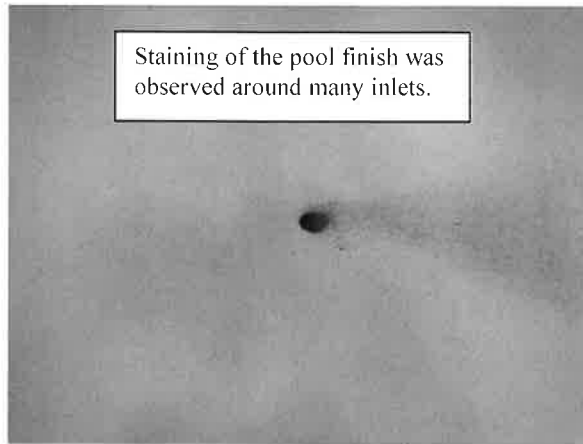
Staining of the pool finish was observed around many inlets.

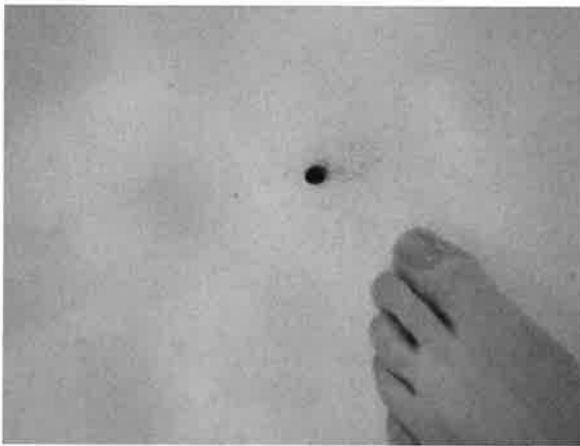
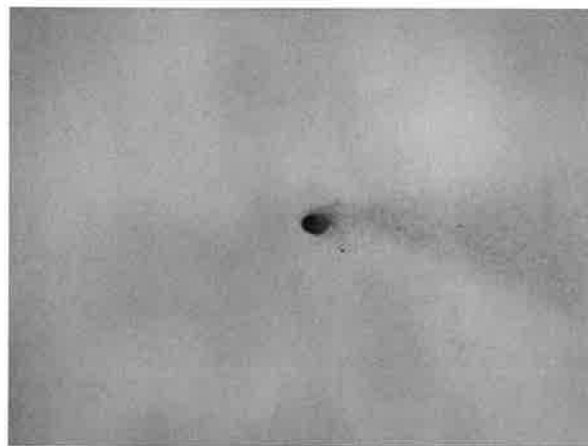
The pool is equipped with 68 floor inlets. A single 6" supply line starts in the mechanical room and braches into two (2) 6" supply lines which run directly under lane markers two (2) and five (5). Once the supply lines are routed under the lane markers they each boast 34 small PVC branches that send filtered water to each inlet. The inlets are crisscrossed so that each of the two supply lines has 17 inlets on each side of its lane marker. The branch piping is assumed to be 1". The floor inlets observed at the pool did not have any type of cover.

Immediate: The current inlet configuration meets all State and Local Codes dealing with spacing and depth requirements. Every time the pool is drained, be sure to thoroughly clean each of the floor inlets to combat corrosion and staining.

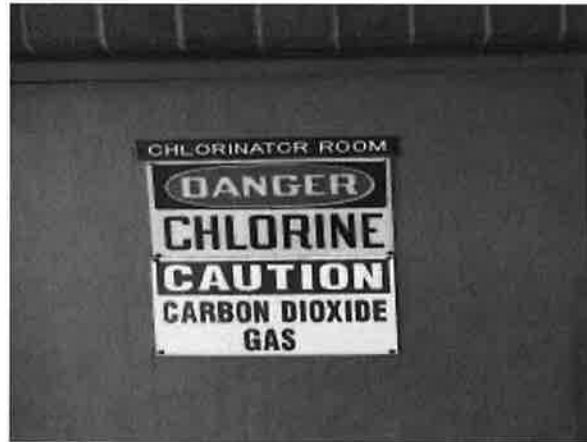
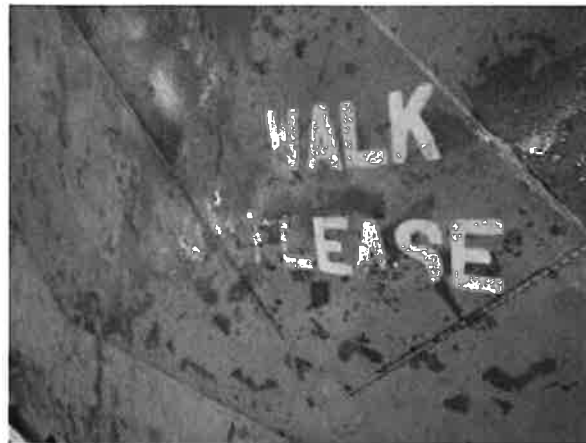
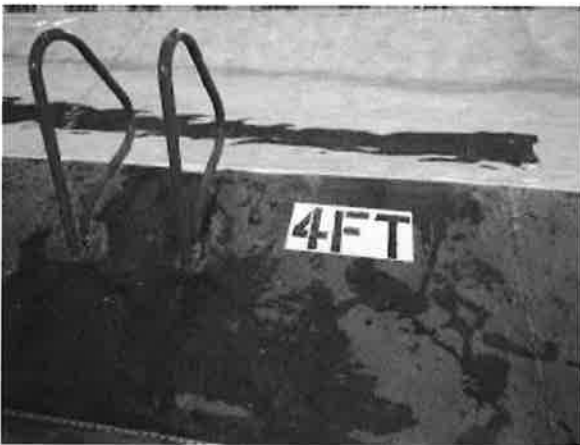
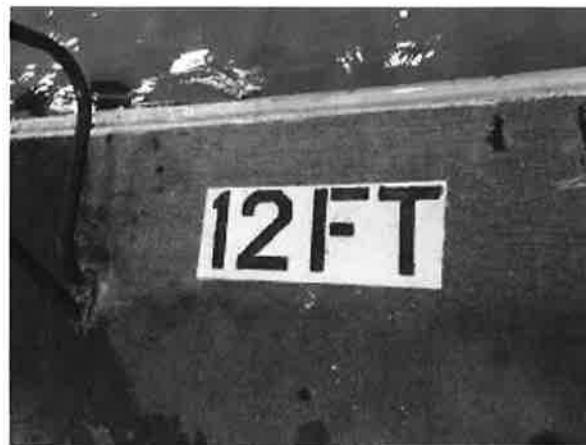
Horizontal and vertical depth markers are located around the pool perimeter in multiple locations. In addition, six (6) "NO DIVING" markers were observed along the sides of the pool from the shallow end up until the bulkhead. Per Industry Standards, "No Diving Signs" and warnings should be provided with all depths of 5'-0" and less. Washington State Pool Code requires a safety line or marking line separating areas where the pool bottom breaks from the uniform shallow end slope to a steeper slope heading towards the deep end of the pool. During the site visit a marking line was not observed on the pool shell at the slope break. Because of the bulkheads position, a floating safety line could be excessive.

Immediate: To ensure code compliance depth makers shall be installed at increments of 2' of water depth or less. Consecutive depth markers cannot be more than 25' apart. "No Diving Signs" shall be provided where ever the pool depth is five' and shallower. Install a marking line on the bottom of the pool at the 5' water depth or provide a floating safety line.

Ensure all required warning and safety signage, such as HAZMAT signage, is found around the natatorium.

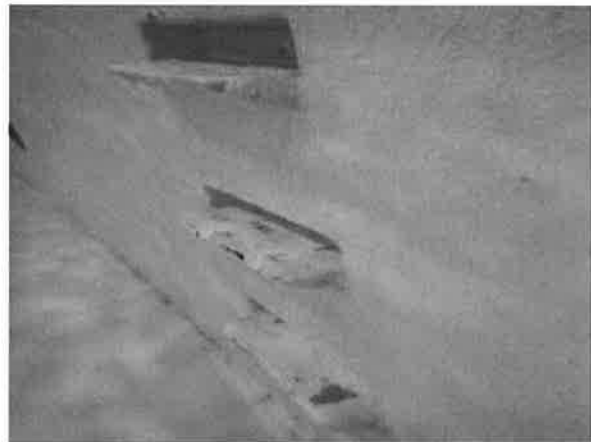
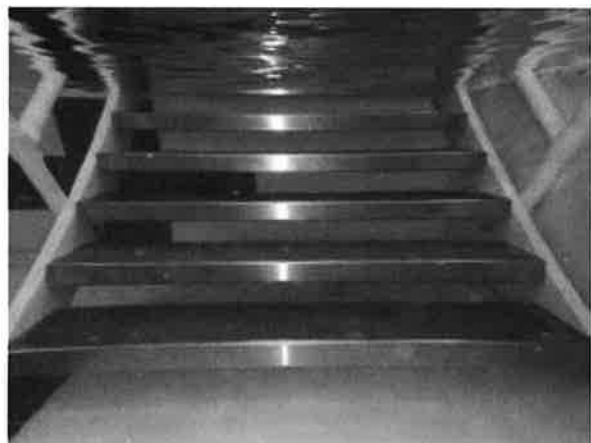
The pool has recessed steps paired with painted metal grab rails located around the pool perimeter at four (4) locations. The recessed steps were only partially recessed, with around 3" of step extending out from the wall. The steps were observed to be in fair condition and the condition of the grab rails is uncertain due to their paint exterior. The grab rails did not contain escutcheon plates. There is also a movable stainless steel and plastic staircase located in the shallow end. One portable Aqua Creek pool lift was observed at the pool facility.

The pool must have two (2) means of ADA access; one (1) primary and one (1) secondary means of access. The primary access should be an ADA pool lift or ramp entry that is permanently anchored to the pool deck. The secondary means of access must be an additional pool lift, a sloped entry, a transfer system, or a compliant entry stair system. In this situation, the cheapest option would be an ADA approved portable stair system. A portable stair system was observed in the pool, however, it is unknown if it is ADA compliant.

Immediate: Ensure that all new and old grab rail anchors are bonded per NEC 680 and have protective escutcheon plates.

Replace the existing portable staircase is an entry ramp.

Future: When the bulkhead is replaced ensure the new bulkhead can move along the pool wall without being damaged by the protruding steps. The bulkhead width dimensions can be specialized to prevent contact with the steps, or the steps can be altered so they don't branch off the pool wall as much as they currently do.

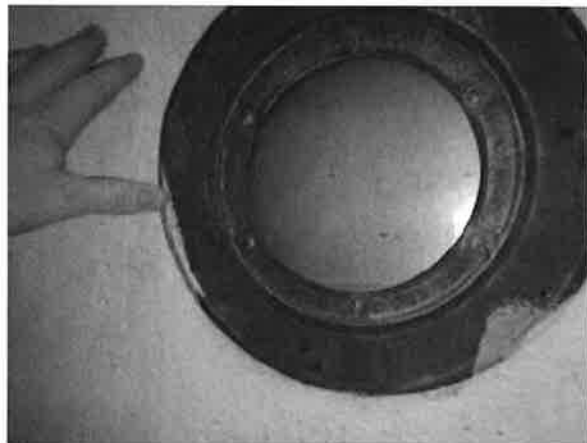
The existing underwater lights are located on the side walls of the pool. All lights have been covered with what appeared to be a stainless steel plate and are not used.

Immediate: Confirm the existing overhead lighting in the natatorium allows the bottom of the pool to be seen at all hours of operation. Protective shielding for all lighting fixtures above walking surfaces and any of the pool surface area shall be provided. Washington State Code requires a minimum of 30 foot candles above an indoor pool surface, and 10 foot candles above any pool deck. Industry standard calls for a minimum of 30-100 foot candles above the pool surface depending on the use of the pool. Foot candle requirements increase when competitions inside the natatorium shall be televised.

Future: Remove all existing light fixtures from the pool structure and repair any consequential holes or pool structure damage.

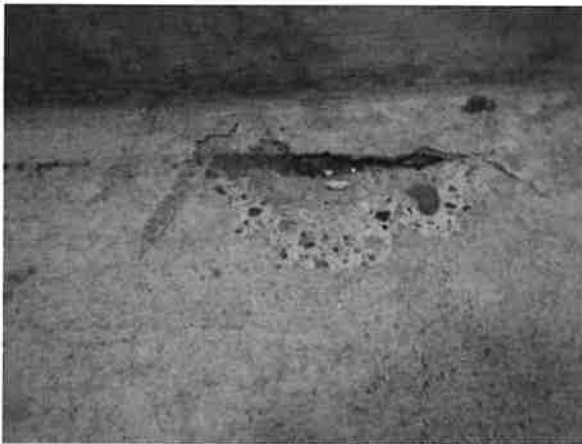
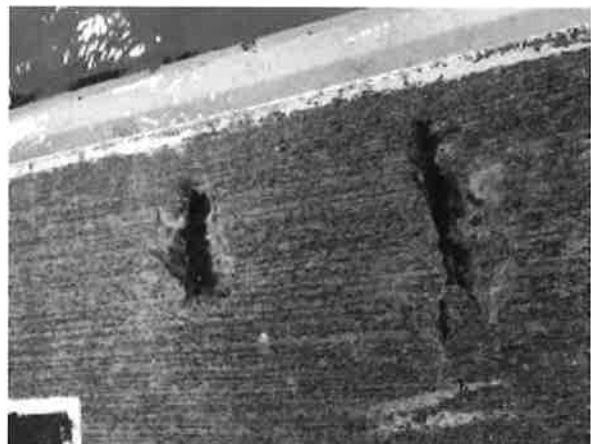
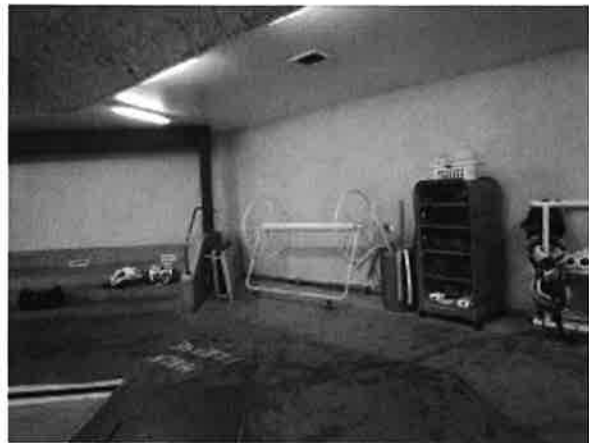
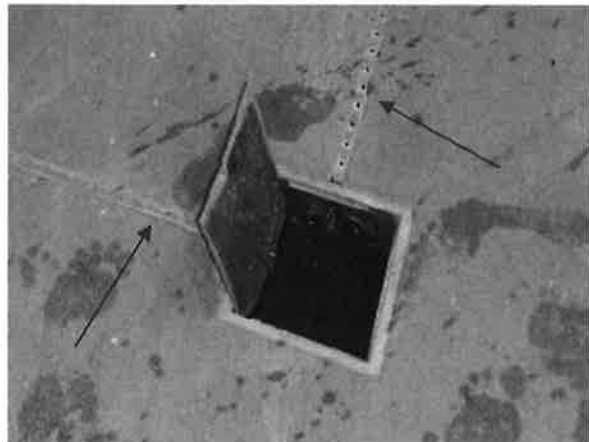
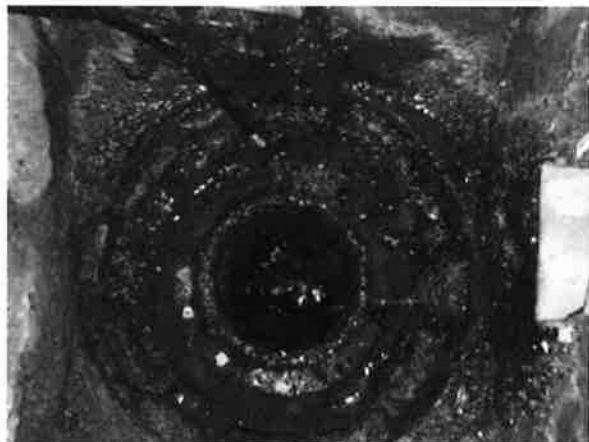
The deck inside the Lions Pool Facility consists of broom finished concrete with painted depth markers and warning signs. The condition of the deck could be described as fair to poor. The concrete was observed to be cracked and stained in numerous places. In multiple locations rebar was visible on the deck's surface and was corroding. From the edge of the pool coping, the perimeter of the deck slopes away from the pool to a narrow slot perimeter drain. The perimeter drain consists of a small trench covered by an even smaller grating with circular holes. The perimeter trench drain empties into four (4) dropouts which were observed to be located at the four (4) corners of the pool. When inspected the dropouts appeared to be full of grit and water. It is possible that the dropouts were partially or fully blocked during the time of inspection.

According to Washington State Code, *"for pools fifteen hundred square feet or larger, walking deck surfaces must be at least six feet wide on fifty percent of the perimeter on indoor pools; and the remaining fifty percent perimeter of the indoor pool must be a minimum of four feet wide"*. Seeing that the Lions Pool deck was greater than 6 feet wide in all areas it exceeds the state code minimum requirements. However, Washington State Code also requires that *"for pools fifteen hundred square feet or more, walking deck surfaces must be at least sixteen square feet per bather"*. To determine if this part of the state code is met, the total surface area of the deck should be calculated. The original construction documents from 1972 list the batherload for the pool to be 400. However using current code requirements, found in WAC 246-260-041 Section 10, the max batherload was calculated to be roughly 186 patrons. Based off a batherload of 186, the total deck area should be at least 2976 square feet.

Immediate: Ensure the deck adequately slopes to drain all water to the trench drains. Repair all areas of the deck that are cracked, especially where there is exposed rebar. Repaint all deck markings with slip resistant paint. Ensure that the deck meets minimum state requirements for square footage.

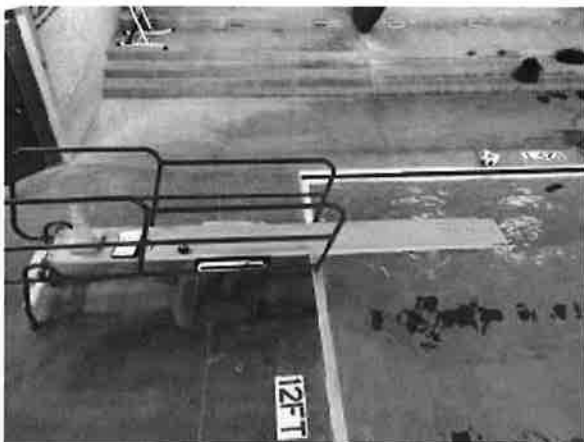
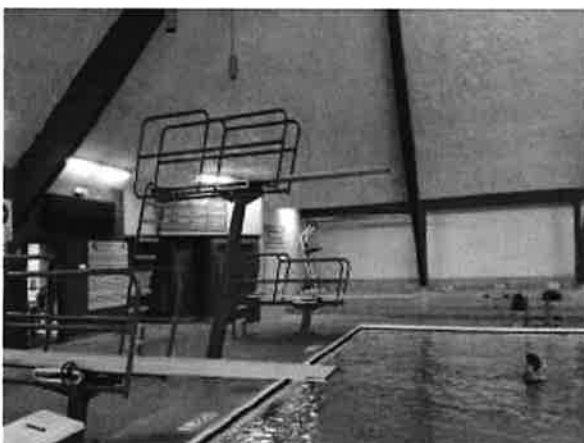
There are currently two (2) 1-Meter springboards and one (1) 3-Meter springboard installed for use at the deep end of the swimming pool. Due to their painted exterior it is hard to tell the true condition of the diving stands. The Washington State Code references FINA as the overarching code for facilities with diving platforms or boards greater than ½ Meter. The Lions Pool meets all minimum requirements spelled out by the FINA diving envelope.

All diving board access steps had a slip resistant finish. The 3-Meter diving board was not fully provided with an unobstructed hand rail/safety rail on both sides of the steps.

Immediate: Based on the facility's history and risk management concerns, it is recommended that all springboards are removed. Install a new 1-Meter springboard in the prior location of the 3-Meter springboard.

Provide escutcheon plates for diving board ladders and support stands. Ensure all diving board stand anchors are properly bonded and installed per the manufacturer's recommendations. Wipe down the safety railings and diving stands with stainless steel cleaner on a regular basis in order to reduce corrosion.

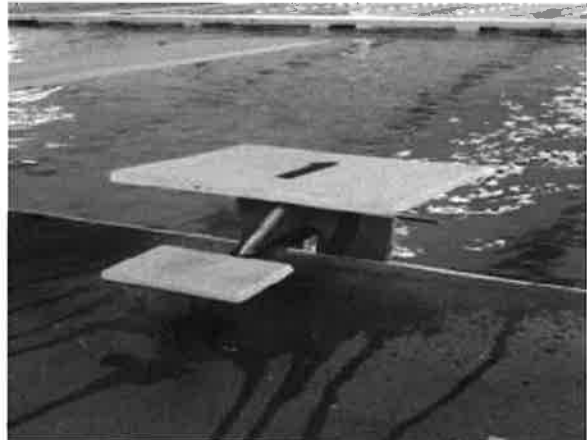
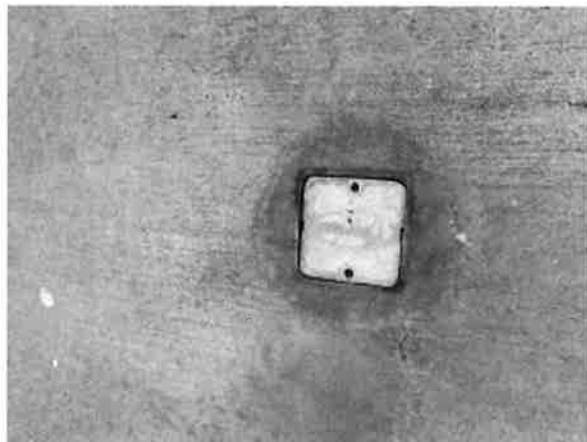
There are anchor slots for six (6) starting blocks for the six (6) lane, 25 Yard, race course layout. The starting blocks appear to be very old and in fair to poor condition. The height of the starting blocks above the water was not measured during the site visit, however most organizations require a maximum starting block height of 30" above the pool water surface.

Immediate: Provide new starting blocks that are compliant with the NFSHA.

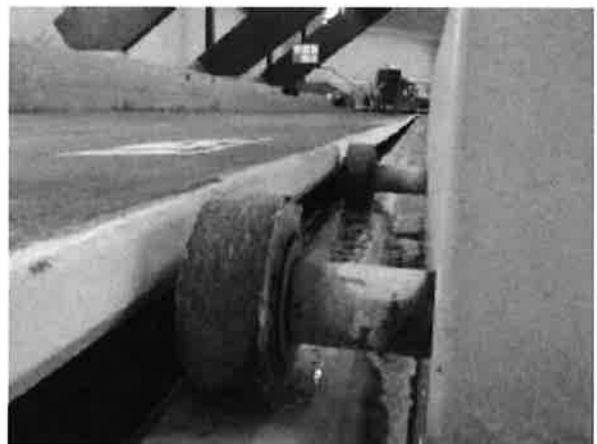
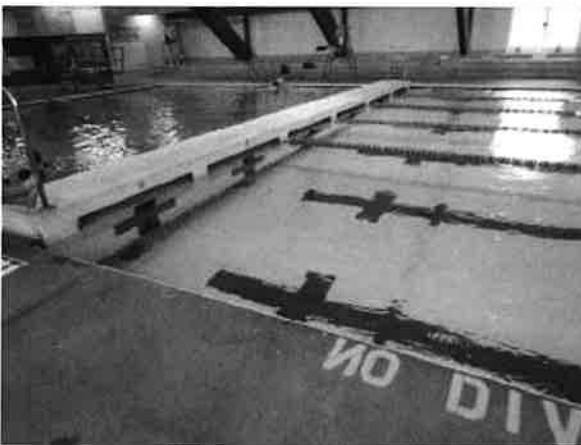
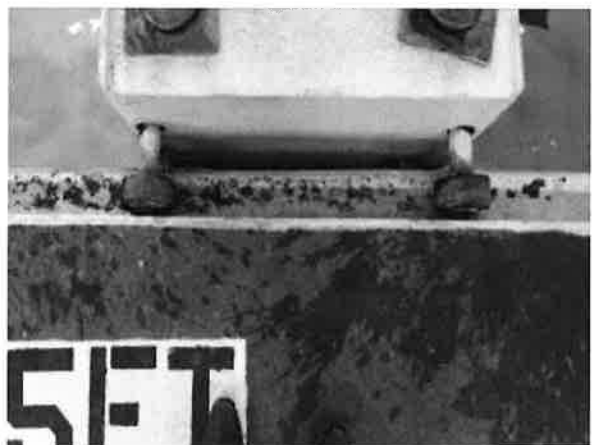
The bulkhead at the Lions Pool Facility was observed to be in poor condition. The actual age of the bulkhead was not recorded during the site visit. The bulkhead was observed to be a Stark fiberglass flow through bulkhead. The bulkhead moves manually, so it requires people to push or pull both ends simultaneously. The bulkhead wheels are located directly on the gutter coping and have damaged the gutter finish over the years.

During the time of the site visit the bulkhead was located at the slope break between the shallow and deep ends of the pool. When located at the slope break, the bulkhead creates a 25 yard race course from the bulkhead to the shallow end wall. This course is 4'6" at its deepest point and therefore would not provide adequate depth for starting blocks. According to facility staff, the bulkhead is moved into the shallow end when the pool is to be used for competitive swimming. The only location that starting block anchors were observed was at the deep end wall. The deep end does provide adequate depth for competitive block starts.

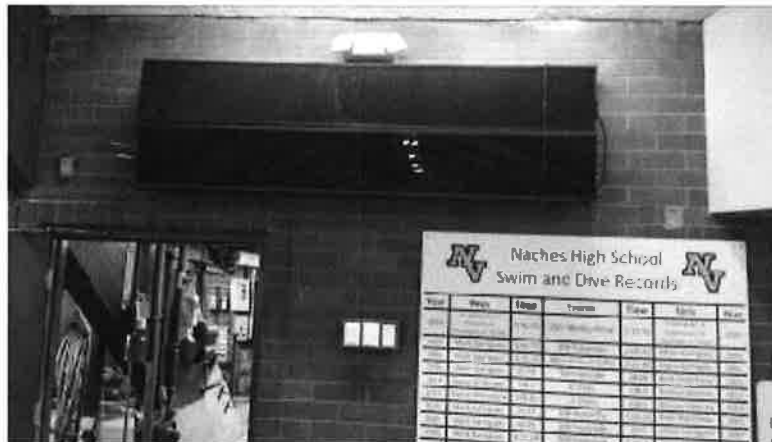
A timing system was not observed at the Lions Pool Facility. A single line scoreboard was observed on the natatorium wall. The scoreboard appears to be in good condition, but it was not observed in operation at the time of the site visit. Deck plates for connection of touchpads nor other timing equipment were observed at the facility during the visit.

Immediate: Repair the scoreboard on an as needed basis. If touch pads are used, verify that the race course meets the requirements of a 75'-0" course length with touchpads installed on the endwalls.

Future: Due to the amount of swim teams that use the facility, installing a permanent timing system may be a beneficial additional to the facility and its users. The timing shall consist of deck plates, wall plates, touchpads, pace clocks, and any other equipment deemed necessary by facility staff. Colorado Timing Systems or Daktronics are the recommended timing system manufacturers. A new six (6) line scoreboard shall be considered for the facility.

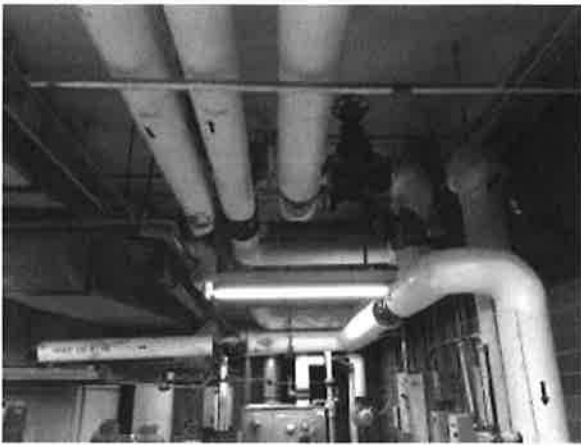
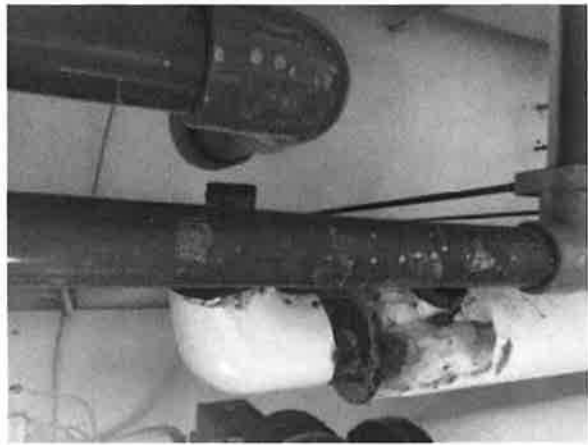
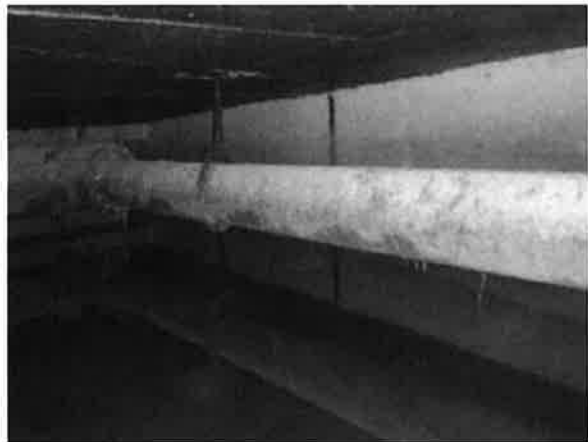
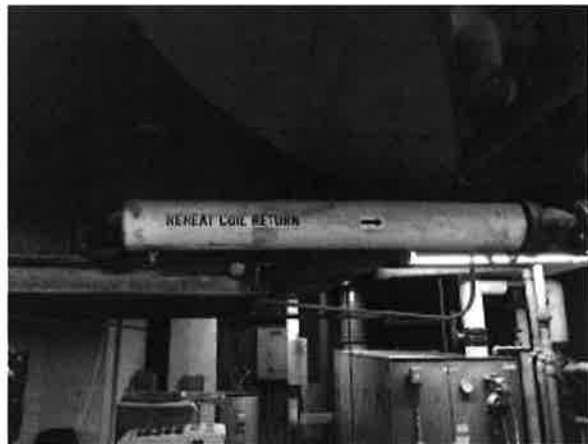
The visible recirculation piping for the pool in the pool mechanical room is cast iron. The chemical feed loop piping that intersects the main recirculation loop and the fresh water fill line are 40 PVC. The piping appears to be in fair to poor condition. Some sections of the main cast iron recirculation pipe were stated to be in near failing condition by facility staff. However, visual observation could not be done due to the pipe locations. The return line from the main drains is shown as an 8" line on the '72 construction drawings. This section of pipe runs underneath the pool, comes up through the surge tank floor, and then penetrates the filter tank wall. Water flows from the main drains into the filter tank when the modulating float valve is actuated. The provided pool drawings indicated the presence of a modulating float valve, but the existence of the valve could not be confirmed from the site inspection.

Very little, if any, color coding or labeling was observed on the mechanical room piping. It is industry standard to provide plumbing identification through either color coding or labels. The majority of the valves in the mechanical room have labels identifying their purpose, however there is no posted piping and valve schematic.

The pool has an 8" cast iron pipe that routes water from the two (2) main drains back to the filter via static pressure head. An 8" cast iron equalizer line also routes water from the surge tank to the filter tank. It is industry standard to size gravity piping to flow at 3 fps. Due to the unique design of the pool's perimeter overflow system, there was no gravity piping to take into consideration, rather the perimeter gutter trench flowed via gravity, albeit in a pressurized condition. Washington State Code requires a 1% slope minimum for all gravity piping. In the case that a 1% slope is not provided for gravity piping, a design solution, prepared with a detailed explanation may be sufficient. The Washington State Code requires suction piping to not exceed 6 fps. The max water velocity in the main drain suction lines would be around 4 fps, assuming a flow rate of 597 GPM. The discharge piping, from the effluent end of the pool recirculation pump back to the pool, is 6" PVC, and believed to be Schedule 40 PVC. Again assuming a flow rate of 597 GPM, the discharge velocity is approximately 6.62 fps. Washington State Pool Code does not provide any guidelines on maximum or minimum discharge velocity, as long as the flow rate meets the minimum State required turnover rate. Because the discharge piping velocity falls below the typical industry maximum velocity, it can be assumed that the piping is adequately sized for the current flowrate.

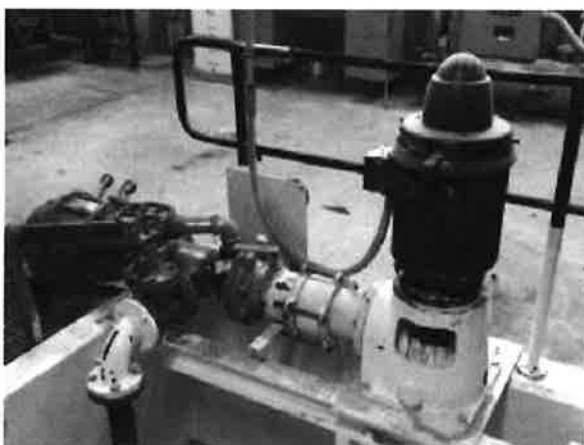
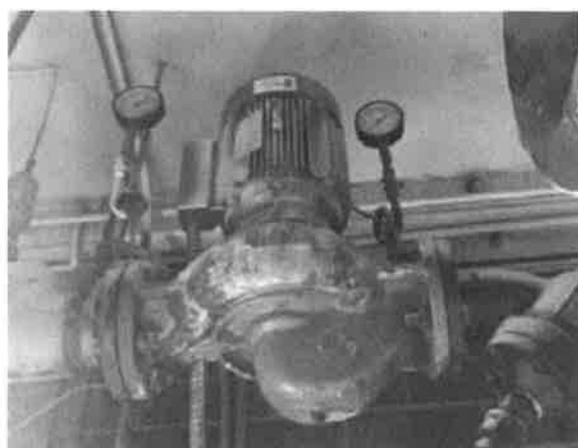
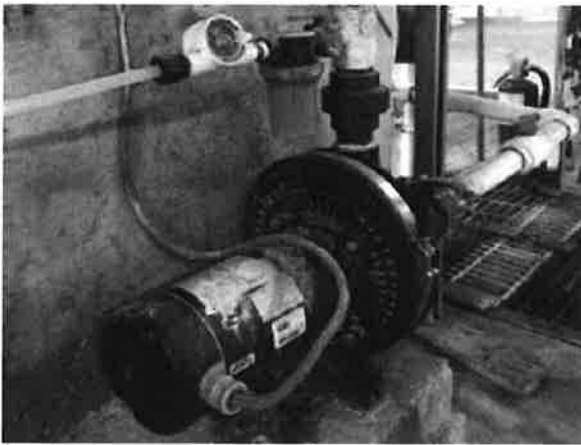
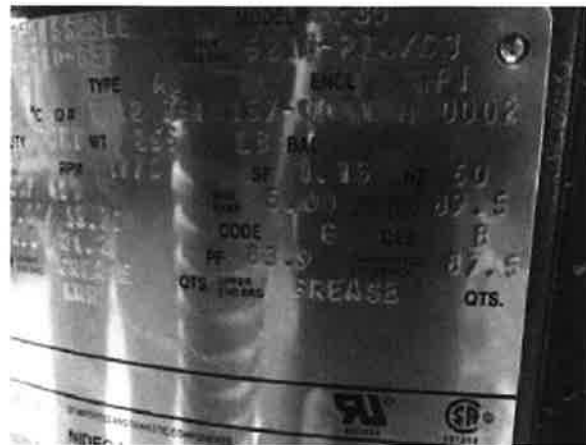
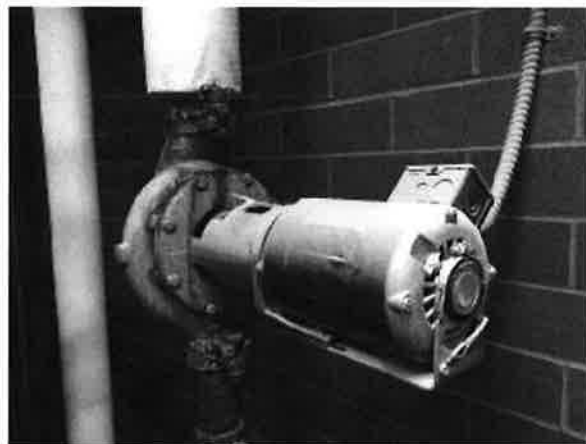
Three (3) additional booster pumps were observed in the mechanical room but were not in operation. One (1) of the three (3) booster pumps was located in the old heat exchanger loop but served no purpose due to the heat exchanger being inoperable.

Immediate: Replace the recirculation pump with a pump that can adequately surpass the state required turnover as well as power the chemical feed loop. To meet a 4 HR turnover the new recirculation pump will need to provide a flowrate of 895 GPM. Provide vacuum gauges on the intake suction side of all pumps and pressure gauges on the discharge side. Provide labels for the knife disconnects and ensure they are working properly. Ensure all pumps are properly bonded as per NEC 680.

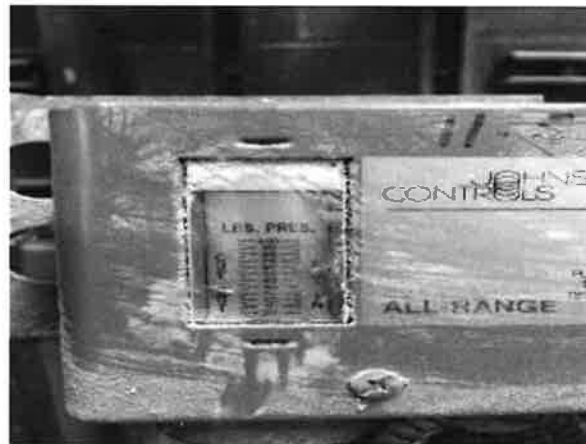
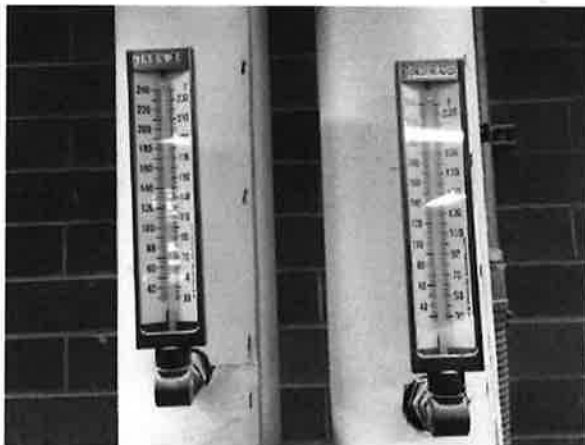
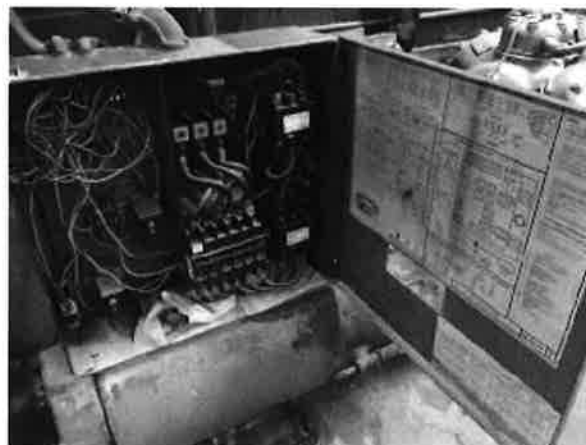
The current pool heating system was recorded to be functioning effectively and therefore no additional immediate action is required. Due to the age of the pool boiler, a replacement should be concerned in 5-10 years.

Immediate: Repair existing dehumidification system.

Future: Replace the natatorium's dehumidification system, HVAC unit, and pool boiler.

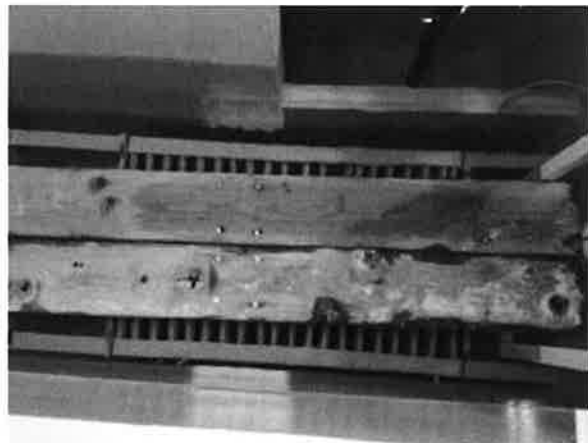
The filter tank itself is open to atmosphere which is convenient for maintenance and monitoring. Two (2) wooden planks were observed to serve as a walking bridge over the filter tank. The floating planks were dangerous due to the fact that they began to sink when stepped on.

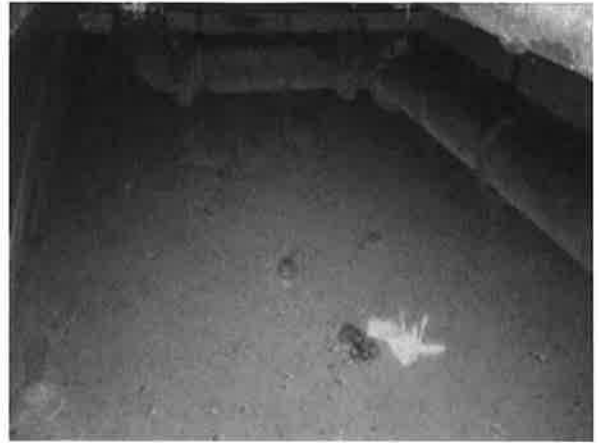
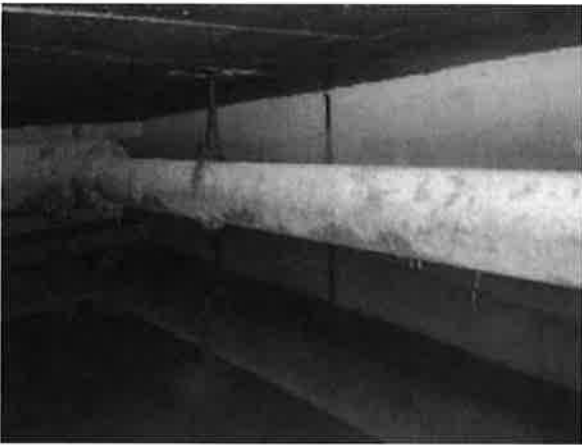
It was not clear if there was waterproofing provided on the interior surfaces of the surge tank. Due to the configuration of the surge tank it seems that the only way for air to evacuate the inside of the surge tank is back out through the perimeter overflow gutter. If this isn't providing adequate ventilation, the chloramine concentration within the surge tank is most likely high. Because chloramines can attack metals contributing to corrosion, the cast iron piping located in the surge tank appeared to be in poor condition.

Immediate: Replace all piping within the surge tank with Sch. 80 PVC. All piping supports found within the surge tank shall be stainless steel.

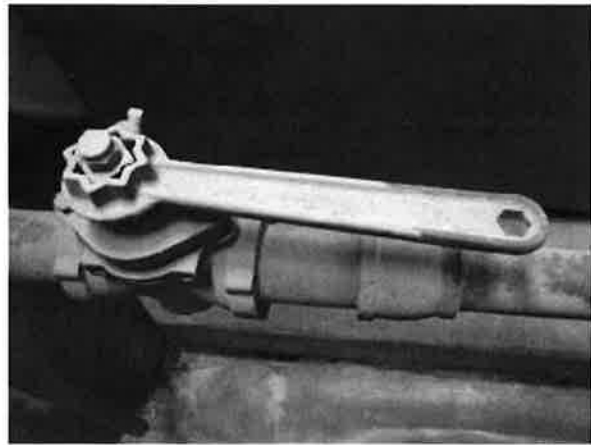
The valves in the mechanical room are a mix of cast iron gate and ball valves, PVC ball valves, and butterfly valves. The industry standard is to use true union ball valves to allow the valve to be accessed without having to cut the connecting PVC piping for valves smaller than 3". All valves greater than 3" shall be butterfly valves. Some of the valves in the mechanical room have identification tags, but there is no posted piping and valve schematic.

Immediate: Provide valve tags for each valve and post a piping and valve chart system schematic in the pool mechanical room.

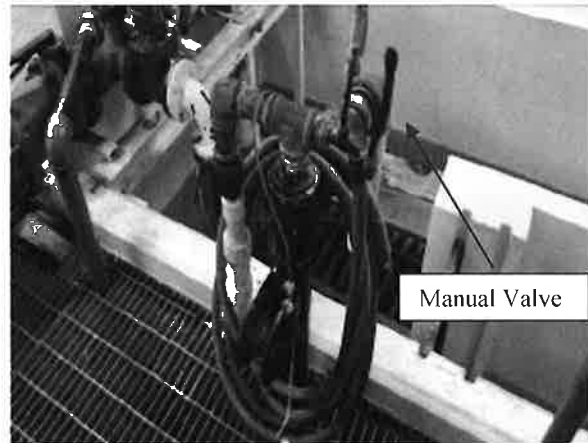
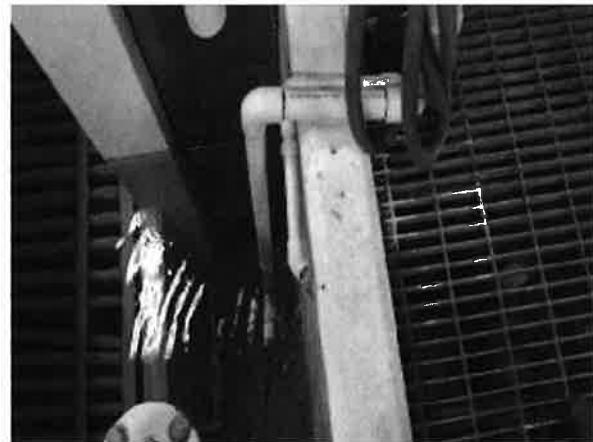
The water level control system for the pool uses a modulating float valve located within the d.e. filter tank. When the water drops to a certain height in the filter tank, the float triggers the valve to open which adds water to the filter tank. The valve will begin to close as the float rises to the desired height from the added fill water. There is also a manual fill valve located by the auto fill line. This valve can be actuated by a facility operator at any time.

Future: Because there appears to be no high level water sensor, it is recommended to provide an automatic water level control system complete with a monitor located in the pool mechanical room, one (1) surge tank mounted wet cell with normal and high level sensor probes, and an automatic solenoid valve on the fill line. System to be similar to an ELC-810 by Aquicontrol Technology. Provide a water totalizer meter for the domestic fill water for the pool system with a digital readout similar to those manufactured by Sensus. It would make the most sense to complete these upgrades when the surge tanks is repaired, replaced, or even cleaned.
