## **ELEVATOR MODERNIZATION REPORT**

**Yakima City Hall  
129 North 2<sup>nd</sup> Street  
Yakima, WA**

December 4, 2015

**Prepared by:**  
Mike Stevens, Senior Vice President  
Elevator Consulting Services, Inc.

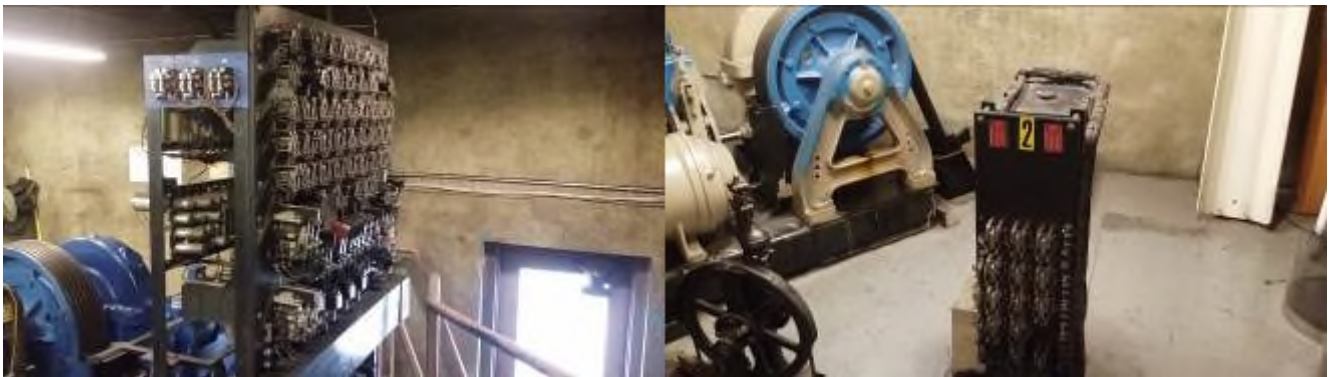
***Existing Controller/Selector:***

The existing controllers and selectors is much outdated relay logic technology and require very high levels of maintenance. We recommend the existing elevator controller and selector be replaced with a new solid state unit with a solid state VVVF drive unit that will significantly improve: 1) the operation of the elevator; 2) the floor leveling accuracy and; 3) the energy efficiency of the elevators. Additionally, the new controllers will be compliant with the firefighter's emergency operation and seismic operation required by current code. The new controller will also be equipped with a Regenerative drive that actually induces power back into the building power grid that creates savings on the power bill.

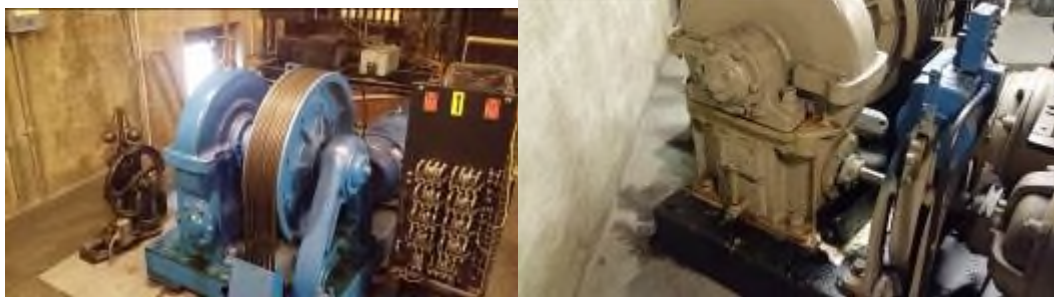
***Existing Geared Traction Machine, Hoist Motor, Brake Assembly and Drive Sheave:***

The geared machines have been well maintained however it has been in continual service for 66 years. The machine is leaking oil but the ring gear seems to be in ok condition despite its age. The modernization would replace the geared hoist machine with new gearless permanent magnet AC machines.

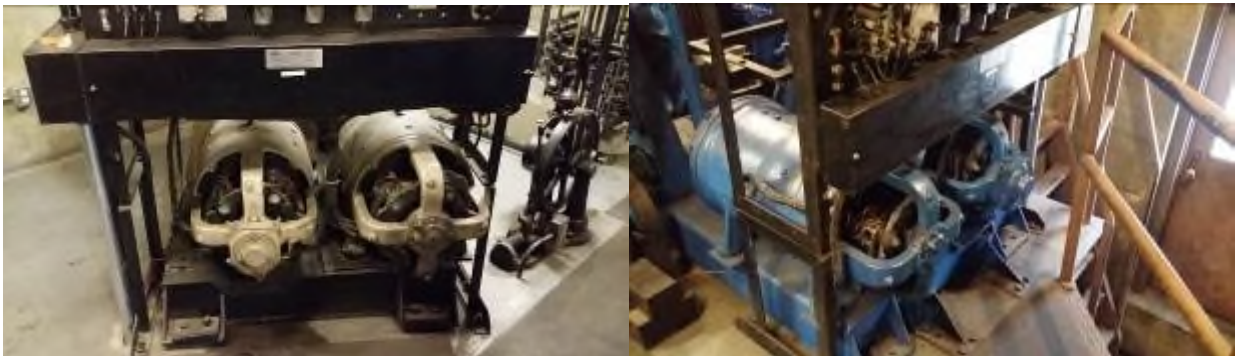
***Existing Motor Generator Set:***

The existing DC motor generator is outdated technology, requires continuous maintenance and generates carbon dust. It will no longer be required and will be replaced with a new solid state motor drive unit when a new AC hoist motor is installed. Its replacement will contribute towards dramatic energy savings, heat reduction, reduced maintenance with greater reliability.

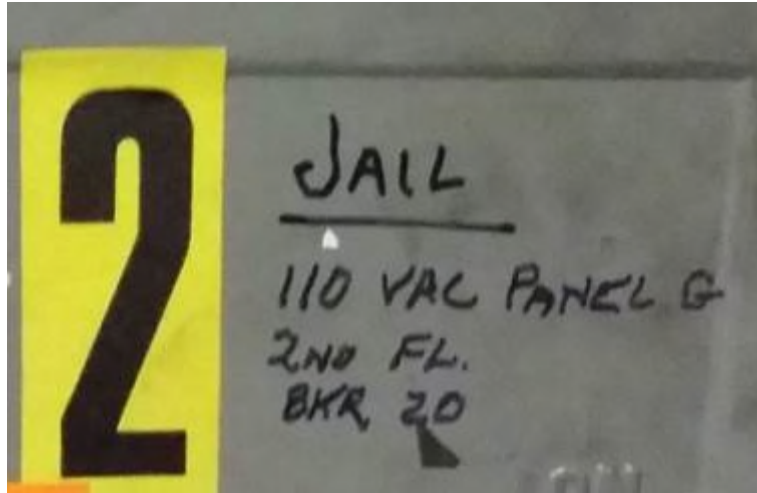
Existing cab lights:

ASME Code A17.1 requires a lockable type disconnect for the car lighting circuit be installed in the elevator machine room. The existing car lighting disconnect is lockable and can be retained as part of the elevator modernization.

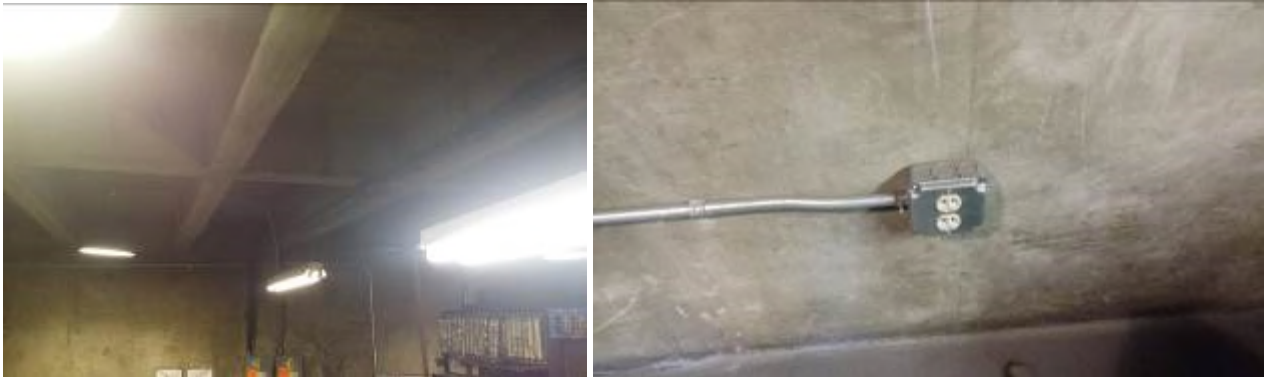
***Existing machine room lights and receptacles;***

The machine room is of adequate size to accommodate the new elevator equipment. Illumination levels must be a minimum of 200 lx (19 fc) measured at floor level. New light will not be required as the room appeared to have sufficient lighting. The machine room electrical outlet will be replaced with a GFCI outlet as required by code. The existing bulbs will have to have guards or sleeves placed over the bulbs.

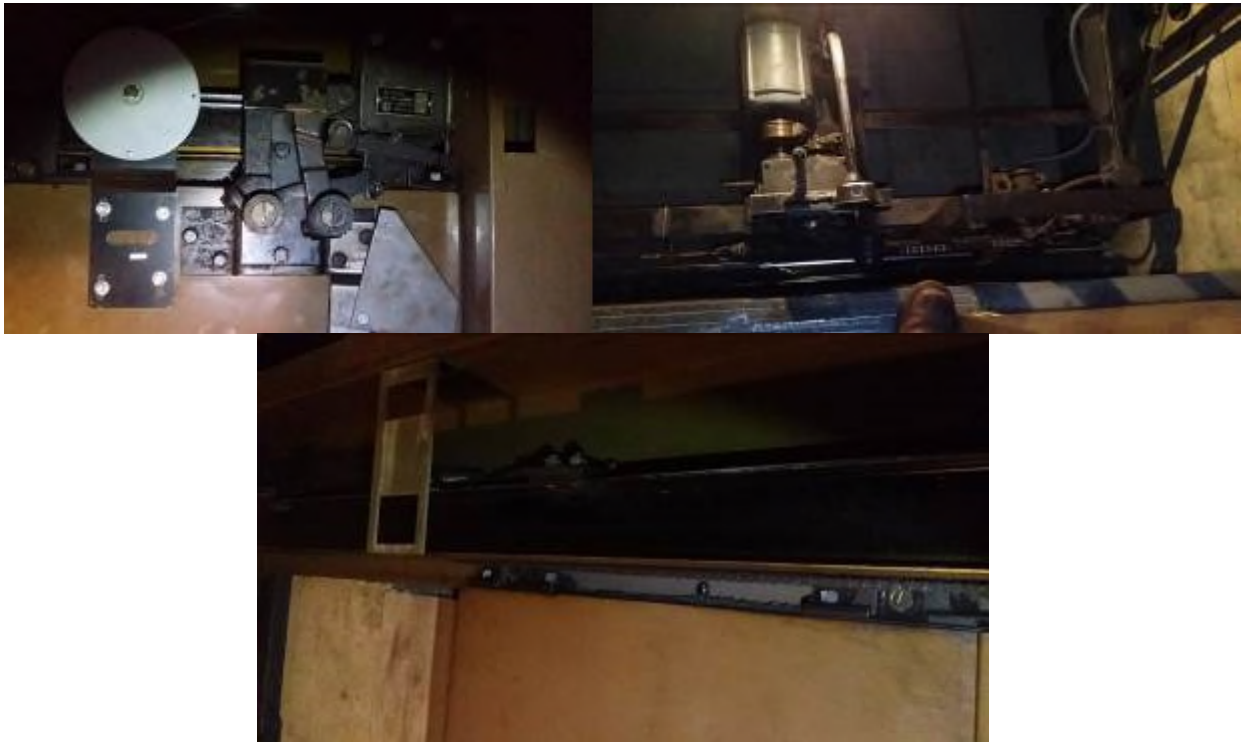
***Existing Hoistway Doors, Headers, Tracks, Struts and Interlocks:***

The hoistway doors are not fire rated, are in poor condition and should be replaced. The door headers and tracks, interlocks, upthrusts, hangers and rollers would be replaced with new. The tracks and hangers are old Otis chain driven type and severely outdated.

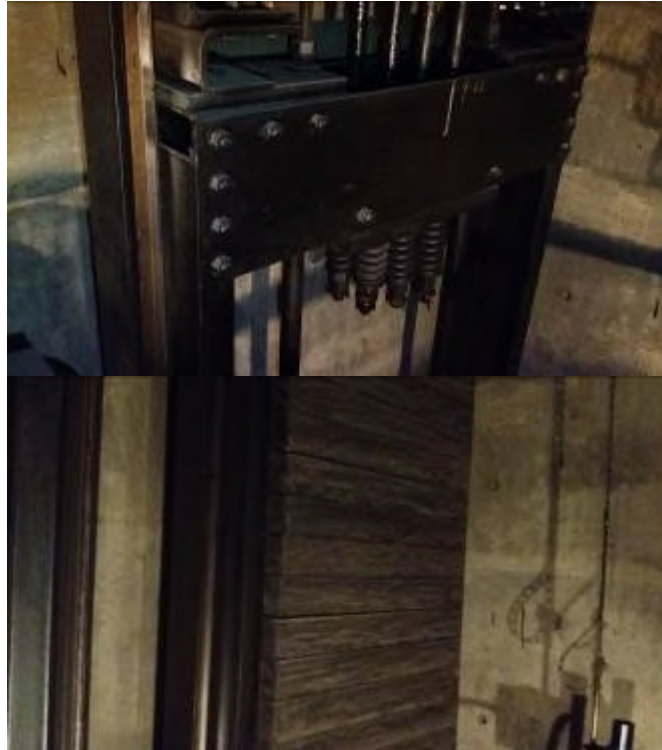
**Existing counterweights:**

The counterweight frames is in good shape and can be retained. All fasteners will be checked for tight.
