## Memorandum

Date: June 18, 2021

Subject: **Top Ten Collision Locations**

Based on accident data from 2017 – 2020, ten intersections within the City have been identified as having the highest number of collisions. The high number of collisions is not unexpected at these intersections due to the high volumes at each location. While each of these intersections is signalized, conflicts still occur due to the turning movements.

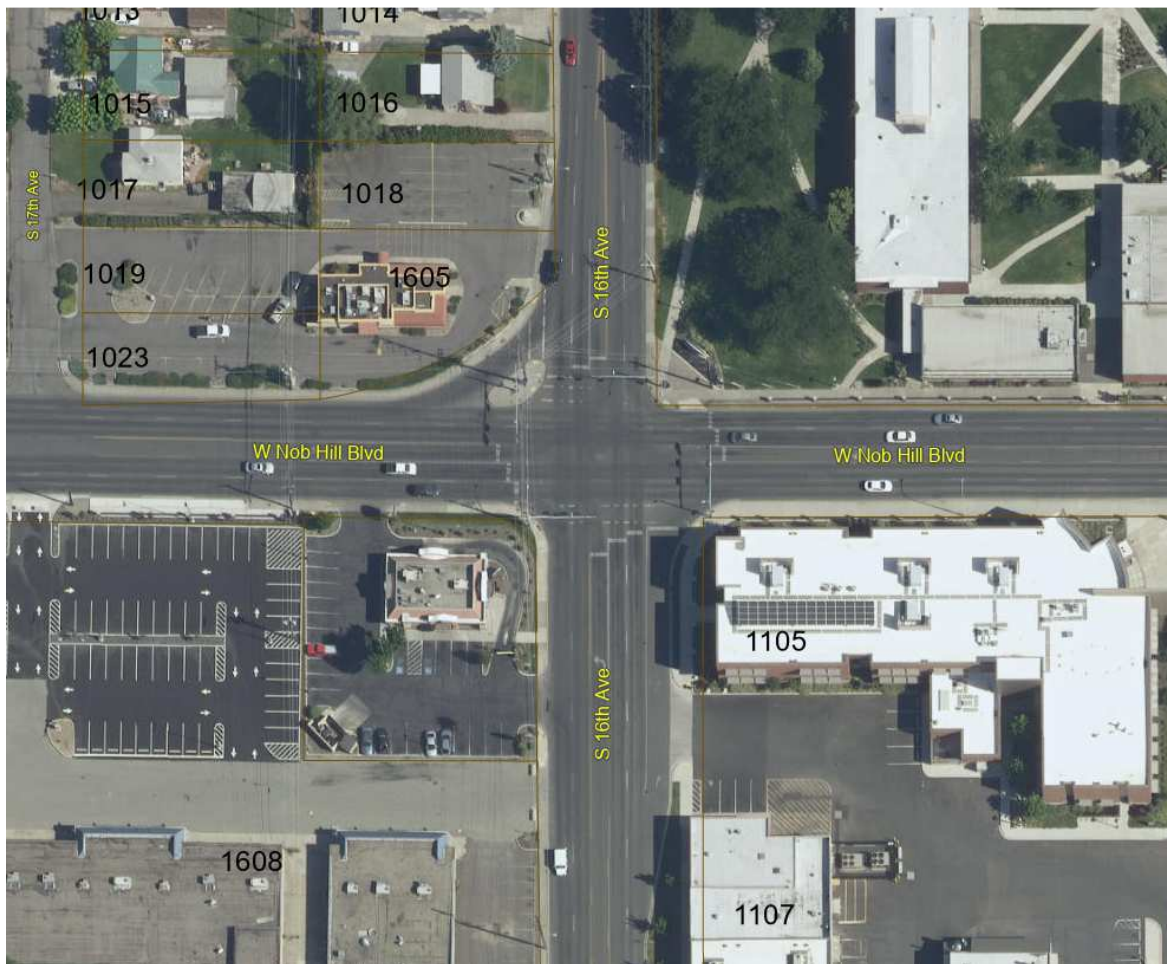
16<sup>th</sup> Ave/Nob Hill Blvd Intersection

The 16<sup>th</sup> Avenue/Nob Hill Boulevard intersection has 5 lanes on each leg plus a right turn lane northbound and a “free” right turn lane southbound. It has a controlled pedestrian crossing on each leg. The travel lanes are narrower than the preferred eleven foot minimum and the southbound left turn lacks adequate vehicle storage.

Of the listed 51 collisions at 16<sup>th</sup> Avenue and Nob Hill Boulevard, 48 collisions were intersection related. The remainder were tied to driveways or were not related to the intersection operation.

Although this intersection ranks at the highest for total number of collisions, it did see a decrease in collisions starting in 2020. 9 collisions in 2020 versus 19 in 2019 and 20 in 2018. Some of this may be related to decreased traffic volumes with the college not in session due to COVID but the City did make recent improvements that may have helped as well. Protected-permitted left turn signals were installed along with upgrading to all LED indications and installation of a battery backup system.

**Recommendation:** While it appears that accidents are going down at this location, further analysis of options is warranted. Existing geometry of the intersection limits what can be done, without a large capital expense, to probable lighting, striping, signing, and/or educational efforts. Increased enforcement is another an option, but that is most effective for accidents not predominantly seen at this intersection. Staff will also continue to evaluate our previous intersection improvements.

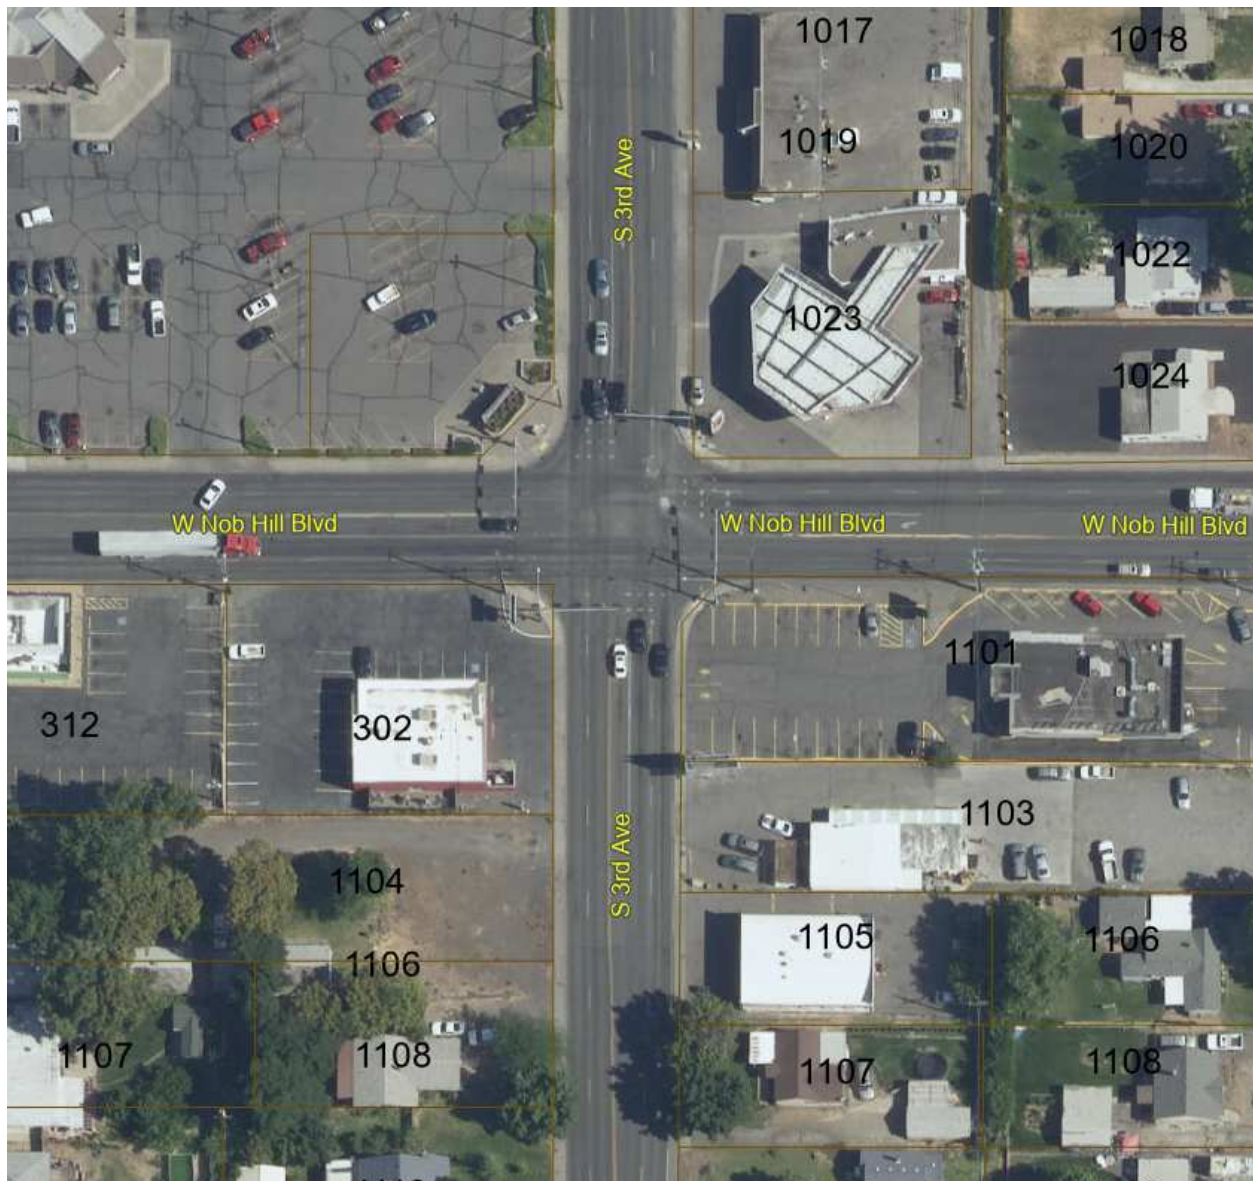
3<sup>rd</sup> Ave/Nob Hill Blvd. Intersection

The 3<sup>rd</sup> Avenue/Nob Hill Boulevard intersection has 5 lanes on each leg with controlled pedestrian crossings. The travel lanes are narrower than the preferred eleven foot minimum and both the northbound and southbound left turn lane lacks adequate vehicle storage. There are several driveway approaches within close proximity to the intersection that create additional conflict points within the intersection's operational area. The predominant surrounding land use is commercial.

Of the listed 37 collisions at 3<sup>rd</sup> Avenue and Nob Hill Boulevard, 35 collisions were intersection related. The remainder were tied to driveways or were not related to the intersection operation.

The collision numbers at this intersection have been a little sporadic. Eleven in 2018, sixteen in 2019 and eight in 2020. Curb medians are installed on the east and west legs of the intersection to control driveway access. Some of the 2020 decrease may be related to decreased traffic volumes due to COVID but, like 16<sup>th</sup> Avenue and Nob Hill Boulevard, the City previously made improvements that may have helped as well. Protected-permitted left turn signals were installed along with upgrading to all LED indications and in May 2021, the City conducted a grind and overlay project; improving the road surface within the intersection which will assist with vehicle control and braking.

**Recommendation:** Staff will continue to monitor the intersection to see if the reduced number of collisions is a trend related to recent intersection improvements or if further action is needed. Increased enforcement at this location presents the same challenges as 16<sup>th</sup>/Nob Hill.

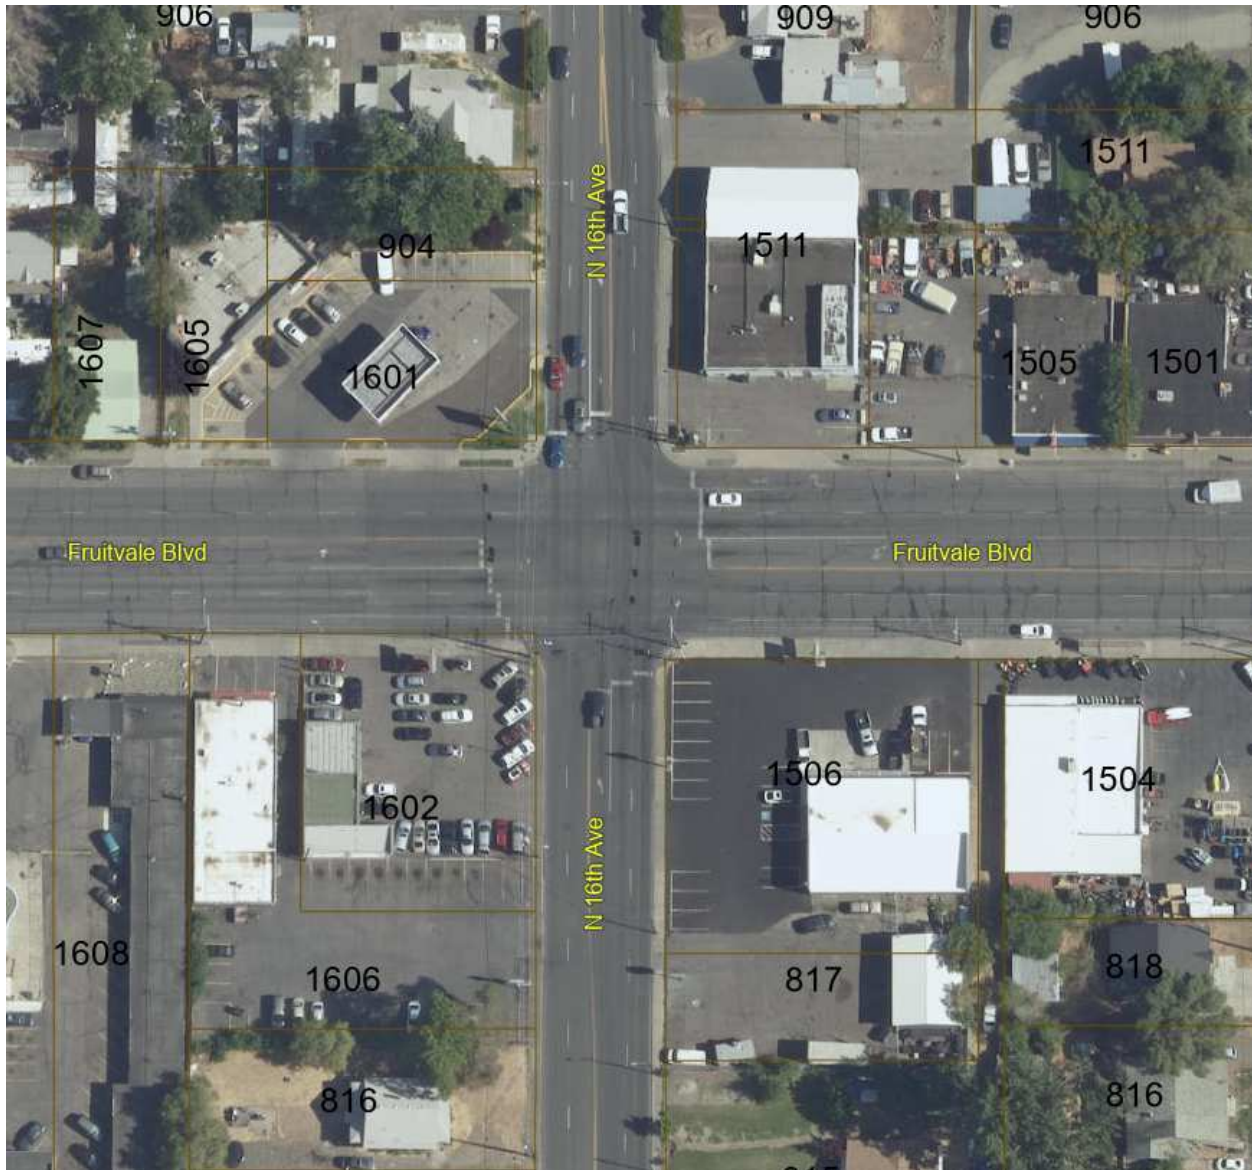
16<sup>th</sup> Ave./Fruitvale Blvd. Intersection

The 16<sup>th</sup> Avenue/Fruitvale Boulevard intersection has 5 lanes on each leg plus has short and narrow right turn lanes on eastbound and westbound Fruitvale. It has controlled pedestrian crossing on each leg. The travel lanes are narrower than the preferred eleven foot minimum on 16<sup>th</sup> Avenue and both the northbound and southbound left turn lane lacks adequate vehicle

storage. There are several driveway approaches within close proximity to the intersection that create additional conflict points within the intersection's operational area.

The curb radii on all four corners is inadequate for the number and size of commercial vehicles traversing the intersection. Pedestrian ramps are needed on all four corners and sidewalk is also needed along the west side of 16<sup>th</sup> Avenue. The predominant surrounding land uses is commercial.

Of the listed 33 collisions at 16<sup>th</sup> Avenue and Fruitvale Boulevard, 29 collisions were intersection related. The remainder were tied to driveways or were not related to the intersection operation.

The collision numbers at this intersection increased dramatically in 2020. Five in 2018, seven in 2019 and seventeen in 2020. Protected-permitted left turn signals have been installed along with upgrading to all LED indications and the installation of a battery backup system. The accident types appear to point towards drivers trying to beat the red light, either at the end of a protected permitted left turn or on the through movement phase. The higher number of injury accidents also points to speed being a major factor.

**Recommendation:** Staff will review the signal timing to evaluate adequate yellow and all-red timing to minimize drivers trying to beat the red light. The review may result in eliminating the protected permitted left turn phasing during part or all of the day. It is also highly recommended that traffic enforcement by YPD be conducted at this intersection for red-light violators.

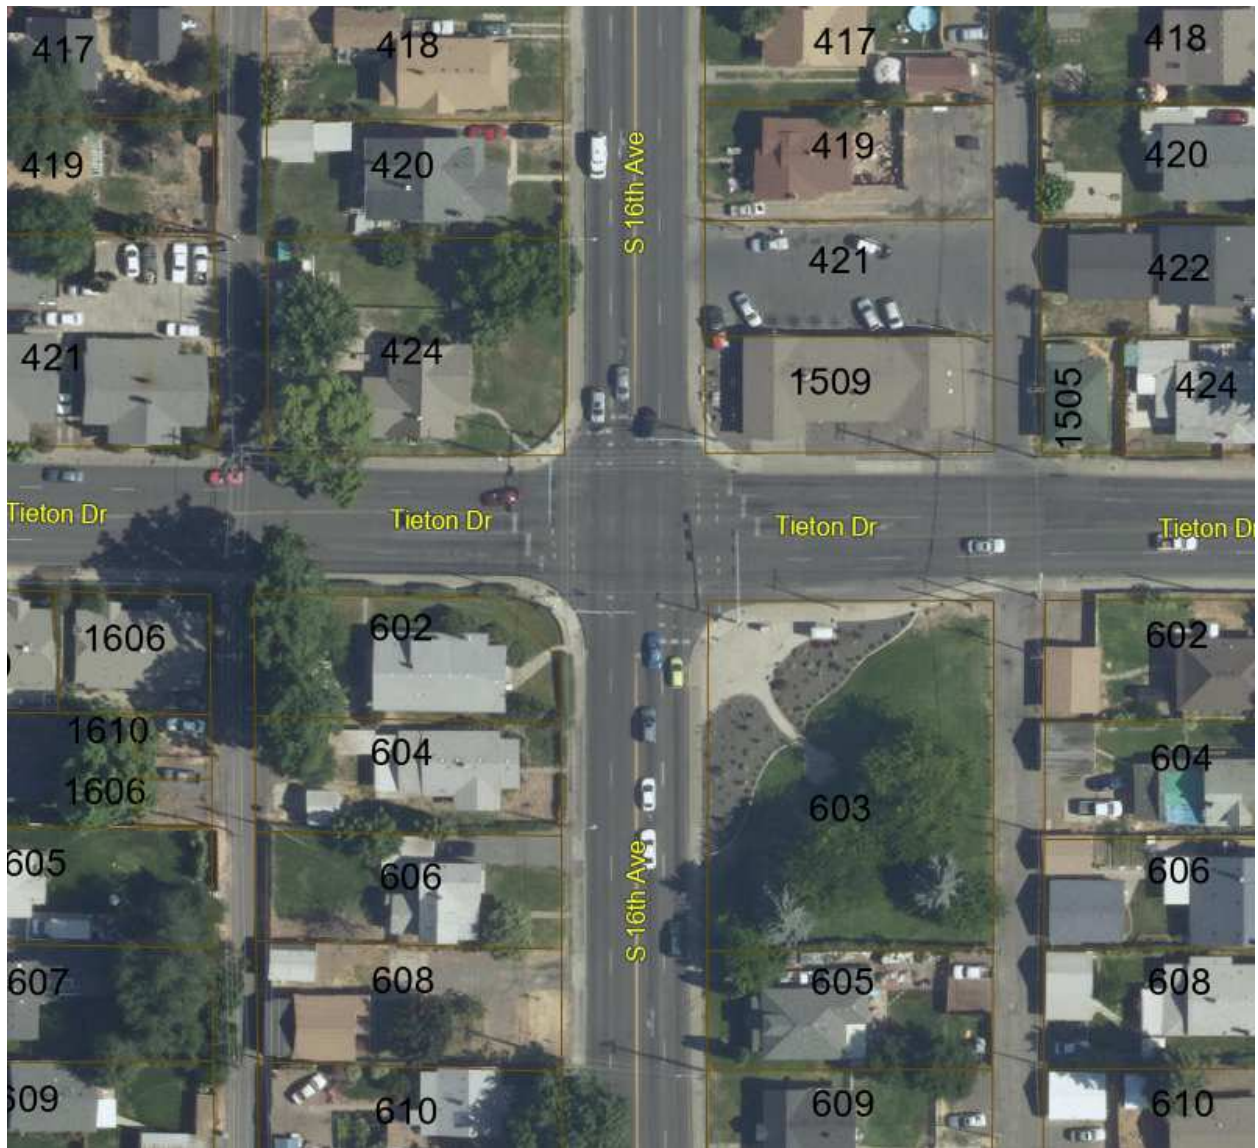
16<sup>th</sup> Ave./Tieton Dr. Intersection

The 16<sup>th</sup> Avenue/Tieton intersection has five lanes on each leg of Tieton Drive and four lanes on each leg of 16<sup>th</sup> Avenue. All traffic lanes are much narrower than the preferred eleven feet. It has controlled pedestrian crossing on each leg. The eastbound and westbound left turn lane lacks adequate vehicle storage. The left turn lanes on 16<sup>th</sup> Avenue were eliminated several years ago because of the number of reported sideswipes, fixed objects and other types of collisions that were occurring. There are several driveways along 16<sup>th</sup> Avenue near the intersection that create additional conflict points.

The curb radii on all four corners is inadequate for larger turning vehicles. Pedestrian ramps exist on all four corners but the narrowness of the existing sidewalk and adjacent traffic lanes, can make standing at the corner uncomfortable for pedestrians. Franklin Middle School is located two blocks away. The intersection is heavily used by students walking to and from school. The predominant surrounding land uses is residential with one corner commercial and another a pocket park.

All 31 collisions listed at 16<sup>th</sup> Avenue and Tieton Drive were intersection related. The high percentage of rear end and sideswipe accidents is indicative of the traffic congestion experienced at the intersection and the narrowness of the travel lanes.

The collision numbers at this intersection are consistent. Eight in 2018, twelve in 2019 and eleven in 2020. Any uptick in collisions appear to be rear end collisions due to increased traffic congestion. Work to install protected-permitted left turn signals on Tieton Drive along with upgrading to all LED indications and installation of a battery backup system, was done a few years ago to help relieve traffic congestion. Those efforts helped during off-peak hours, but recent traffic growth has since reduced some of those recognized improvements.

**Recommendation:** Staff will continue to monitor the intersection and adjust signal timing as needed to minimize traffic congestion as much as possible. Reduced congestion should help with the rear end collisions. Geometric constraints will limit what further improvements can be made without the capital improvements indicated above. Any educational efforts city wide can provide additional focus at this intersection.

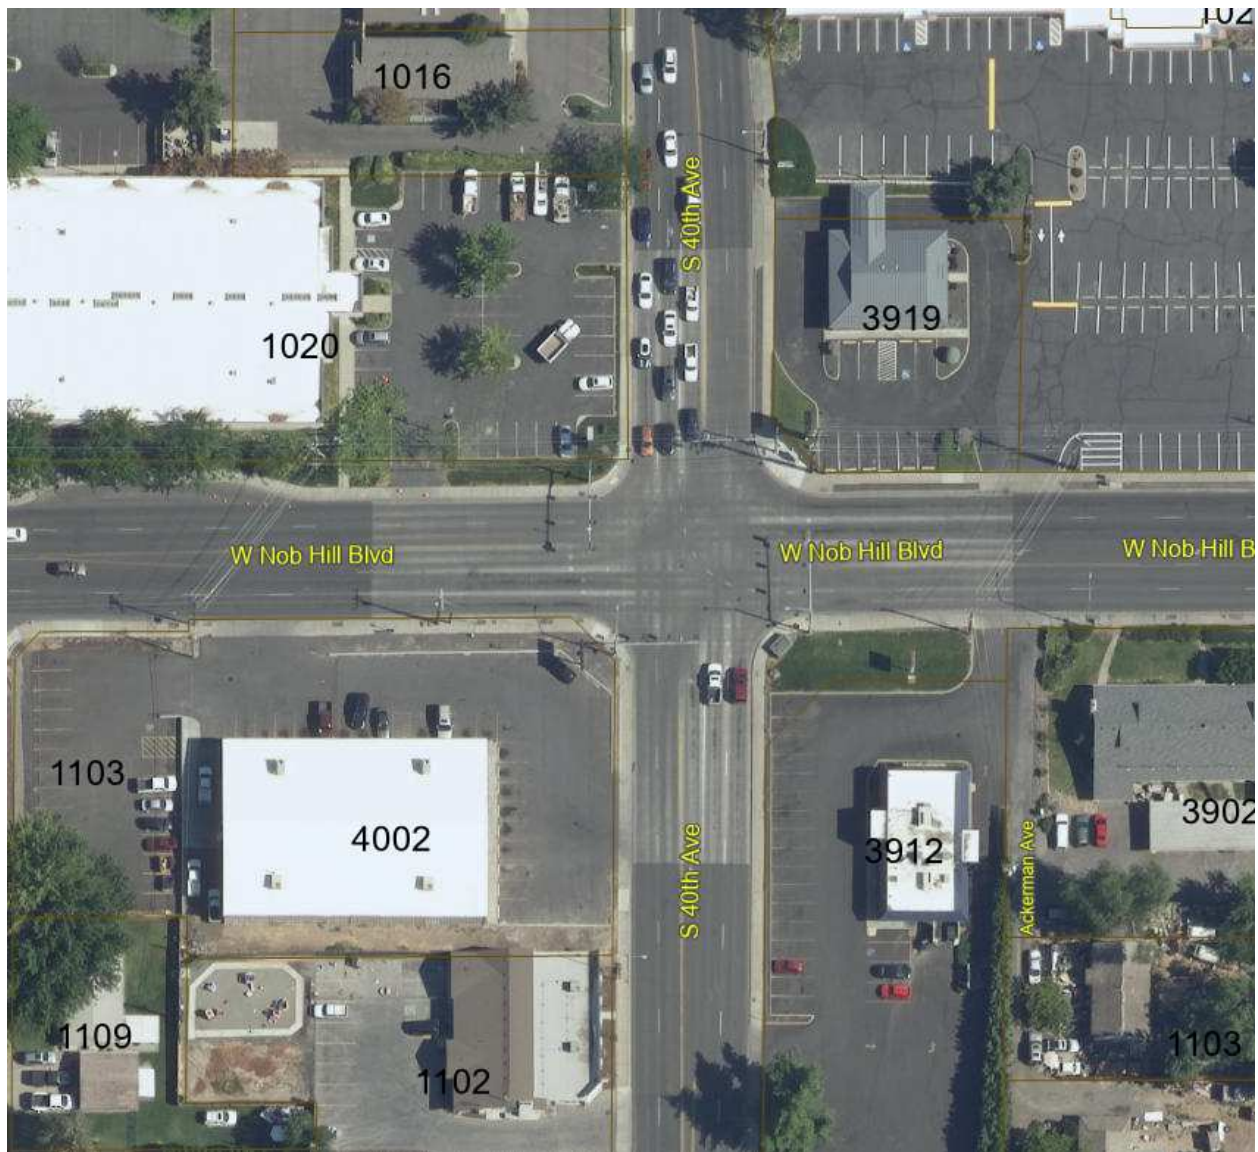
40<sup>th</sup> Ave./Nob Hill Blvd. Intersection

The 40<sup>th</sup> Avenue/Nob Hill Boulevard intersection has 5 lanes on each leg and controlled pedestrian crossings across each approach. What is different in comparison with the other intersections, is that this one contains a double-left turn lane for southbound 40<sup>th</sup> Avenue. The travel lanes widths are adequate but the southbound turn lanes lack enough storage through most of the day. There are a few driveways in close proximity to the intersection but do not appear to have an impact to general traffic flow.

Collisions have been consistent over the last three years. Eleven collisions in 2018, eight in 2019, and twelve in 2020. The higher number of sideswipe collisions is related to vehicles not staying within their lanes as they travel through the double-left turn movement. LED signal heads were installed last year and an updated controller and battery backup system is scheduled for later this summer. These upgrades will improve the reliability and allow more flexibility in signal operations.

There does not appear to be any design or operational issues that can be tied to collisions other than drivers not maintaining within their lanes through the double-left turn movement.

**Recommendation:** Many of the standard improvements have already been made at this location. As staff continues to monitor the intersection we will look for other options such as striping/signing which may help. As with the others, enforcement and education may help some.

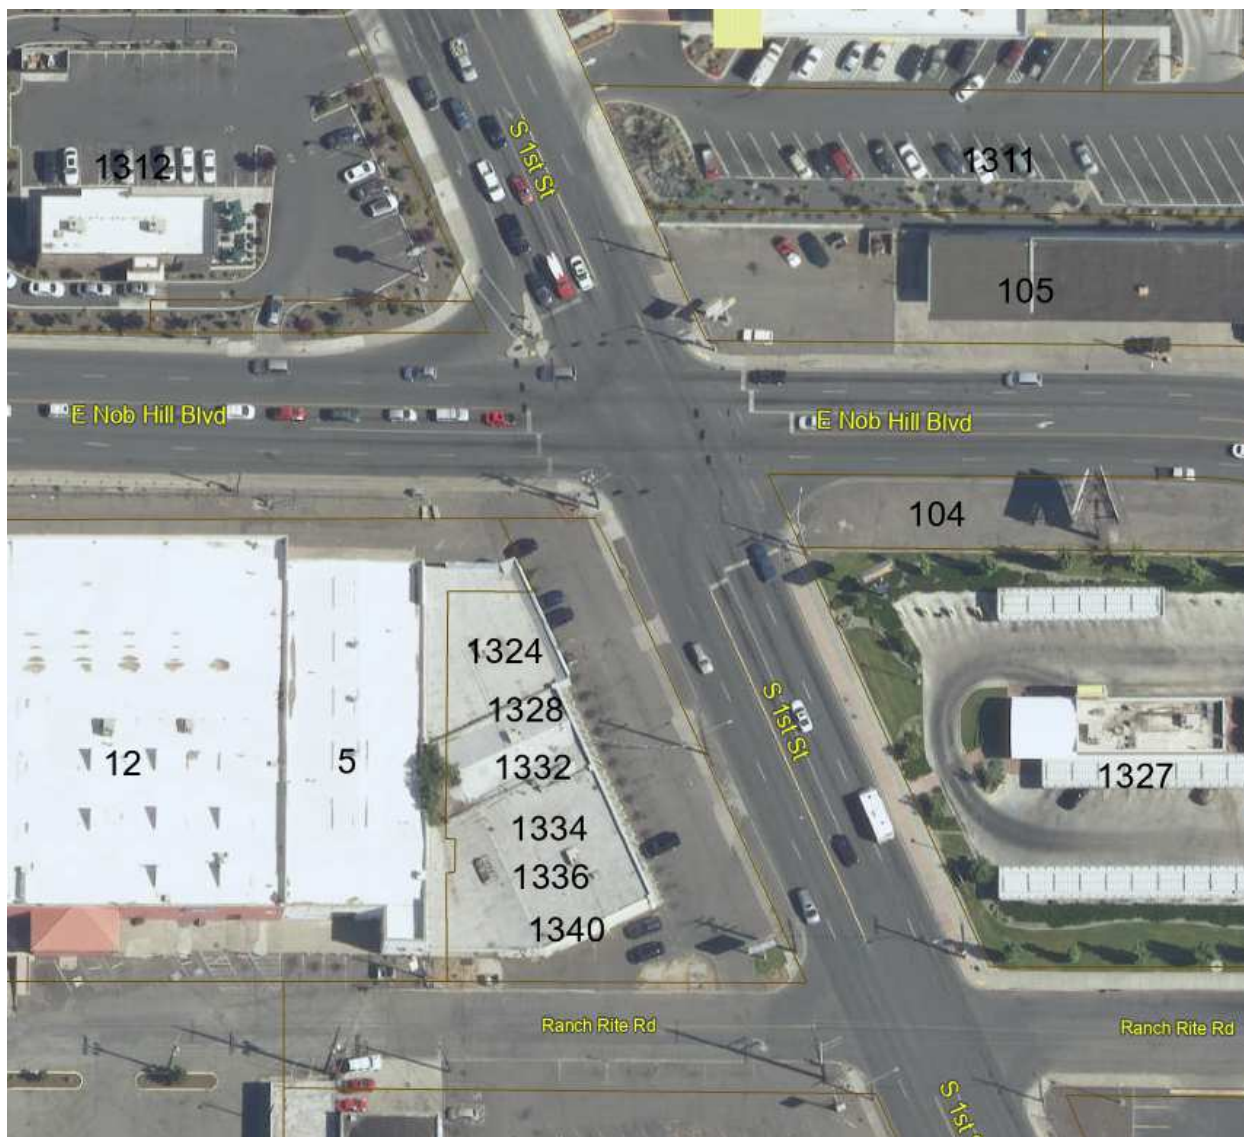
1<sup>st</sup> St./Nob Hill Blvd. Intersection

1. The curvature of the westbound approach can reduce sight distance for drivers as they approach the intersection and may have limited opportunity to react to traffic conditions.
2. The eastbound approach is on a grade due to the railroad overpass. The road can become slick during inclement weather; increasing stopping distance significantly. There is also limited sight distance as vehicles crest the overpass and may have reduced reaction times if traffic is queued up from the intersection.
3. 1<sup>st</sup> Street and Nob Hill Boulevard intersection is at an angle. This may lead some drivers to misidentify which signal indication applies to them. It also makes the northbound to eastbound turn challenging for large trucks due to the inadequate curb radii.

There are several driveways and one intersection at Ranch Rite Road, within the intersection’s operational zone that significantly impact traffic. Drivers often make illegal or unsafe maneuvers to access or egress these driveways. The surrounding land uses commercial with several high-volume driveways.

The annual number of collisions at this intersection has been decreasing. Thirteen collisions in 2018, ten in 2019, and six in 2020. Curbed medians were installed on 1<sup>st</sup> Street to limit access to some driveways at or within the intersection. These were modified and extended with the Starbucks development and remodel of McDonald’s. Signal indications were upgraded to LED and a battery backup system has also been installed. These measures appear to have had a significant impact towards reducing collisions.

A high percentage of the collisions that have occurred have involved injuries. Excessive speed through this intersection may be a major factor.

**Recommendation:** Upgrade the current traffic signal, which is a span wire design, to that of poles and mast arms, to better position the signal indications and remove some of the visual clutter will provide a better view of the indicators to driver. The cost of upgrading the traffic signal is approximately \$500,000. It is also recommended that an emphasis on traffic enforcement by YPD on excessive speeding at this intersection may help reduce the frequency and severity of collisions. A more in depth analysis of the cause may provide additional alternatives given the cost of a new signal.

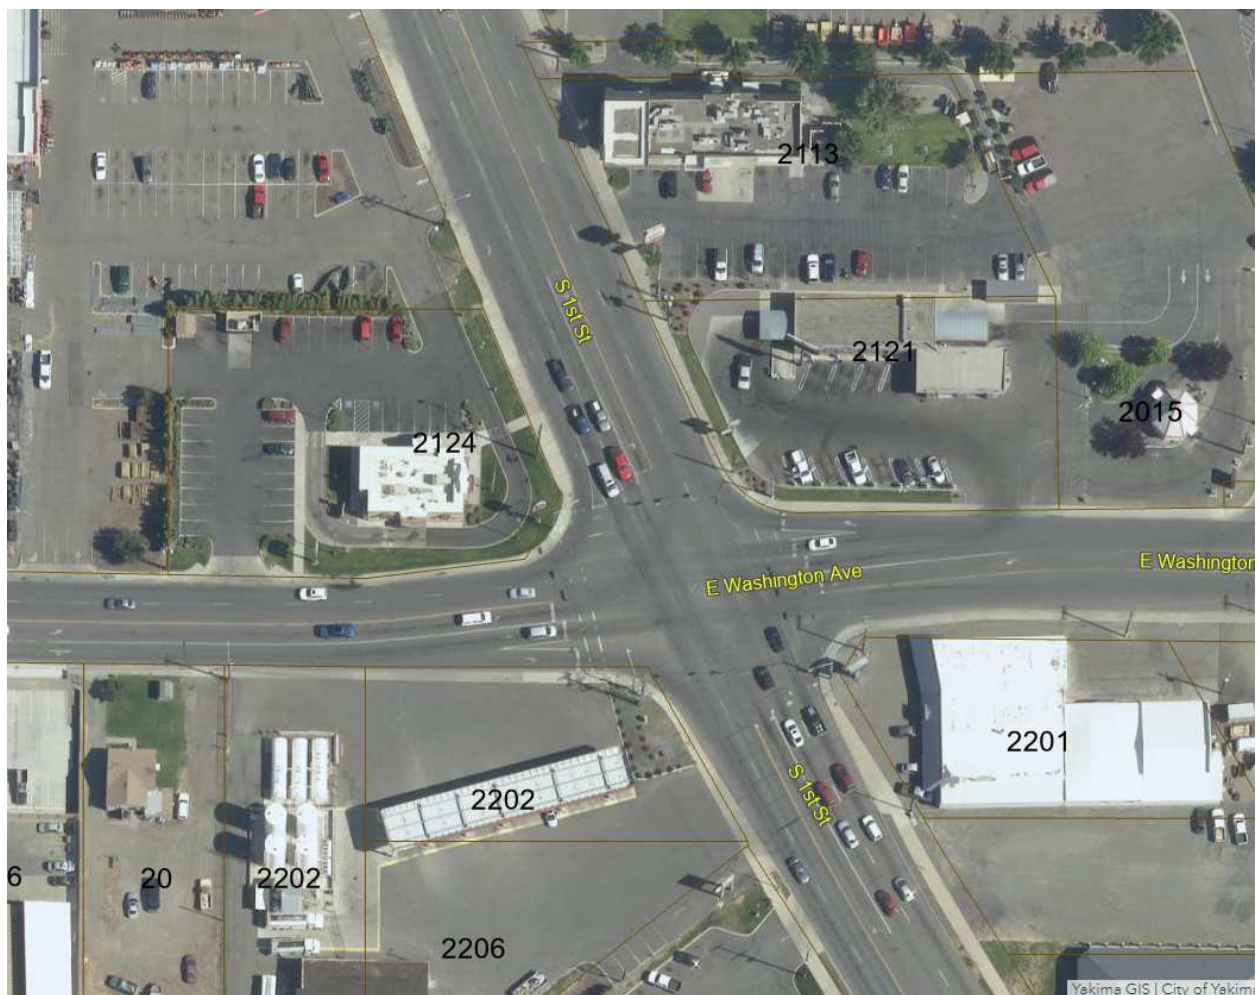
1<sup>st</sup> St./Washington Ave. Intersection

1. The curvature of both Washington approaches can reduce sight distance for drivers as they approach the intersection and may have limited opportunity to react to traffic conditions.
2. The 1<sup>st</sup> Street and Washington intersect at an angle. This sometimes may lead to drivers misidentifying which signal indication applies to them. It also makes the northbound to eastbound turn awkward for many drivers; particularly large trucks.
3. The traffic signal heads are mounted on span wire. During periods of high winds, the signal heads have a lot of movement which can block view of the indicators and can become misaligned.

There are several driveways near the intersection's operational zone where drivers make unsafe maneuvers to access or egress these driveways. The surrounding land uses are commercial with several high-volume driveways.

The annual number of collisions at this intersection has decreased since 2018. Thirteen collisions in 2018, seven in 2019, and eight in 2020. Protected permitted left turns were installed at about that time. In addition, the eastbound through and left turn lanes were separated to provide better vehicle storage and eliminate abrupt lane changes. These measures appear to have had a significant impact towards reducing collisions. However, the most severe accidents appear to be due to drivers trying to get beat the red light on either through or left turn movements.

**Recommendation:** Staff will plan the necessary improvements as TBD, or other, funding becomes available. It is also recommended that an emphasis on traffic enforcement by YPD on red light running at this intersection may help reduce the frequency and severity of collisions. Due to the unusual lane distribution on Washington, additional signing may help ensure traffic is in the correct lane.

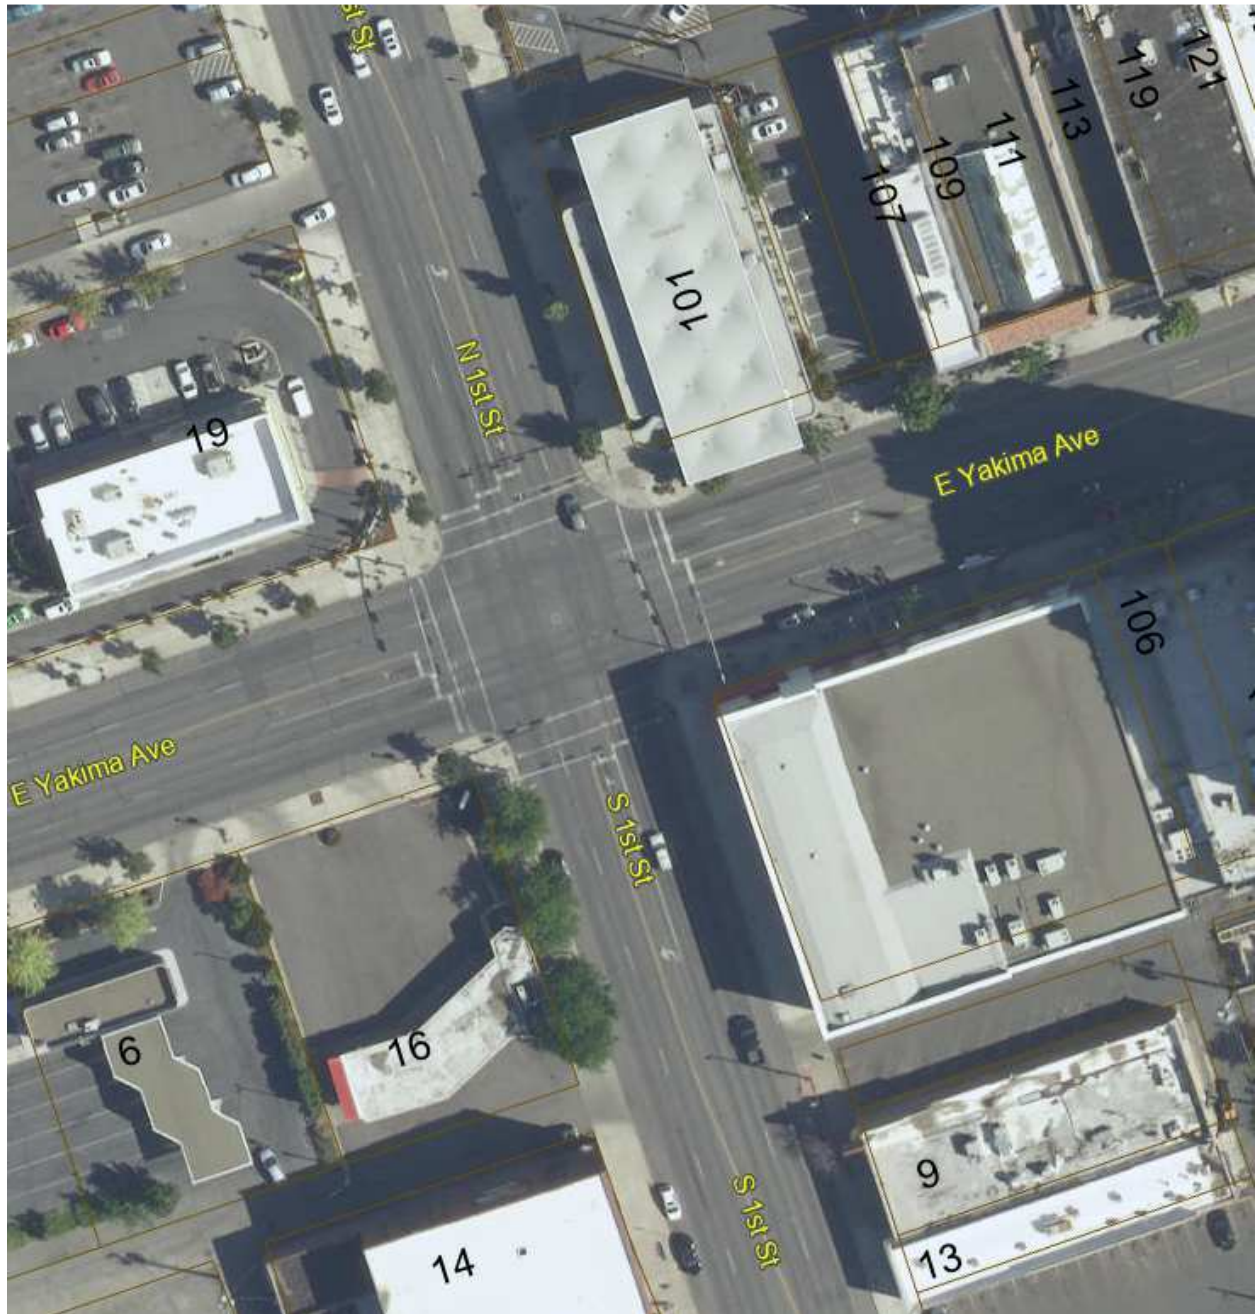
1<sup>st</sup> St./Yakima Ave. Intersection

The 1<sup>st</sup> Street/Yakima Avenue intersection has 5 lanes on each leg. There is a parking lane on each side of both streets. If clear, drivers use the parking lanes as right turn lanes. There are controlled pedestrian crossings on each leg. The travel lanes are of adequate width and all left turn lanes have adequate vehicle storage. There are driveways and alleys within close proximity to the intersection that create additional conflict points within the intersection's operational area.

Of the listed 25 collisions at 1st St. and Yakima Ave., 23 collisions were intersection related. The remainder were tied to driveways or were not related to the intersection operation.

The collision numbers at this intersection dropped slightly after 2018. Eleven in 2018, seven in 2019 and seven in 2020. Protected-permitted left turn signals have been in operation for several years. A battery backup system and LED signal indicators were also installed in to keep the signal operational during power outages.

**Recommendation:** The accident types appear to point towards drivers trying to beat the red light on the through movement phase. An emphasis on traffic enforcement by YPD to monitor red light running and an evaluation of signal timing is recommended.

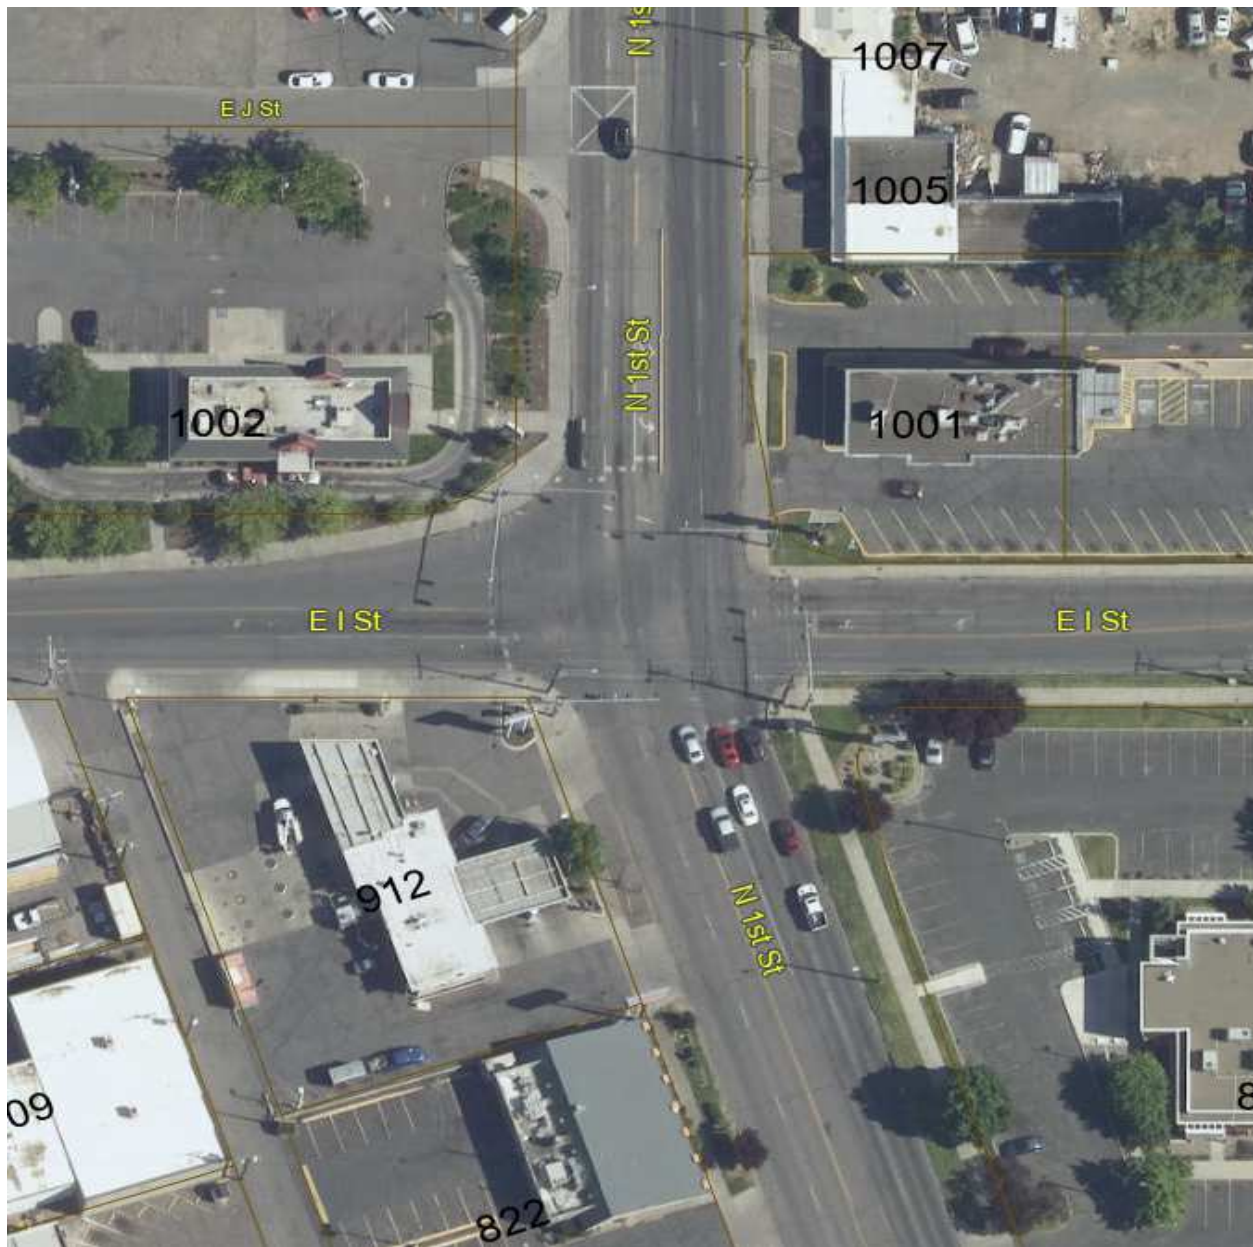
1<sup>st</sup> St./I St. Intersection

1<sup>st</sup> Street curves within the center of the intersection. This curvature can create issues for some drivers as they make their turn in the intersection. The turn makes the lanes operationally narrower than they are; and may also miss direct the drivers' view of the signal indicators.

There are several driveways, and the J Street intersection, within the operational area of the 1<sup>st</sup> St/I St. intersection. As a result, drivers make unsafe maneuvers to access or egress these driveways.

The annual number of collisions at this intersection has been slightly increasing. Four collisions in 2018, five in 2019, and eight in 2020. The increase has been in sideswipe and rear end accidents. Signal indicator heads were realigned several years ago to help reduce driver confusion. In addition, a curb island was installed on the north side of the intersection to limit driveway access as part of a state traffic safety grant.

**Recommendation:** The intersection will be realigned to reduce the curvature along with new signal poles, lighting, pedestrian crossings, and striping. The improvements are anticipated to significantly improve the operational and safety issues that exist today. Staff will monitor the effectiveness of the safety improvements when completed.

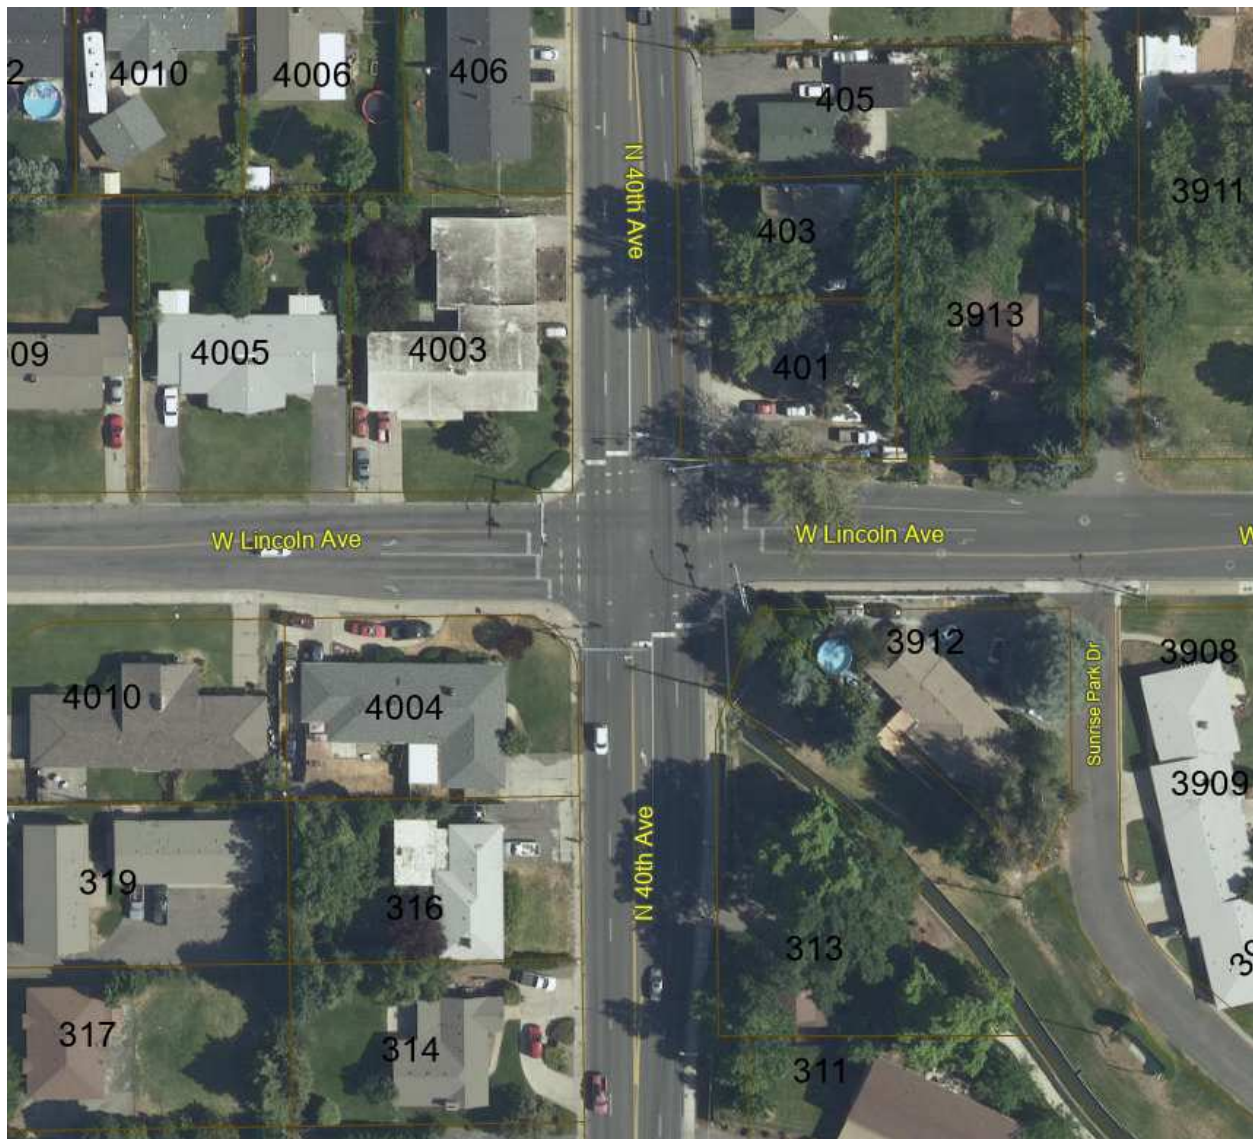
40<sup>th</sup> Ave./Lincoln Ave. Intersection

The general terrain on 40<sup>th</sup> Avenue has a slight curvature. Adding the left turn lane at the intersection, increased the curvature. It is not severe, but may contribute to some of the sideswipe accidents occurring away from the intersection. Lincoln Ave. drops in elevation from the intersection eastward. This slope along with residential landscaping at the corners, limits sight distance for westbound vehicles. There are several residential driveways within the operational area of the intersection; impeding traffic as they access the properties.

23 of the 25 listed collisions at 40<sup>th</sup> Ave. and Lincoln Ave. collisions were intersection related.

The annual number of collisions at this intersection has been variable. Eight collisions in 2018, eleven in 2019, and five in 2020. The intersection has had protected permitted left turns for several years. What is unusual at this intersection is the high number of angle and turning collisions versus rear end and other types of collisions possibly due to individuals running red lights.

**Recommendations:** The signal pole at the northeast corner is being relocated later this year after being hit several times. In addition, signal indicators are scheduled to be replaced this year as well, eliminating the 8-inch incandescent signal indicators and converting them to 12-inch LED. Staff will monitor the effectiveness of the safety improvements when completed.

Further analysis is needed to evaluate if removing the right turn lanes on Lincoln would be beneficial. The advantage would be to widen the other traffic lanes and reduce the number of right turn on red movements that can be hazardous due to sight line limitations. The disadvantage would be some additional delay to vehicles which could increase traffic congestion.
