# **Environmental Memo**

## **Nelson Dam Replacement**

### **Ramblers' Park Reach**

### **Naches River**

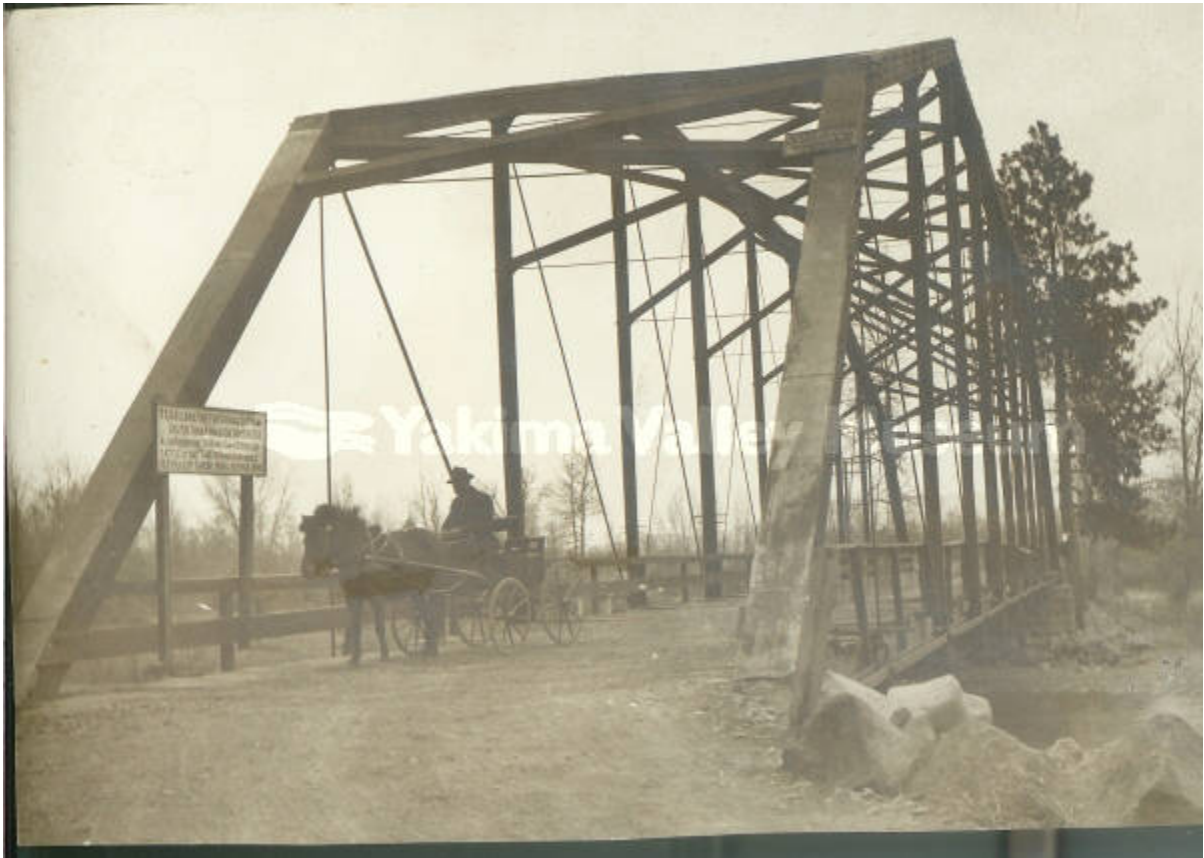
**Figure 3.** Undated photo (likely prior to 1930) of second Pacific State Highway 5 bridge, this bridge remained in use until 2007.

Other infrastructure in existence by the early 1900's was Powerhouse Road, then called the Naches Highway. It was constructed as a county Road, the original wooden bridge was damaged in the 1910 Flood and replaced just downstream with a bridge that continued in use until 2007. The Naches Highway later became incorporated into Pacific State Highway 5/Inland Empire Highway in the 1920's, and then becoming Powerhouse Road (reverting to the County) in the 1950's when US 12 was constructed north and just downstream of the Powerhouse Road and Nelson Dam. Downstream of the diversion, the Railroad Bridge had been constructed in 1895, it was apparently salvaged by the NPRR from another location in Iowa and constructed on this site. It is worth noting that old photos of the NPRR bridge show the western (upstream) approach was originally a trestle structure approximately 450 feet long, constructed over the gravel bar that existed at that location. Only after US 12 was constructed and that portion of floodplain cut off by the road prism of US 12, was the western approach converted to compacted fill.

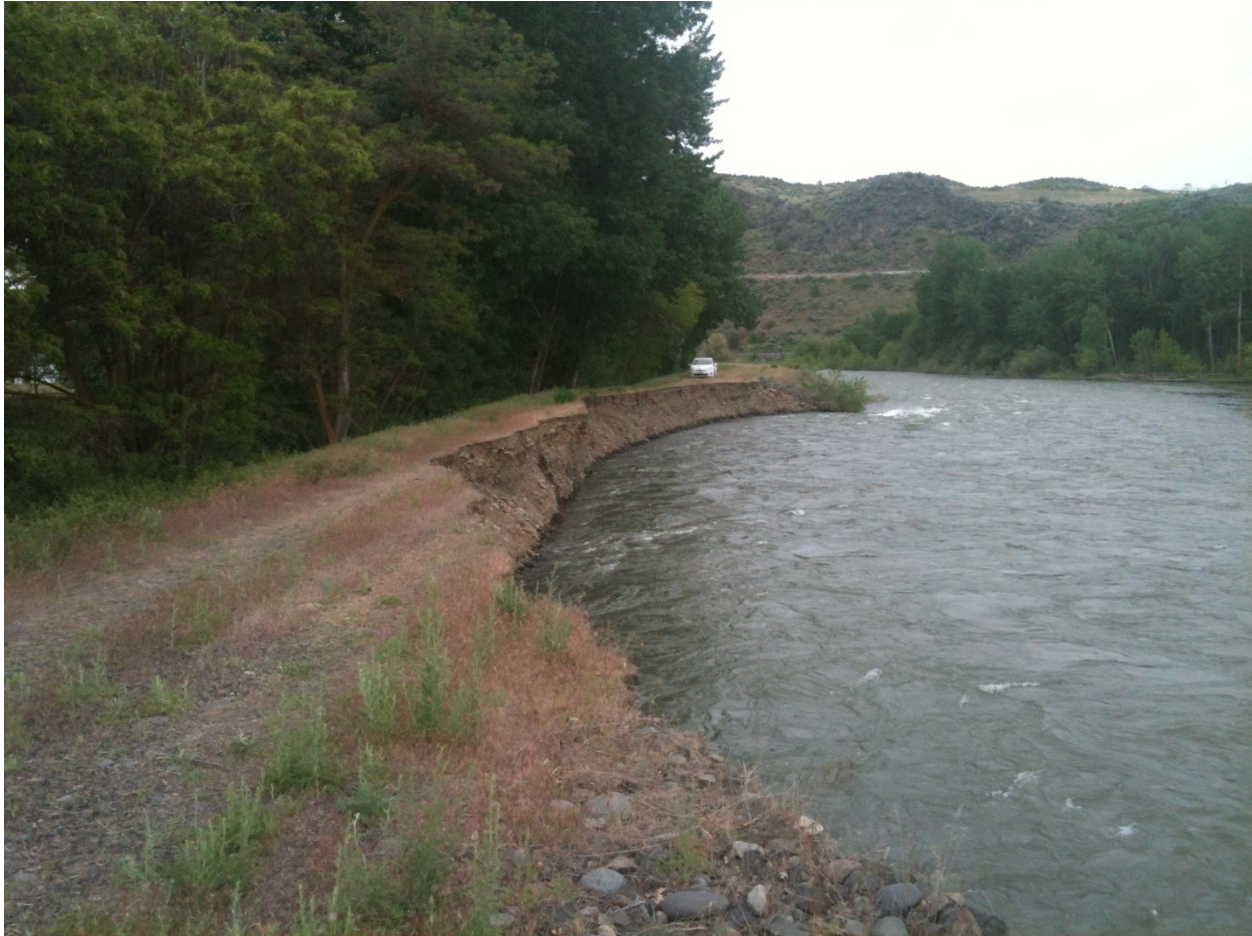
**Figure 5** - May 2012 Ramblers' Park levee undercut and collapse at 2 year flow, the year after 2011 approximately 15 year peak flow. In foreground in 1996 failure, car in background is parked just upstream from 2006 failure.

**Lower Ramblers Park Levee Setback (2012)** – with the sudden collapse of the levee at a relatively low flow during the Spring 2012 runoff - shown in Figure 5 – the adjacent landowner, the County and the Corps of Engineers agreed that the best course was to purchase the remaining property, relocate the residence and belongings in accordance with State and Federal Law, and implement the CFHMP recommendation to set back or remove the Ramblers’ Park Levee. With financial assistance from the Department of Ecology’s Flood Control Assistance Account Program and the Corps of Engineers acceptance, design, and implementation of a non-structural (setback) alternative to repairing the levee in place, that recommendation – setting the lowest 1200 feet of the levee back to the edge of the Powerhouse Road Right of Way - was implemented in the summer of 2013.

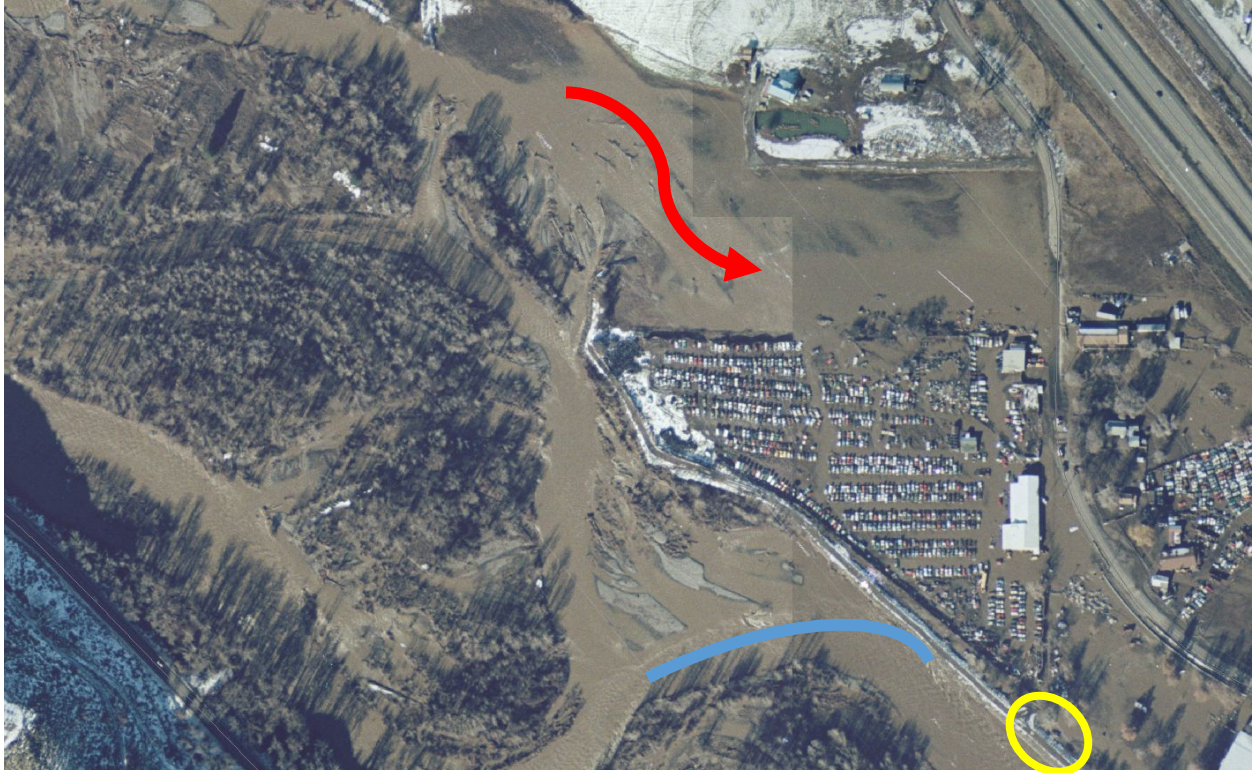
**Figure 6** – 1996 Flood 2 days after 50-year peak flow, river is at about 25-year flow in photo. Red arrow shows flanking path upstream of Ramblers’ Park levee, Corps and County extended the levee 450 feet upstream in the ensuing weeks. Just above the blue line in the development of the “jet” as the flow falls, area where the “jet” hits the levee would fail and collapse 3 days later. Yellow circle is second failure, approximately a month later as the “jet” reformed downstream. Note also the fresh gravels depositing upstream of the blue line, along the red line and continuing upstream off the photo.

As sediment deposits in the channel and floodplain upstream of the Ramblers’ Park levee, not all of that sediment is later remobilized and transferred downstream. In a situation such as the 1948 flood - several months of sediment transport flow, and then no major floods occurring for more than a decade - much of the sediment is colonized by vegetation and becomes a permanent rise in floodplain and channel elevation. This rise, in turn, creates a reduction in slope or gradient of the channel, and since slope is proportional to stream power and the ability of the stream to transport sediment, that reduction in slope increases sediment deposition upstream of the sediment that was deposited upstream of the levee. If that sediment then is colonized by vegetation, the deposition moves farther and farther upstream over time. As the channel and the floodplain next to the channel rises, the river may also avulse (change course dramatically during a flood event) as is beginning to occur in Figure 6 above, increasing risk to public and private structures.

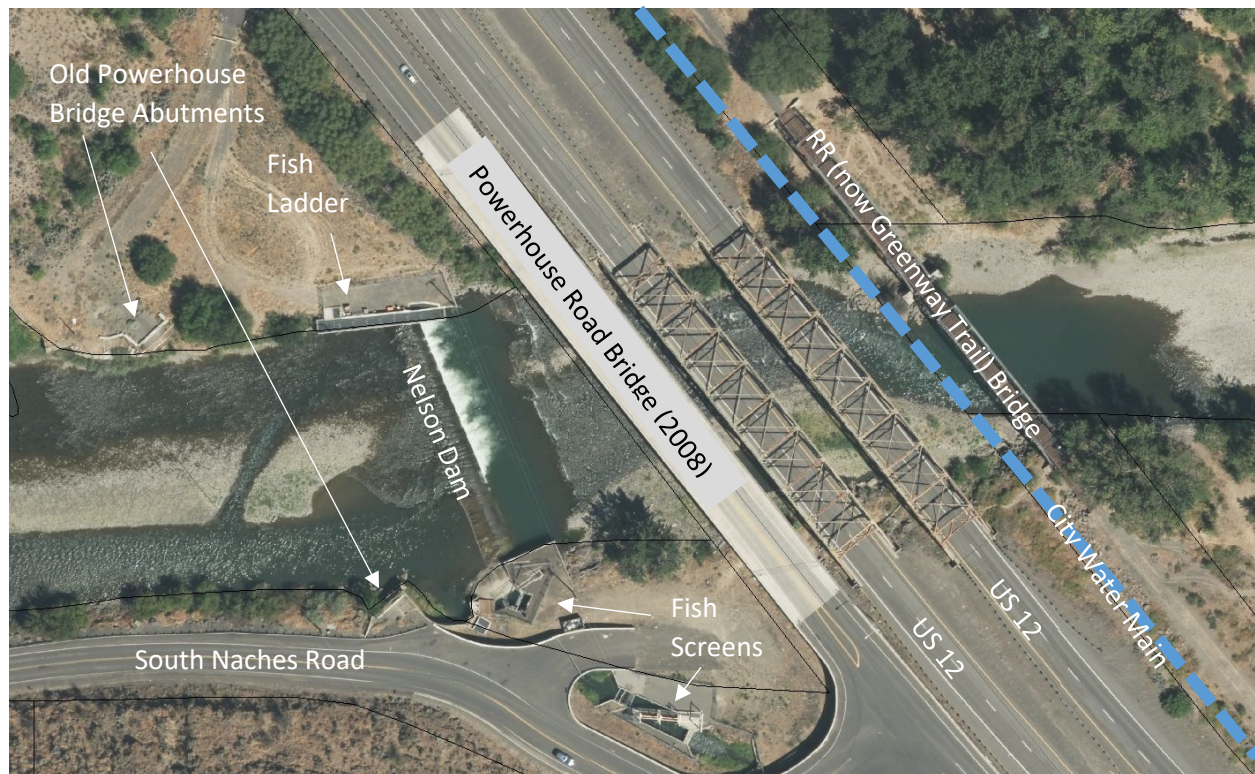
**Figure 9** – Aerial view of Nelson Dam vicinity with infrastructure labeled. The photo was taken during the very low flow of summer 2015. Note that the river tends to hug the Tieton Andesite wall near S. Naches Road, which provides good flow to the irrigation diversions and fish screens, but poor flow to the fish ladder. Note channel cut across bar to improve flow to the ladder.

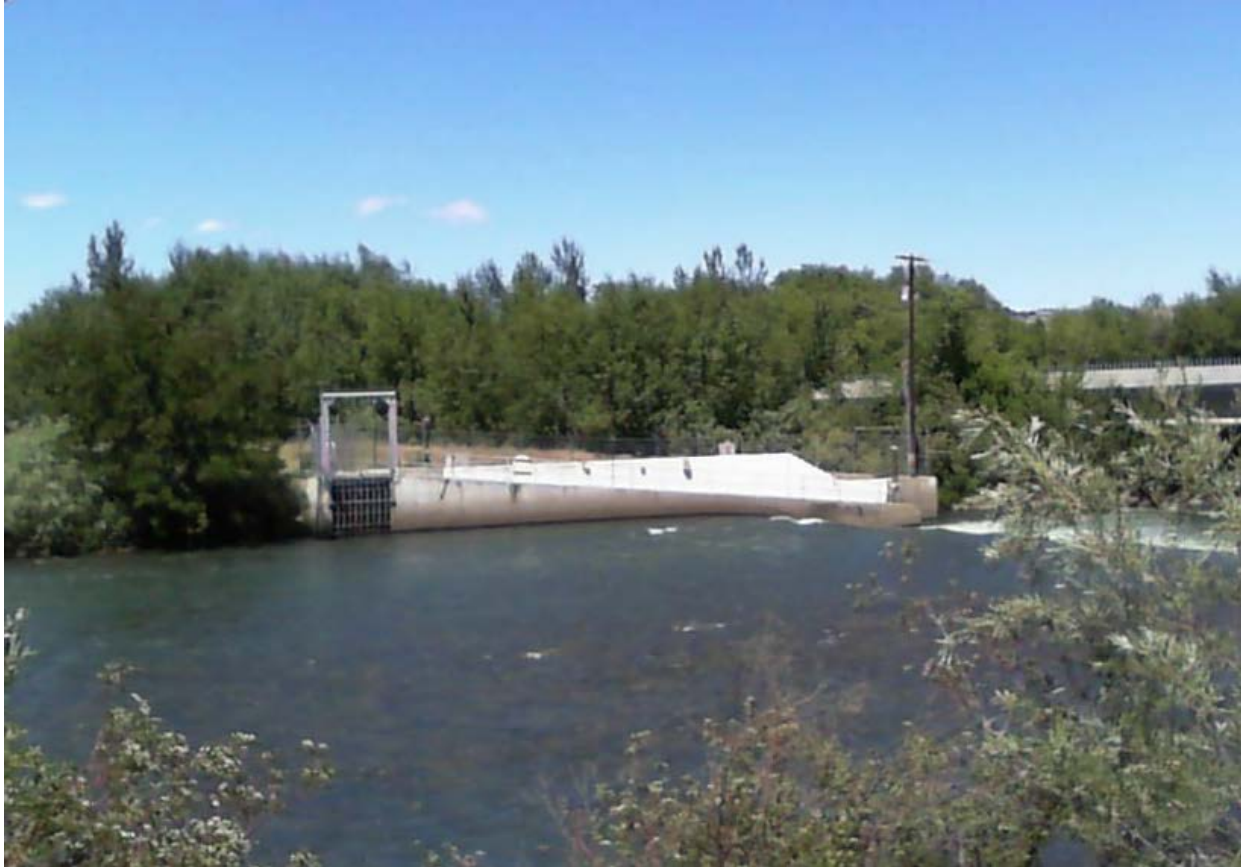
**Figure 10** – Fish Ladder Entrance at Nelson Dam, 2018

Cowiche Creek, just downstream of the dam, where the lava flow came into contact with older, uplifted basalts. Ongoing uplifting of the basalt ridge on the north side of the valley keeps the river's south bank hard against those Tieton Andesites, a gentle curve above Nelson Dam concentrates flows on the south side of the channel (see Figure 10)

Upstream fish passage at the dam is provided by a fish ladder constructed when the dam was last reconstructed in 1985, there was no passage structure prior to that time. As shown in Figure 9 sediment tends to accumulate just upstream of the dam, especially on the inside of the river bend near the fish ladder. This can cause the ladder exit ladder to be plugged, or for sediment to enter the ladder and fill the pools in the ladder during sediment transport events. Downstream of the ladder, sediment can accumulate near or in the ladder entrance, plugging the entrance and/or changing the attraction flow to the ladder. Management of this structure to maintain fish passage has included closing the upper ladder entrance during sediment transport events (typically in the spring when the ESA-listed Steelhead are migrating) and excavation of the channel at the upstream exit, excavation of material from the pools in the channel itself, and excavation of sediment near the downstream ladder entrance.

The structure shown in Figure 11 has a hydraulic and sediment transport effect of its own as can be seen in Figure 10. This structure tends to reduce water conveyance thorough this section of the bridge, forcing it to the north and forming a bar on the south bank, with the trickle of water flowing from the bypass pipe flowing across the bar and downstream. The bypass pipe was located in this area because it was thought that the dominant channel location would be on the south side, below the channel that runs along the andesite wall below S. Naches Road. This loss of conveyance capacity and resultant bar formation also encourages sediment to accumulate on the downstream side of the dam, plugging the fish ladder entrance. Maintenance of that entrance by sediment removal must be balanced with the need to not over-excavate the sediment and destabilize the “Ecology block” structure which protects the fish bypass discharge.

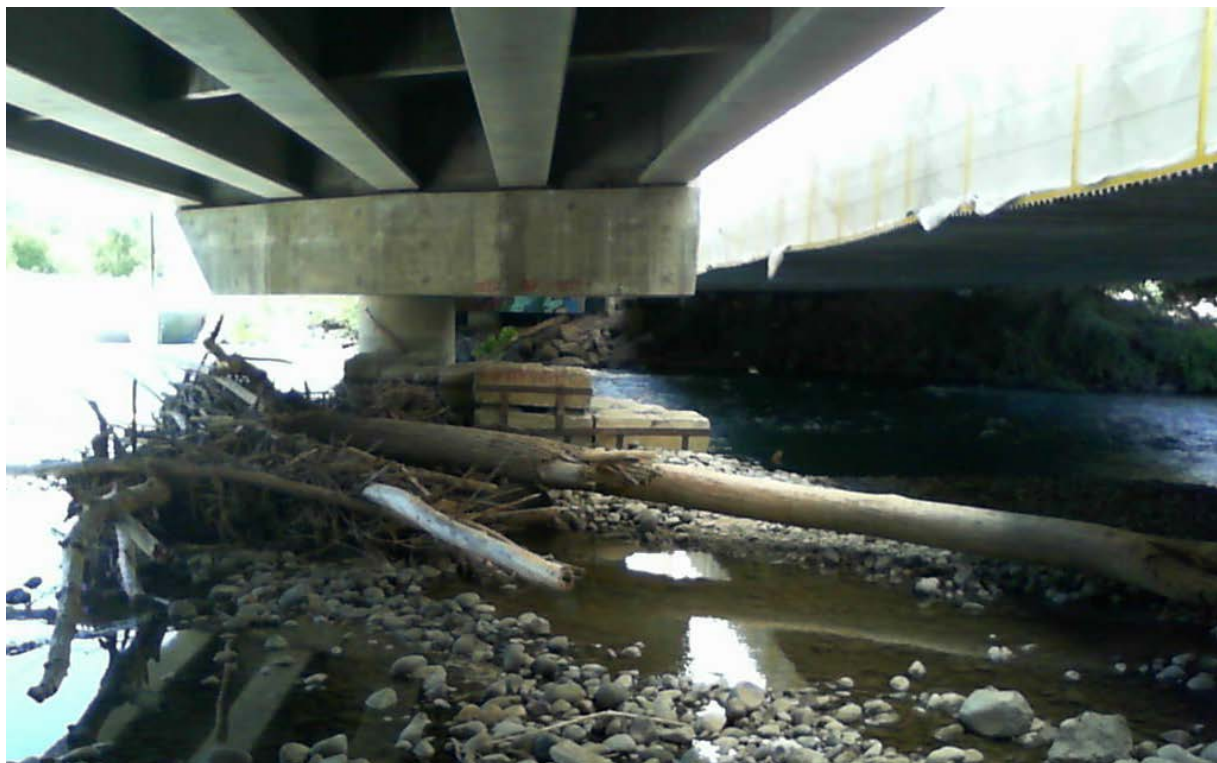
**Figure 11** – Fish bypass discharge pipe location beneath Powerhouse Road Bridge. “Ecology Block” structure and racked woody material shown. (downstream US 12 bridge is sheathed in plastic for painting)

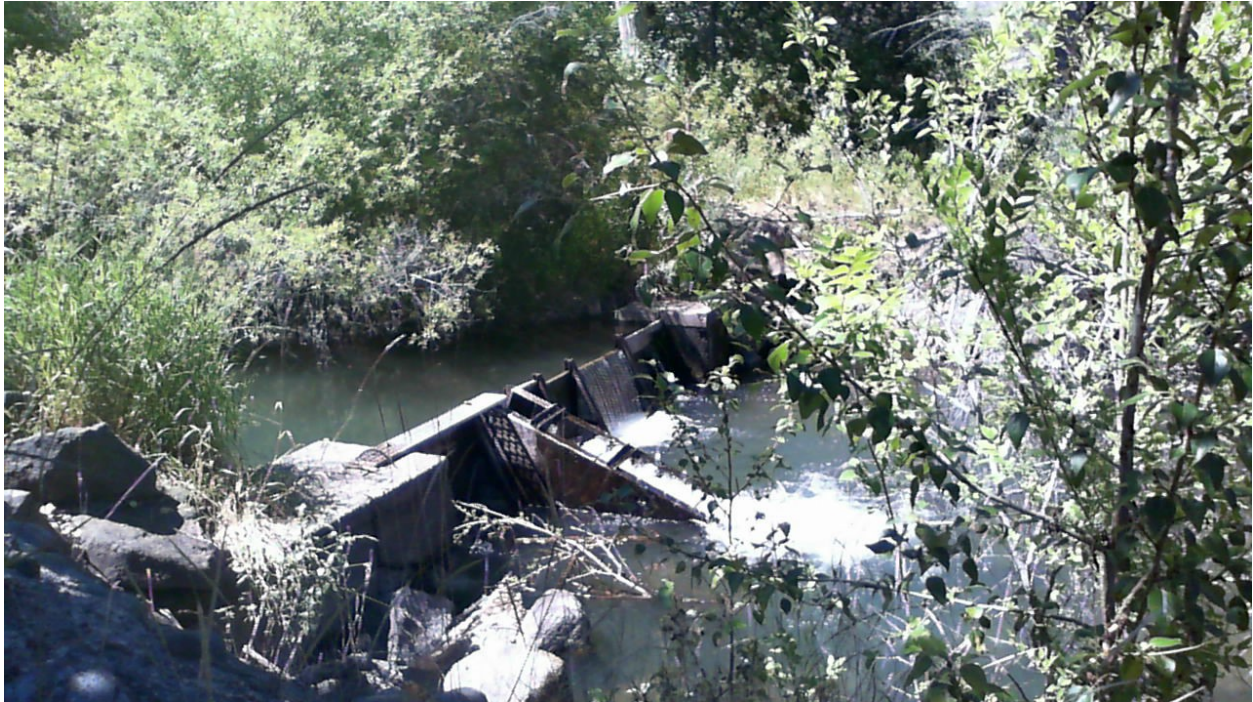
**Figure 15** – Dam and Fishway at Cowiche Creek mouth.

The Alaska Steep Pass Fishways generally require frequent (weekly) maintenance in the form of maintaining upstream and downstream water surface elevations to maintain fish passage velocities required for passage. City of Yakima staff checks the dam for blockage or material buildup, WDFW does not currently make regular weekly visits to the fishway to ensure upstream passage is maintained.

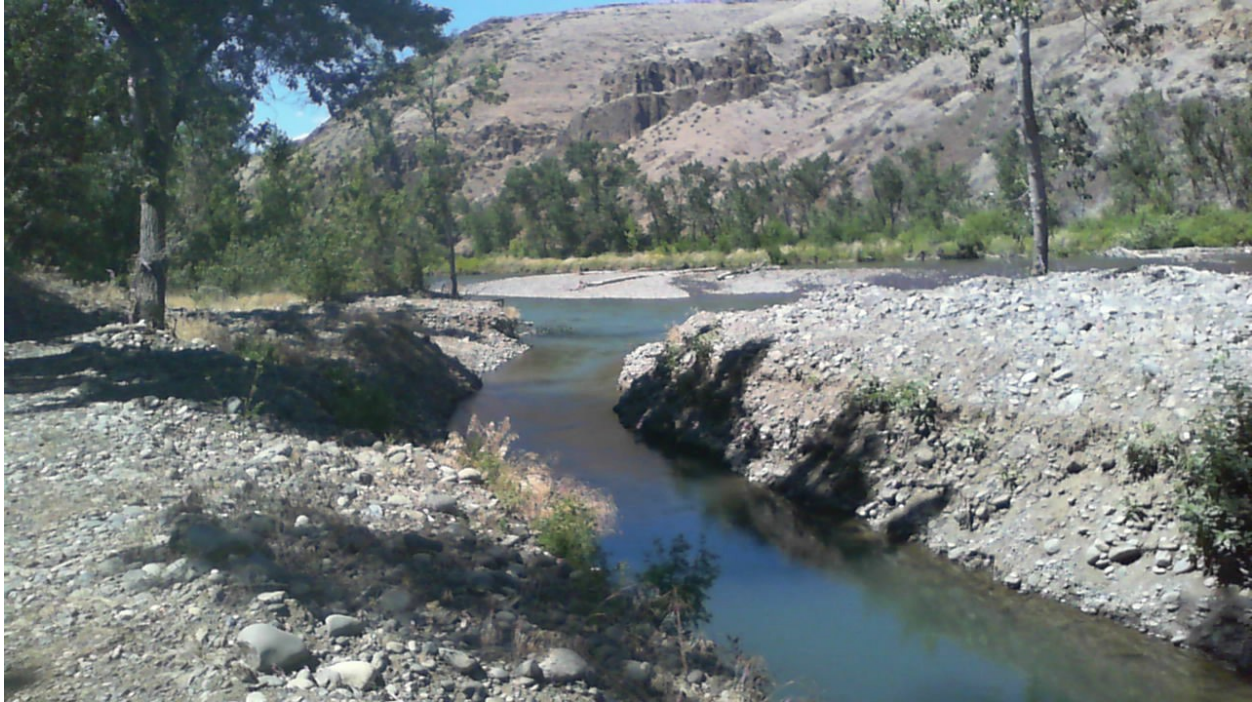
**Figure 16** – Old Union Diversion in 2018.

Finally, as the channel in the downstream portion of this reach continues to lower, the Old Union Irrigation Company continues an annual battle to maintain the flow of water to their point of diversion. The photo above shows the upstream end of a constructed side channel that is heads 800 feet upstream of their diversion point and check dam structure, which requires annual excavation and armoring to keep up with the declining bed elevation. The diversion works also includes another 600-foot-long constructed side channel downstream of the check dam to take excess flow and the fish bypass flows back to the Naches River. This maintenance causes significant amounts of disturbance each spring and is a very large maintenance load for a small and underfunded private irrigation company.

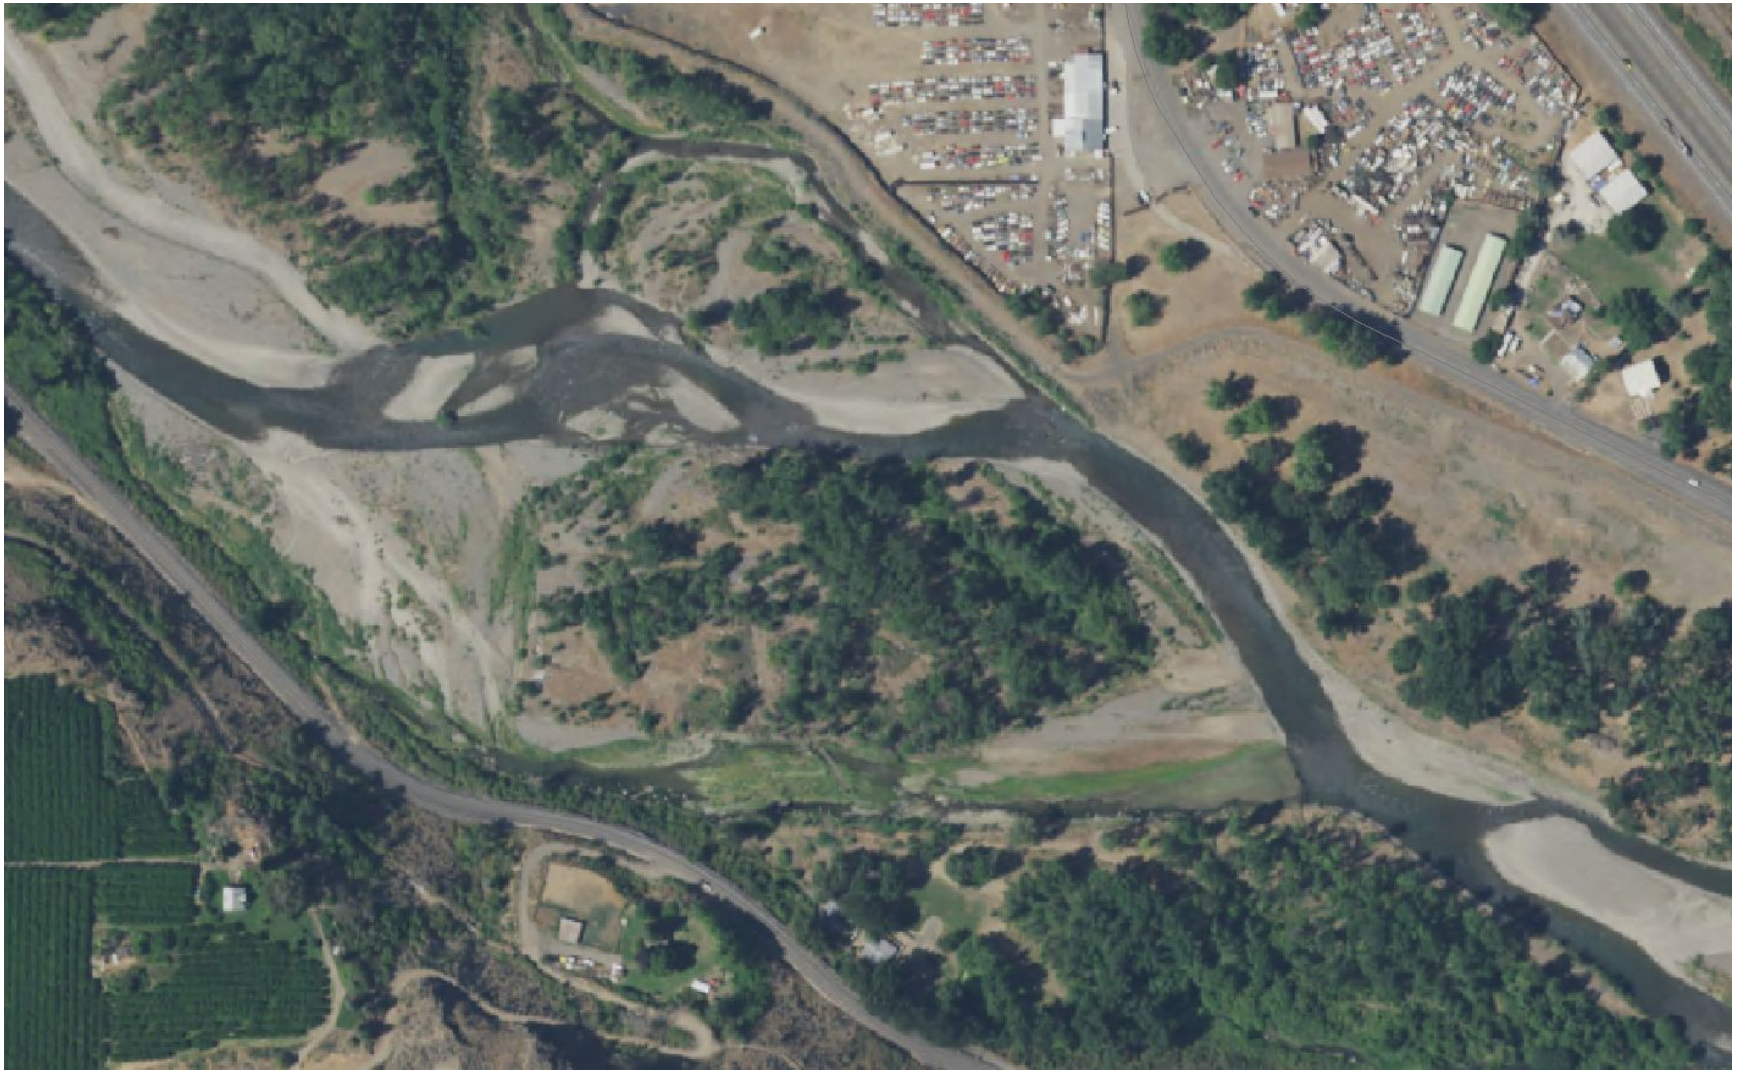
**Figure 21** – Aggraded Bar, Ramblers Park 2015 (water levels very low in this extreme drought year).

The constructed pilot channels in the upstream reaches would be somewhat different than those shown above, as the example above is located in the area with the highest potential energy/slope, where channel regrade would be expected in most spring runoff. There was no effort to install woody material in these channels as we did not want to encourage salmonid spawning in areas of rapid regrade. Farther upstream, Steelhead and Coho channels could be constructed with woody material, or woody material placed after the first flood, to encourage spawning or resting in those much lower gradient lower energy channels.

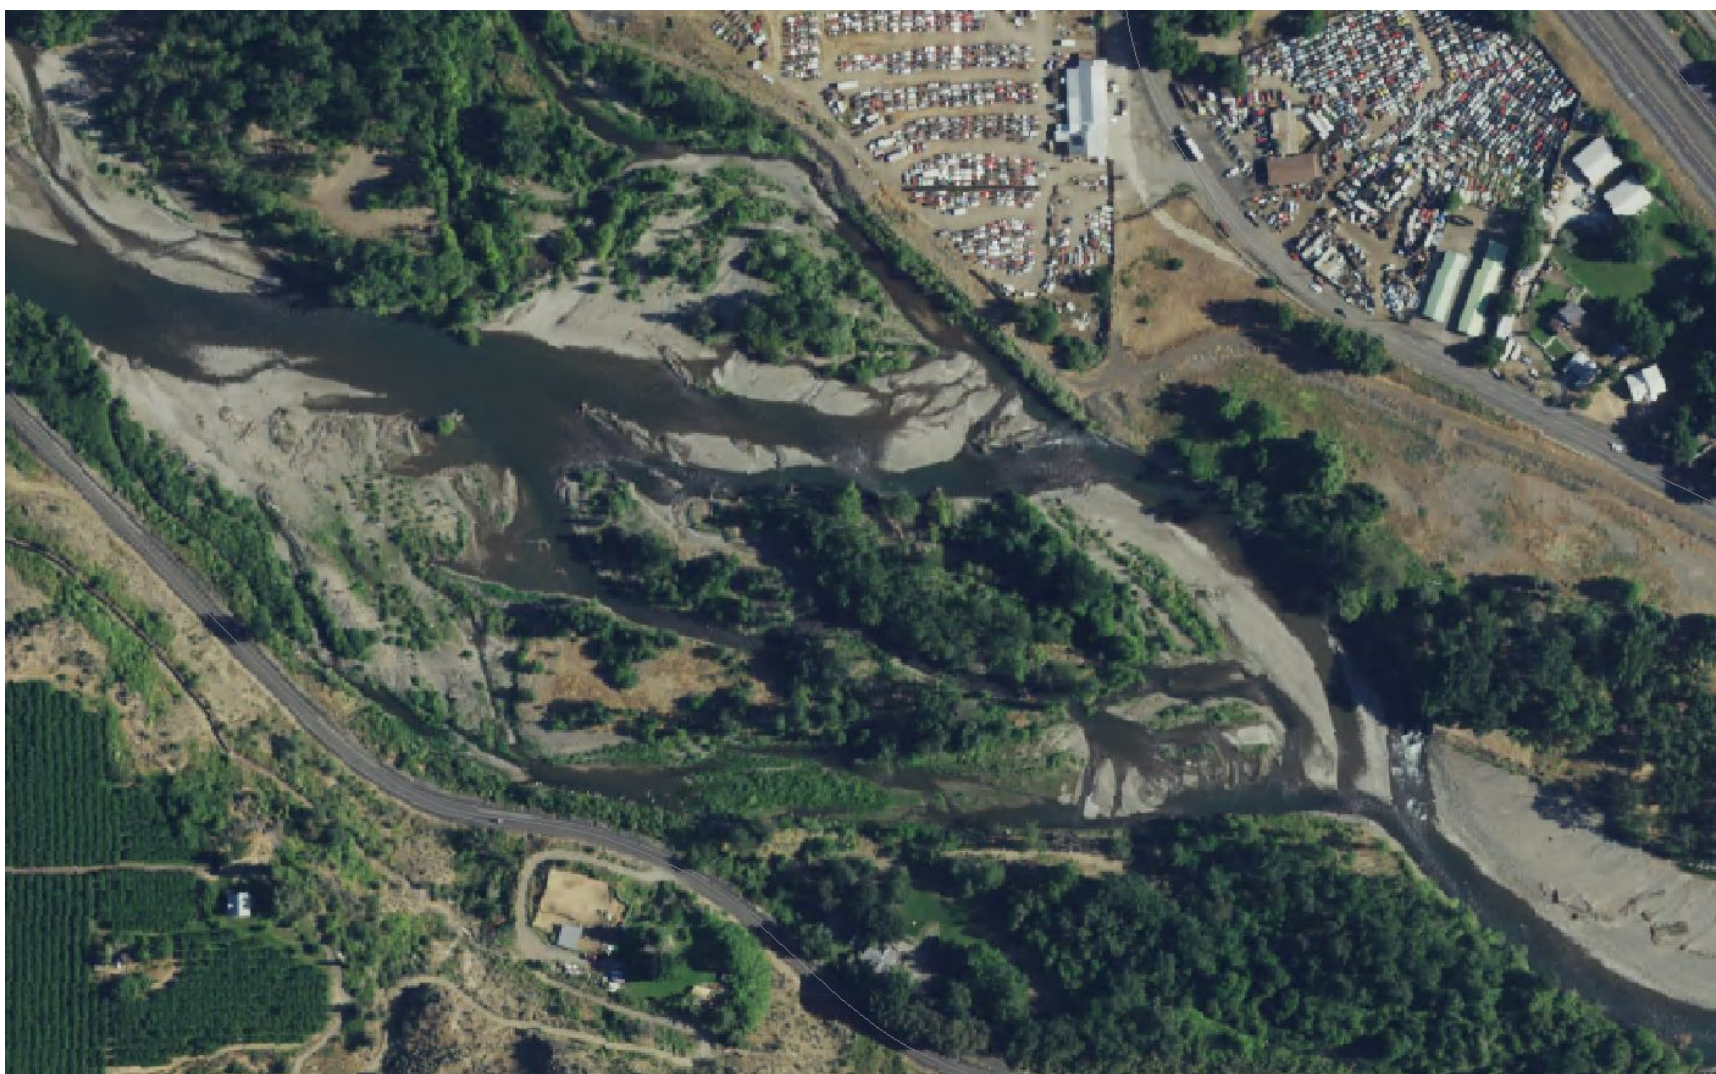
**Figure 22** – Aggraded Bar, Ramblers’ Park 2017, after construction of 3 pilot channels in late 2015. Note increase in wetted channel area and diversity.
