***Water of Life***

Yakima's Millennium Plaza

Inventory, Condition Report,  
Critical Review and Proposals for Restoration and Repair

July 1, 2022

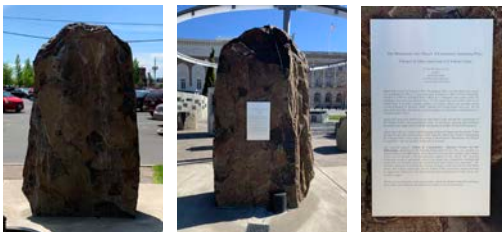
Stele #1 is 8 feet tall. Its plaque describes “The Millennium Plaza: Community Gathering Place.”

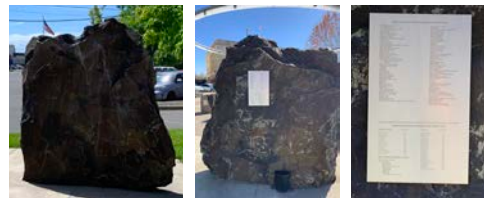
Stele #2 is 7.5 feet tall. Its plaque thanks project participants and builders.

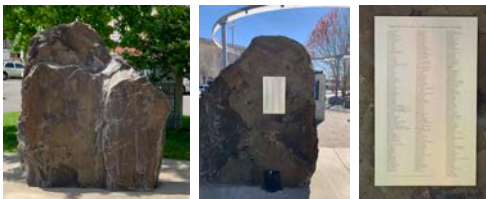
Stele #3 is 7 feet tall. Its plaque thanks project supporters.

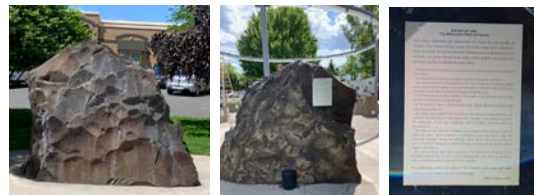
Stele #4 is 6 feet tall. The artist’s statement, *“Water of Life”* by Wen-ti Tsen, is on its plaque. The plaque is damaged.

The tubes were stolen or vandalized long ago, and the standing stones have been dry ever since. Some remnants of broken tubing remain, along with holes and scars where tubing had been attached to the stone surface. Other than this, the stelae are naturally stained and streaked from past water.

- Broken tubing and scars/chips/holes.
- One damaged plaque.

- Tinted masonry patches on basalt scars and holes.
- Replacement Plaque

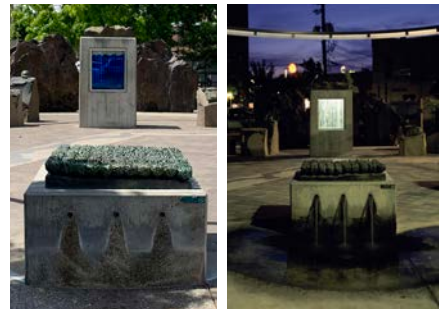
This element of the plaza is one of its most prominent features and a significant visual hook drawing people into the plaza, especially at night when the bubbling water tank is lit and glowing. The cast of the Nelson Ridge sitting atop the tank is dwarfed by the scale of the monolith and is easily missed by visitors.

The concrete and surfaces and plaques are in good condition. A new bubbler has been installed by the City and is working fine, but the water is light blue, unlike the original natural water color (note the difference in appearance between the recent daytime photo and the 2003 nighttime photo above). The new light blue color is not as dark and bright as the color in the photos above; it may be fine.

No damage. No repairs needed.

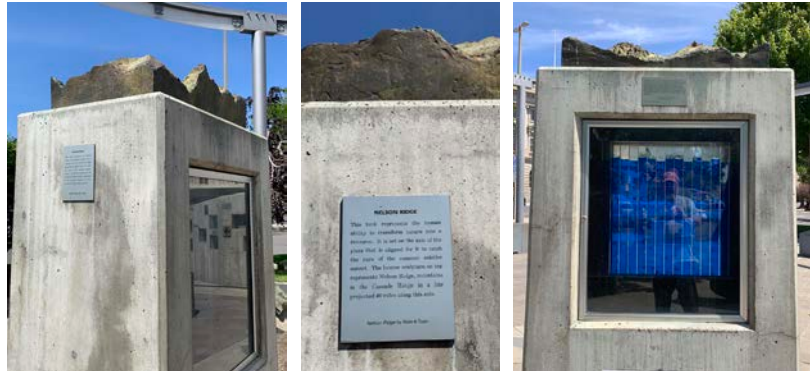
The plaque that identifies the Nelson Ridge watershed and discusses the water tank's meaning is located on the southwest side of the concrete tank and is not easily seen. Another engraved plaque, of a different design and bearing a quote from William O. Douglas, is displayed below the Nelson Ridge on the northwest side, above the water tank, in a very prominent location. This "label" is easily seen and read, in contrast to the water tank's "ID label."

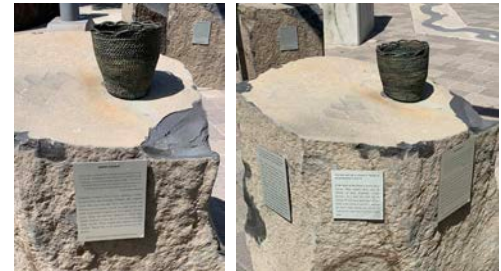
### Yakama Berry Basket

Good condition. This bronze has 3 related plaques. All plaques have minor dings, but main title plaque has bent corner and dents, but text is fully legible.

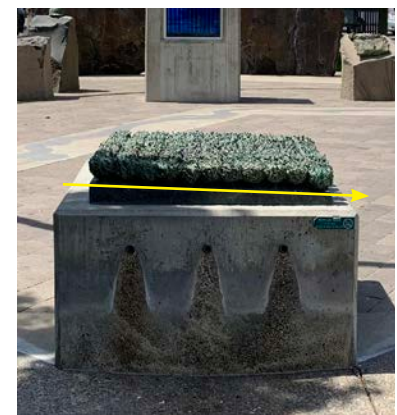
Concrete and bronze are in good condition. I believe fountains are in good working condition, but they were dry when I checked them recently.

Orchard is aligned incorrectly. The bronze orchard casting was mounted incorrectly in 2002. It is not properly aligned with the “flow” of water along the axis of the plaza, from mountain ridge to orchard. The slope of the orchard tilts perpendicular to the axis of the plaza, and the fountains flow out the side of the orchard instead of out from the downhill end. This could be fixed if the bronze was removed from the concrete base and re-set in

the proper orientation. If the bronze is set to the base with caulk adhesive, it may be removed by cutting through the adhesive seat (with a hot wire or fine blade) while prying/hoisting the casting from the base. If it is attached to the concrete base with metal pins set into the concrete, it's a different story (and probably not worth consideration).

The orientation of the orchard is not noticed by the public, but I do believe that if the orchard were turned 90 degrees so that the water flowed out the downhill side it would have a heightened subliminal impact on the viewer — they may be more likely to recognize the relationship the plaza parts that mark its axis and create the water's journey from mountain to orchard in a downward flow. But the impact of this installation mistake is subjective and unknowable. I would recommend re-setting the bronze orchard in its proper alignment only if it can be done easily.

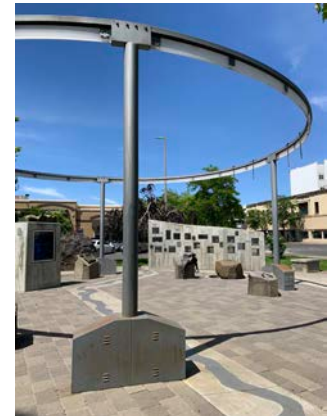
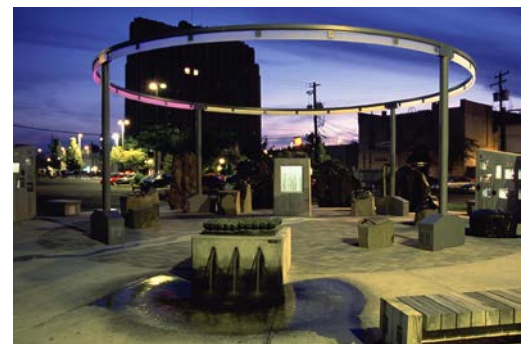
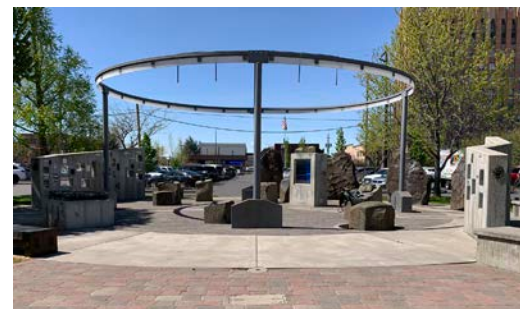
Standing 13 feet above the plaza is a “circle of life” — bands of light fixtures mounted on a 30 foot diameter metal ring supported by metal posts, painted gray. The four 10-foot posts sit on metal cabinets (approx. 12” x 32” x 26” tall) that once housed the projector lamps for the original fiber optic lighting system. When this outdated system failed, it was replaced with a new programmable LED system.

The new LED lighting system has been installed, but it may not yet be programmed. When last observed, it was a steady blue light with no movement or changes in color.

I suggest, though, that while the large metal cabinets may appear prominent in the photographs above, they are less so when observed in real life. When in the plaza, these forms seem to blend into the infrastructure.

I can investigate the possibility, feasibility, and cost of the change if requested.

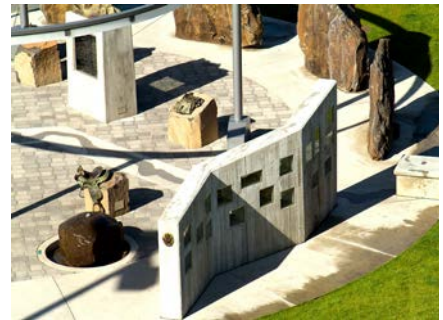
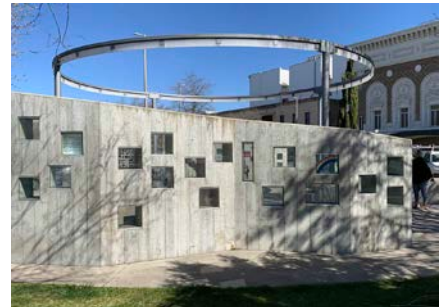
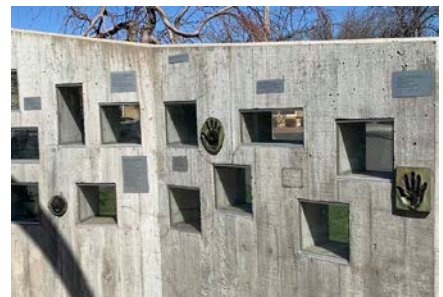
The inner face of the northeast wall displays 5 bronze handprint “tiles” and 12 engraved plaques bearing statements and quotations from community members (one of these plaques is missing). The inner face of the southwest wall displays 5 bronze handprint tiles, a bronze fish tile, and 15 engraved plaques bearing statements and quotations from community members (two of these plaques are missing).

There is a noticeable sense of clutter when looking outward at the Community Walls from within the plaza’s center. The many small plaques (thin engraved metal as found on sports trophies) are located only on these inner walls, together with the 11 bronze “tiles,” in and among the 36 window displays. In contrast, the outer faces of the Community Walls have a clean, minimal look, and the display windows are more prominent and striking. While it may be suggested that the many thin engraved plaques be re-located (possibly to the narrow ends of the walls where they would form single tall “stacks”) so that the inner walls gain the clean look of the outer walls, it is more important to note that it is better that the “busy side” be inward, in the more sheltered center of the plaza, and the minimal side faces outward, giving the entire plaza a more unified and clean appearance when approached from a distance.

Overall condition of the concrete walls is good, except that niche lighting is not functioning throughout. Concrete shows minor cracks, staining, and 3 scars where plaques have been removed (inner side of wall). Display niches vary in condition — some broken glass has been replaced, some niches appear to have moisture issues, some niches have UV and other natural light issues, and all have security issues.

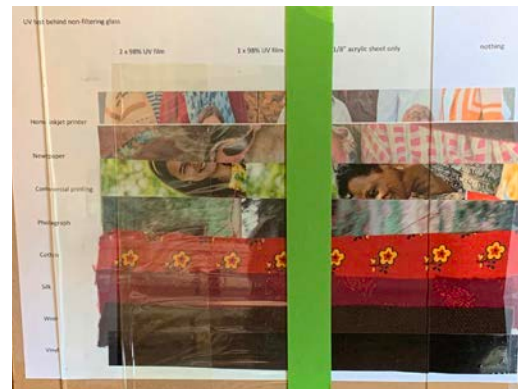
**A UV exposure test** is installed in the wall right now. Samples of various printed materials and fabrics have been placed in a highly exposed niche (niche N15, Marty Lovins’s *School* sculpture) and protected by various layers of UV-filtering film and acrylic, with duplicate test panels facing north and south in the same niche. Damage and fading will be monitored and compared throughout 2022 and beyond.

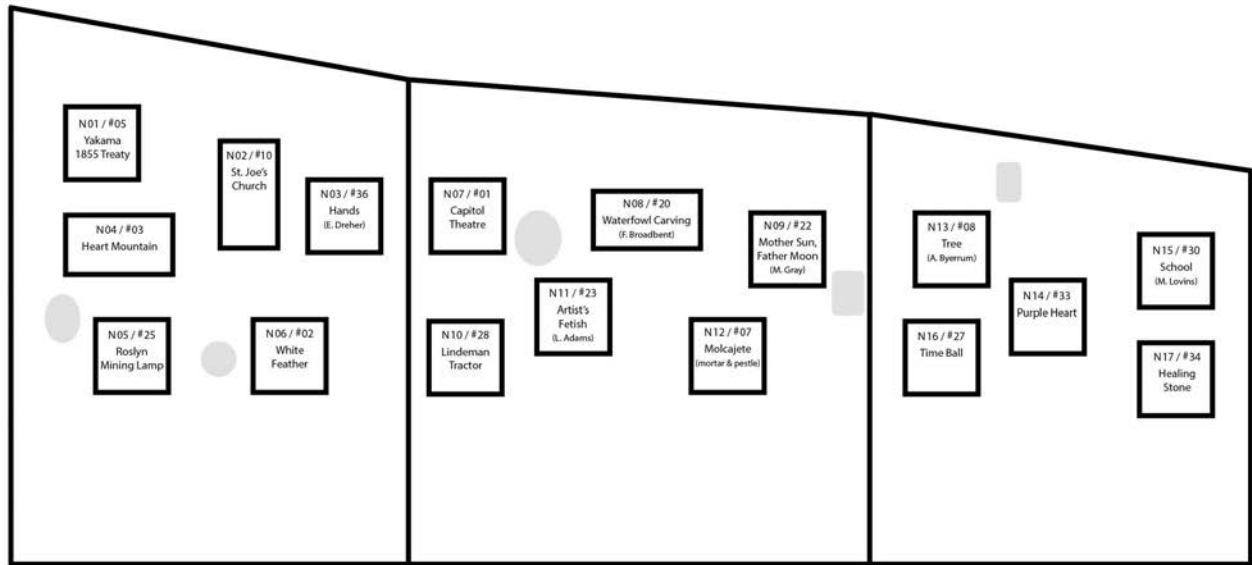
NORTHEAST COMMUNITY OBJECT WALL  
 MAP AND NICHE IDENTIFICATION KEY

NOTE: **LIGHTING NOT FUNCTIONING THROUGHOUT.**  
**ALL GRAPHICS AND TEXT ON GLASS WINDOWS IS DAMAGED OR GONE ON ALL COMMUNITY WALL WINDOWS.**

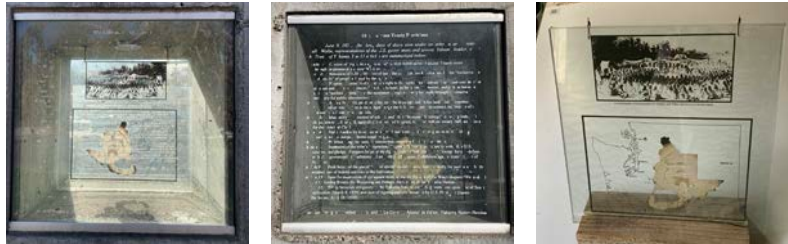
Transparency map and photo  
sandwiched between two 11" x 11" glass panes, hung from top.  
Text (380 words, 1855 Yakama Treaty Provisions) silkscreened white  
on window glass.

Transparency sandwich FAIR—film adhesion shows faint bubbles when light hits it right.  
Window text damaged.

**We have all needed graphic files and text for replacements:**

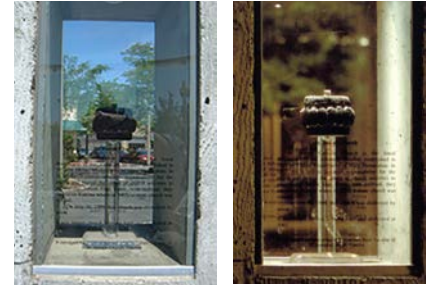
2003 photos:

**Present condition:** EMPTY. Artifact gone.

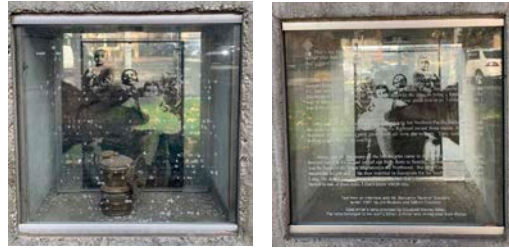
Transparency poor—film adhesion shows bubbles when light hits it right.

Window text damaged.

**Mining lamp is in good condition, a photo file for the transparency, and text files for window text.**

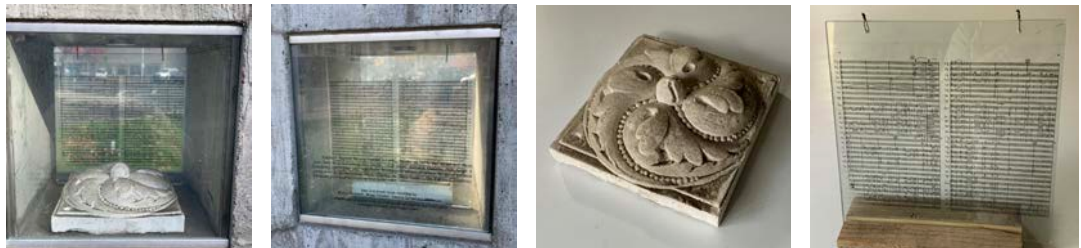
Transparency music score sandwiched between two 11" x 11" glass panes, hung from top.

Transparency Poor — glass cracked, film adhesion shows faint bubbles when light hits it right.

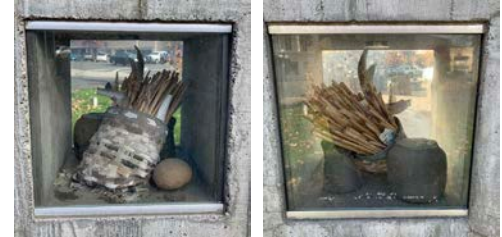
NORTHEAST WALL

Faded but in good condition.

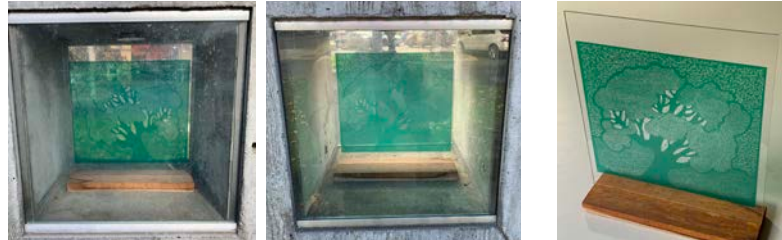
Faded, but not bad.

Window text damaged.

**We have text files for window text.**

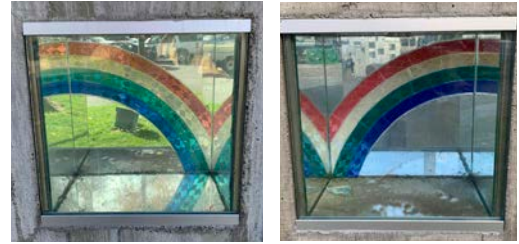
Artist's statement (46 words) silkscreened on window glass.

**Present condition:** FAIR. Reflector plastic badly faded.  
One mirror cracked. Dirty and needs cleaning.

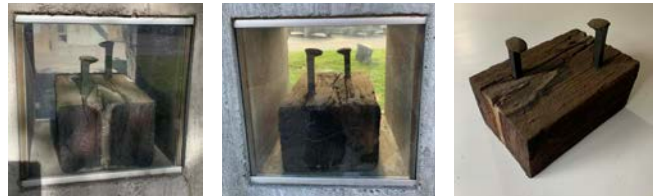
Section of railroad tie with spikes

Artifact dirty but in fine condition.

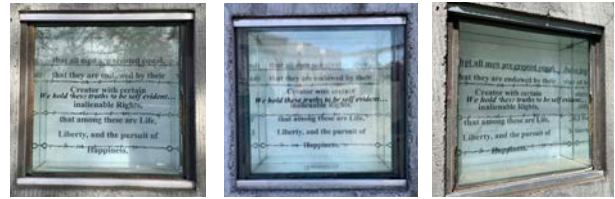
Transparency overlays on inner glass panels,  
assembled and adhered into niche.

Some fading and dirt, but basically good condition,  
except for cracked interior side glass and text bad on south window.

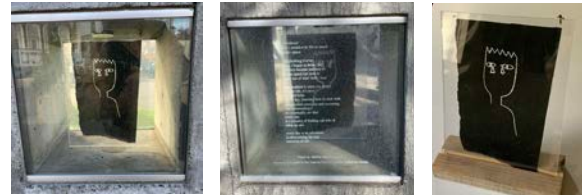
Poem and text (120 words) silkscreened white on window glass.

Good condition inside. Transparency and plex good.  
Window text badly damaged.

**We have graphic file for artwork and text files for window text.**

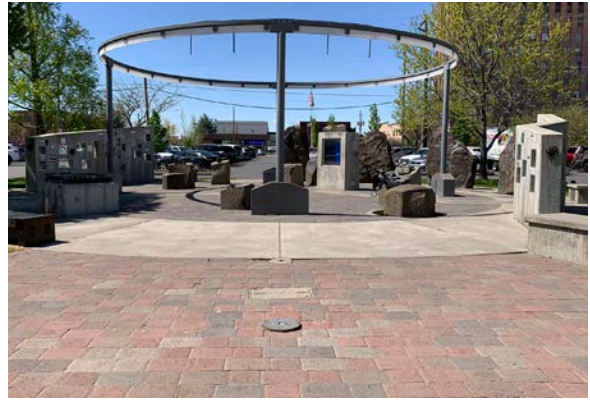
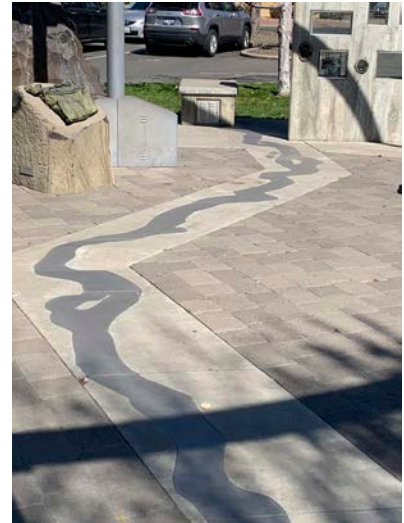
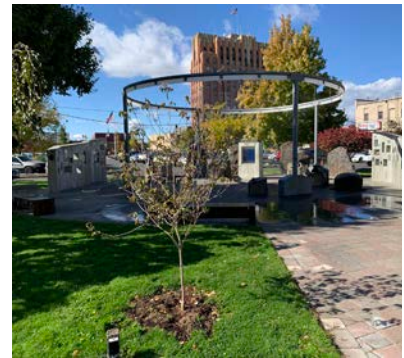
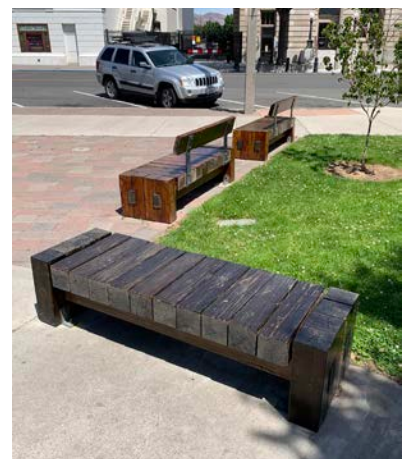
There are 6 benches in the plaza space, 4 at the entrance from the 3rd St. sidewalk, and 2 along the southeast edge of the plaza ring, situated to afford an “axis view” into the plaza. All benches have been recently refinished and are in excellent condition.

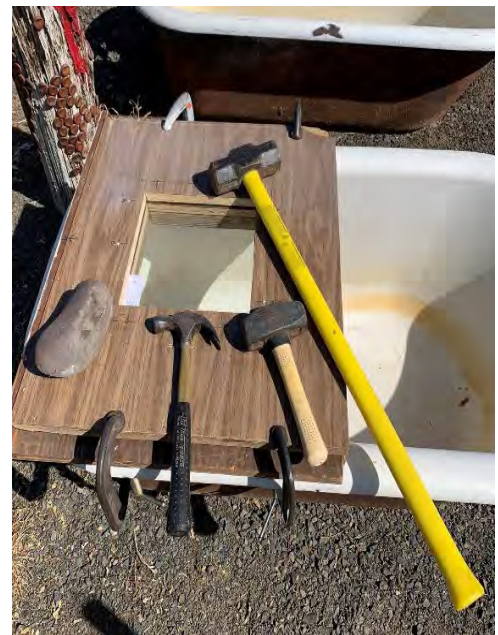
## APPENDIX IV — WINDOW GLASS TEST, MAY 2022

Glass is then struck with large 8 lb. sledge hammer multiple times with increasing force until glass breaks ...or doesn't.
