Swimming Pool Assessment

**Lions Indoor Pool
509 West Pine St.
Yakima, WA**

April 22nd, 2015

RE: Lions Indoor Pool
Swimming Pool Assessment

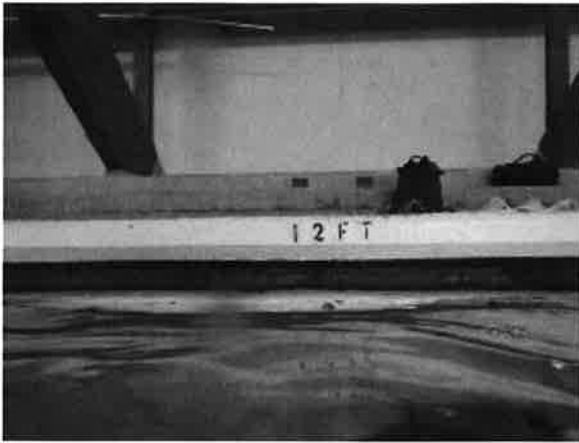
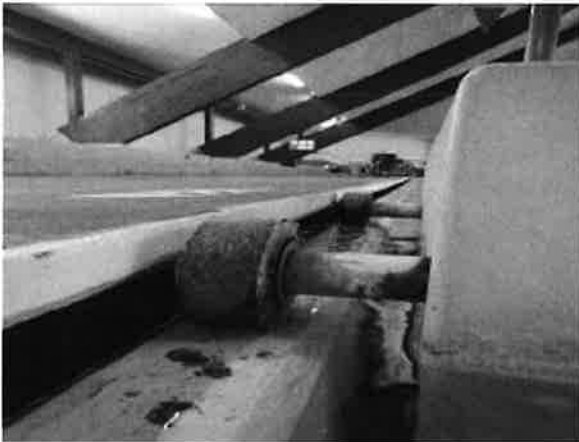
Due to the slopped trough, the gutter appeared to move water towards the surge tank at an effective rate which prevented standing water. The inside of the trough was observed to be stained and discolored in some areas. It is unknown if the gutter is watertight, but water loss was not an issue mentioned by the facility staff.

The gutter lip, the coping at the top of the pool wall, was observed to be slightly damaged and stained in some areas. An uneven gutter lip could lead to inconsistent overflow in some areas along the perimeter of the gutter. The bulkhead observed at the facility consisted of four wheels which rolled directly on the wall coping. The direct contact of the bulkhead wheels have damaged the wall coping from years of use.

Immediate: Confirm that the front of the gutter lip is level. In the case that the front of the gutter lip is not level, sections of the gutter lip may need to be removed and replaced as necessary.

Thoroughly clean the gutter trough on a regular basis to cut down on staining and corrosion.

Future: Perform a water tightness test on the gutter system to ensure that it is water tight and does not have any leaks.

Replace the gutter system with either a new stainless steel gutter system or a new concrete gutter system that better captures swimmer surge and is more user friendly for egress similar to a deck level gutter or rollout gutter system. The new gutter system should have 100% capacity of the recirculation flow rate. Recommend selecting a gutter system with PVC grating covering the gutter trough opening for safety reasons.

The gutter coping is currently damaged due to the placement of the bulkhead wheels. A new bulkhead shall be installed that is moved by means of a track and wheel system or is inflatable to eliminate any further coping damage. Refer to *Section 2.5* for further information on the existing bulkhead and suggested replacement.

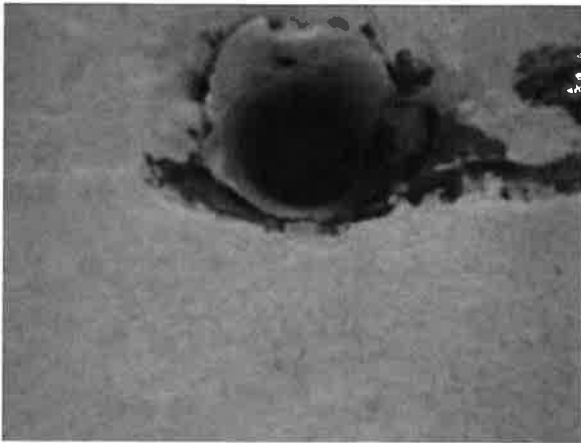
The tile and grout were observed to be stained and dirty.

Immediate: The next time the pool is completely drained, replace any missing or damaged tiles.

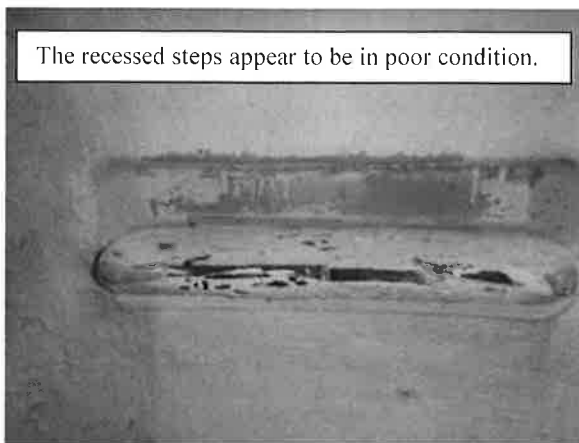
The recessed steps appear to be in poor condition.

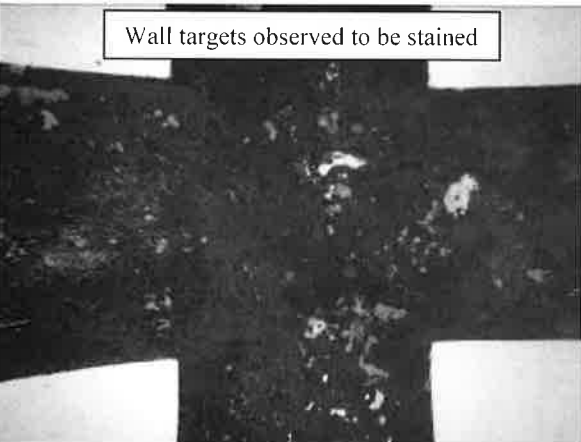
Wall targets observed to be stained

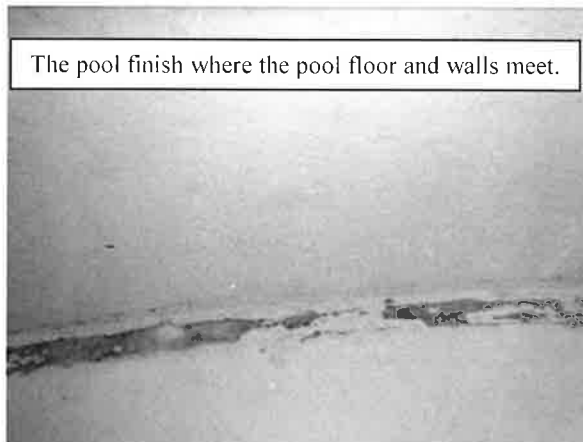
The pool finish where the pool floor and walls meet.

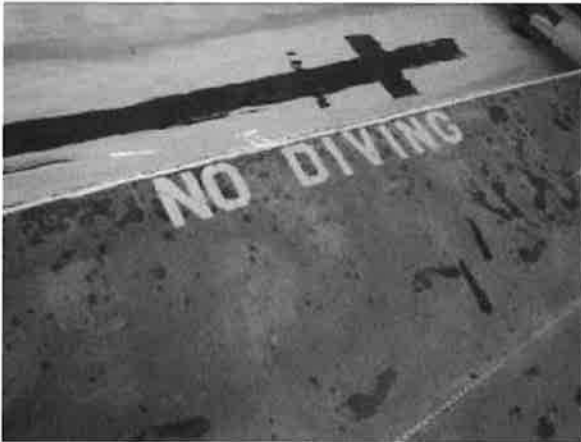
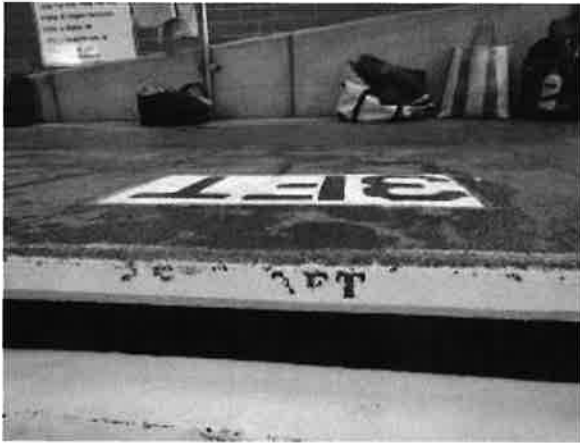
Horizontal and vertical depth markers are located around the pool perimeter in multiple locations. In addition, six (6) "NO DIVING" markers were observed along the sides of the pool from the shallow end up until the bulkhead. Per Industry Standards, "No Diving Signs" and warnings should be provided with all depths of 5'-0" and less. Washington State Pool Code requires a safety line or marking line separating areas where the pool bottom breaks from the uniform shallow end slope to a steeper slope heading towards the deep end of the pool. During the site visit a marking line was not observed on the pool shell at the slope break. Because of the bulkheads position, a floating safety line could be excessive.

Immediate: To ensure code compliance depth makers shall be installed at increments of 2' of water depth or less. Consecutive depth markers cannot be more than 25' apart. "No Diving Signs" shall be provided where ever the pool depth is five' and shallower. Install a marking line on the bottom of the pool at the 5' water depth or provide a floating safety line.

Ensure all required warning and safety signage, such as HAZMAT signage, is found around the natatorium.

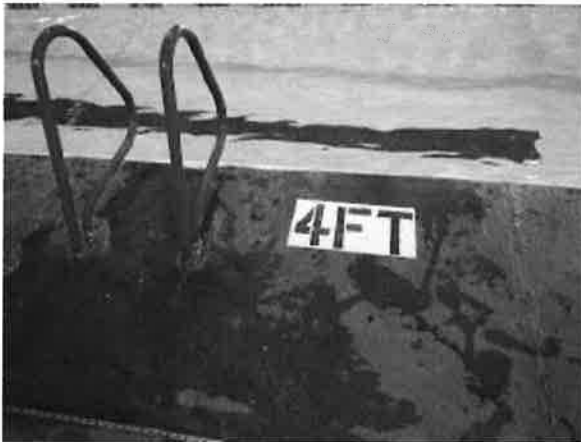
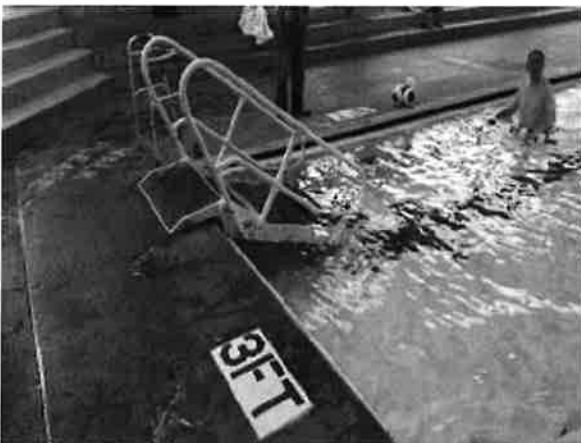
The pool has recessed steps paired with painted metal grab rails located around the pool perimeter at four (4) locations. The recessed steps were only partially recessed, with around 3" of step extending out from the wall. The steps were observed to be in fair condition and the condition of the grab rails is uncertain due to their paint exterior. The grab rails did not contain escutcheon plates. There is also a movable stainless steel and plastic staircase located in the shallow end. One portable Aqua Creek pool lift was observed at the pool facility.

The pool must have two (2) means of ADA access; one (1) primary and one (1) secondary means of access. The primary access should be an ADA pool lift or ramp entry that is permanently anchored to the pool deck. The secondary means of access must be an additional pool lift, a sloped entry, a transfer system, or a compliant entry stair system. In this situation, the cheapest option would be an ADA approved portable stair system. A portable stair system was observed in the pool, however, it is unknown if it is ADA compliant.

Immediate: Ensure that all new and old grab rail anchors are bonded per NEC 680 and have protective escutcheon plates.

Replace the existing portable staircase is an entry ramp.

Future: When the bulkhead is replaced ensure the new bulkhead can move along the pool wall without being damaged by the protruding steps. The bulkhead width dimensions can be specialized to prevent contact with the steps, or the steps can be altered so they don't branch off the pool wall as much as they currently do.

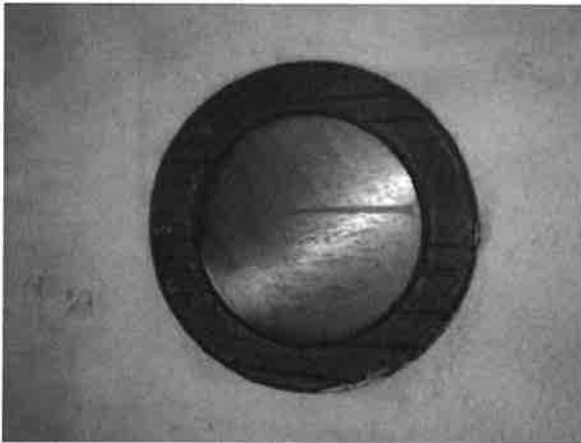
The existing underwater lights are located on the side walls of the pool. All lights have been covered with what appeared to be a stainless steel plate and are not used.

Immediate: Confirm the existing overhead lighting in the natatorium allows the bottom of the pool to be seen at all hours of operation. Protective shielding for all lighting fixtures above walking surfaces and any of the pool surface area shall be provided. Washington State Code requires a minimum of 30 foot candles above an indoor pool surface, and 10 foot candles above any pool deck. Industry standard calls for a minimum of 30-100 foot candles above the pool surface depending on the use of the pool. Foot candle requirements increase when competitions inside the natatorium shall be televised.

Future: Remove all existing light fixtures from the pool structure and repair any consequential holes or pool structure damage.

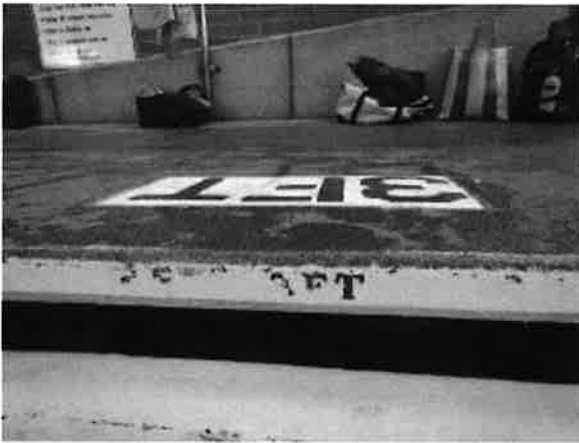
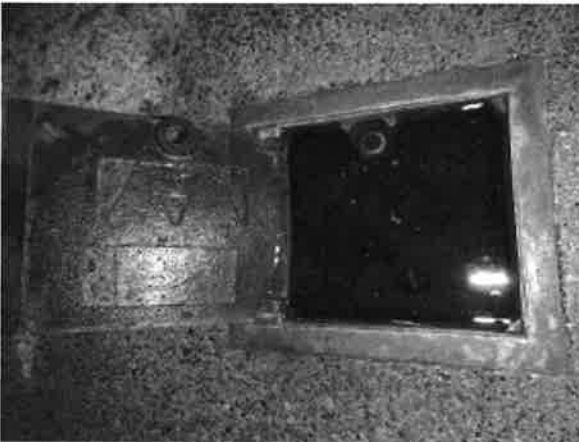
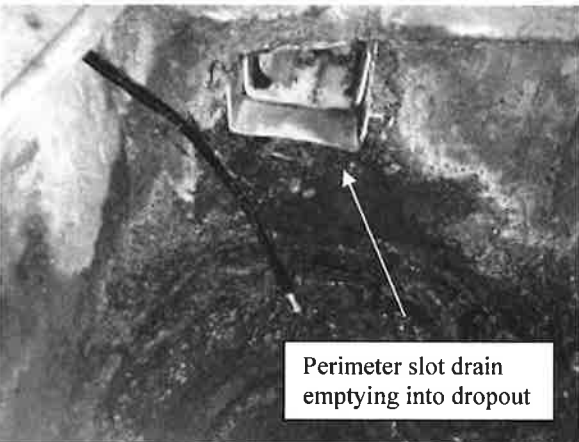
The deck inside the Lions Pool Facility consists of broom finished concrete with painted depth markers and warning signs. The condition of the deck could be described as fair to poor. The concrete was observed to be cracked and stained in numerous places. In multiple locations rebar was visible on the deck's surface and was corroding. From the edge of the pool coping, the perimeter of the deck slopes away from the pool to a narrow slot perimeter drain. The perimeter drain consists of a small trench covered by an even smaller grating with circular holes. The perimeter trench drain empties into four (4) dropouts which were observed to be located at the four (4) corners of the pool. When inspected the dropouts appeared to be full of grit and water. It is possible that the dropouts were partially or fully blocked during the time of inspection.

Immediate: Ensure the deck adequately slopes to drain all water to the trench drains. Repair all areas of the deck that are cracked, especially where there is exposed rebar. Repaint all deck markings with slip resistant paint. Ensure that the deck meets minimum state requirements for square footage.

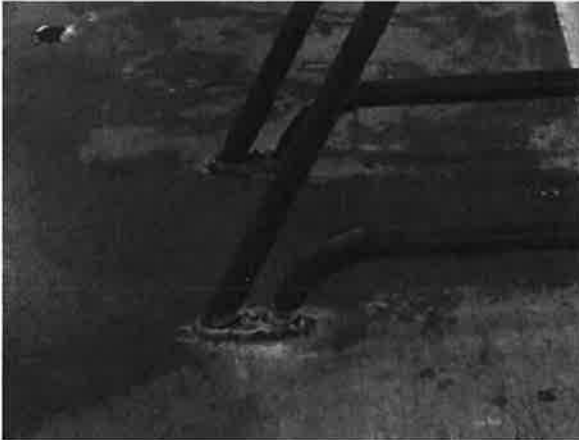
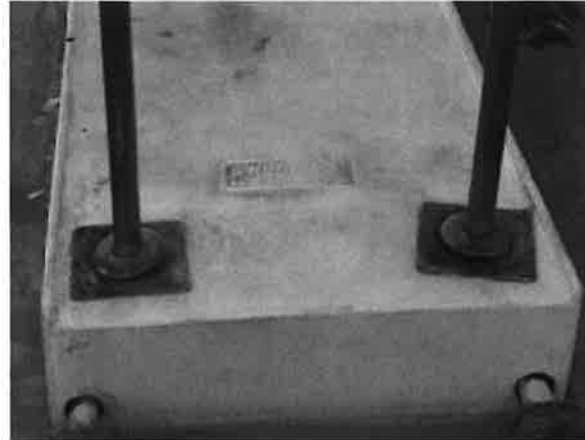
Starting block anchors were observed in the pool deck at the deep end of the pool. Several of the anchors were observed to display signs of corrosion and possible electrolysis. Few escutcheons were observed on the equipment around the pool. All deck anchors should be bonded to the pool shell per NEC 680.

Immediate: Remove and fill in any abandoned and unused deck anchors. Evaluate and confirm that all used deck anchors are properly bonded to the pool shell per NEC 680. Replace corroding escutcheon plates for all grab rail deck anchors and ensure they are properly tightened and secured. Provide flush mounted caps for all utilized deck anchors when they are not in use (e.g. stanchion anchors and starting block anchors when the backstroke flags and starting blocks are removed for recreation).

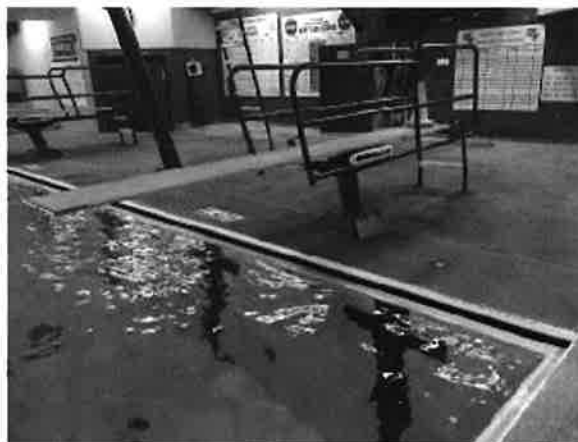
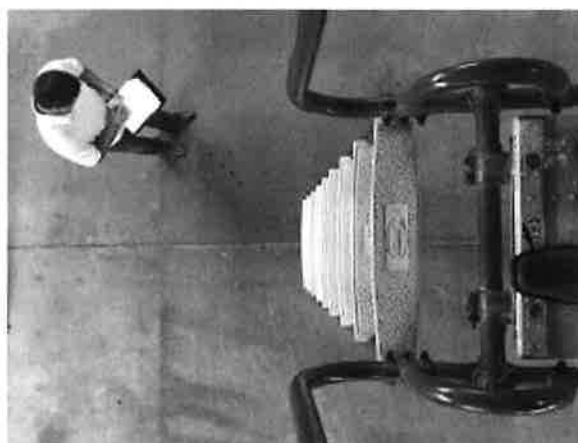
There are currently two (2) 1-Meter springboards and one (1) 3-Meter springboard installed for use at the deep end of the swimming pool. Due to their painted exterior it is hard to tell the true condition of the diving stands. The Washington State Code references FINA as the overarching code for facilities with diving platforms or boards greater than ½ Meter. The Lions Pool meets all minimum requirements spelled out by the FINA diving envelope.

All diving board access steps had a slip resistant finish. The 3-Meter diving board was not fully provided with an unobstructed hand rail/safety rail on both sides of the steps.

Immediate: Based on the facility's history and risk management concerns, it is recommended that all springboards are removed. Install a new 1-Meter springboard in the prior location of the 3-Meter springboard.

Provide escutcheon plates for diving board ladders and support stands. Ensure all diving board stand anchors are properly bonded and installed per the manufacturer's recommendations. Wipe down the safety railings and diving stands with stainless steel cleaner on a regular basis in order to reduce corrosion.

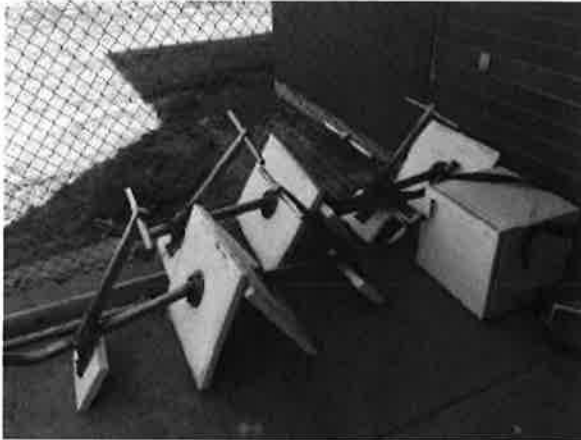
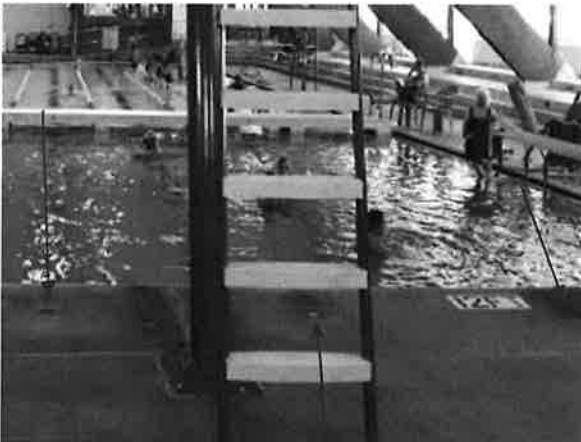
There are anchor slots for six (6) starting blocks for the six (6) lane, 25 Yard, race course layout. The starting blocks appear to be very old and in fair to poor condition. The height of the starting blocks above the water was not measured during the site visit, however most organizations require a maximum starting block height of 30" above the pool water surface.

Immediate: Provide new starting blocks that are compliant with the NFSHA.

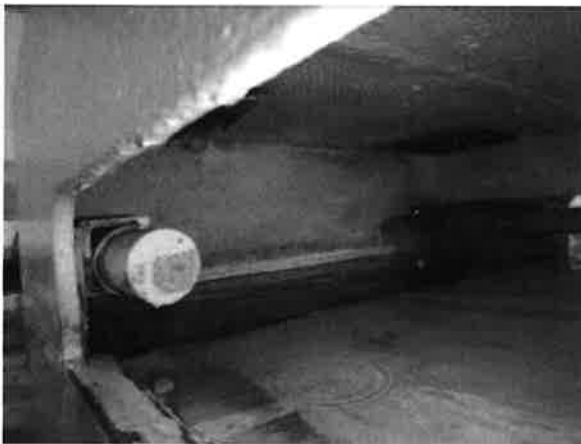
The bulkhead at the Lions Pool Facility was observed to be in poor condition. The actual age of the bulkhead was not recorded during the site visit. The bulkhead was observed to be a Stark fiberglass flow through bulkhead. The bulkhead moves manually, so it requires people to push or pull both ends simultaneously. The bulkhead wheels are located directly on the gutter coping and have damaged the gutter finish over the years.

During the time of the site visit the bulkhead was located at the slope break between the shallow and deep ends of the pool. When located at the slope break, the bulkhead creates a 25 yard race course from the bulkhead to the shallow end wall. This course is 4'6" at its deepest point and therefore would not provide adequate depth for starting blocks. According to facility staff, the bulkhead is moved into the shallow end when the pool is to be used for competitive swimming. The only location that starting block anchors were observed was at the deep end wall. The deep end does provide adequate depth for competitive block starts.

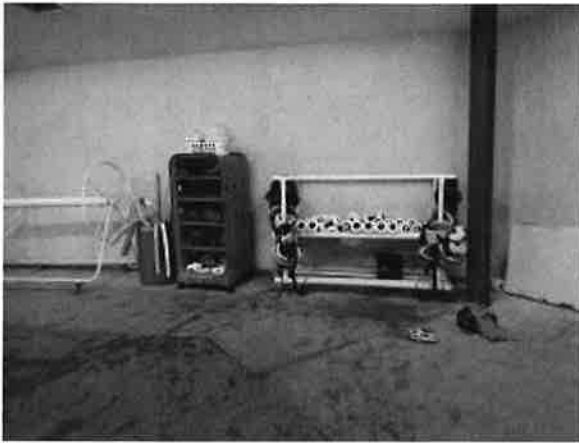
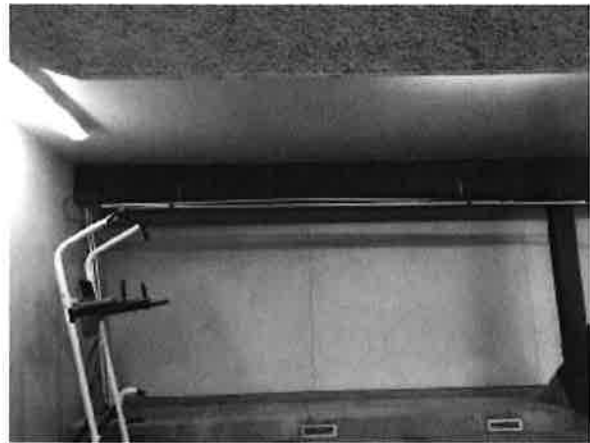
Various pieces of deck equipment can be found throughout the natatorium and its support spaces. A complete inventory was not taken at the time of this site visit. Kick boards, fins, life jackets, aqua belts, weights, and other flotation devices were observed to be stored on the pool deck and in the storage closet behind the diving boards.

Immediate: It appears that almost all of the pool deck equipment is stored on the pool deck. Although deck clearance does not appear to be an issue, it would be advisable to store deck equipment in a nearby storage room or support space.

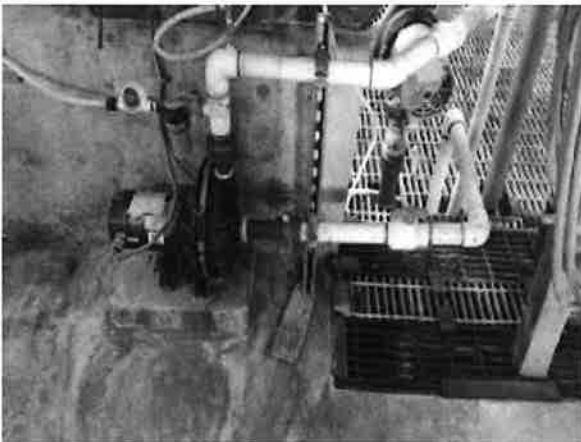
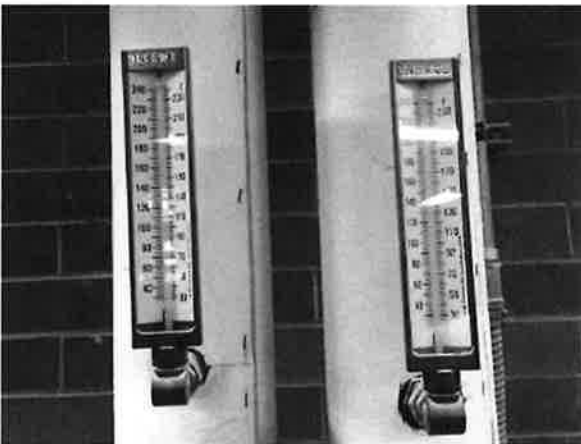
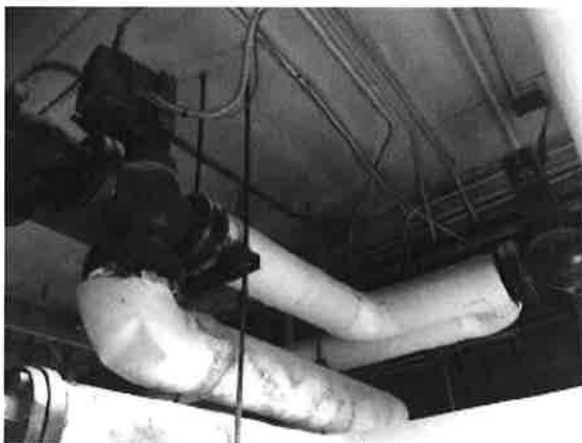
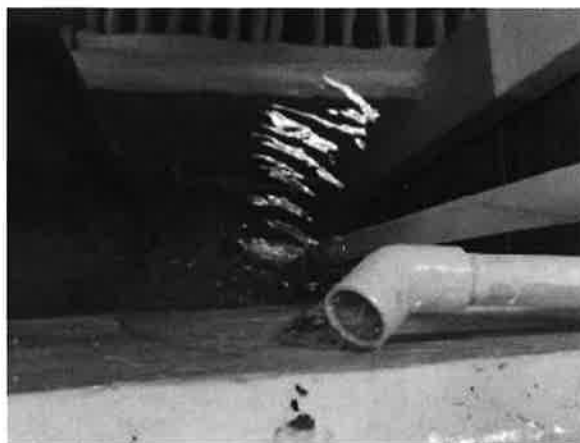
The visible recirculation piping for the pool in the pool mechanical room is cast iron. The chemical feed loop piping that intersects the main recirculation loop and the fresh water fill line are 40 PVC. The piping appears to be in fair to poor condition. Some sections of the main cast iron recirculation pipe were stated to be in near failing condition by facility staff. However, visual observation could not be done due to the pipe locations. The return line from the main drains is shown as an 8" line on the '72 construction drawings. This section of pipe runs underneath the pool, comes up through the surge tank floor, and then penetrates the filter tank wall. Water flows from the main drains into the filter tank when the modulating float valve is actuated. The provided pool drawings indicated the presence of a modulating float valve, but the existence of the valve could not be confirmed from the site inspection.

Very little, if any, color coding or labeling was observed on the mechanical room piping. It is industry standard to provide plumbing identification through either color coding or labels. The majority of the valves in the mechanical room have labels identifying their purpose, however there is no posted piping and valve schematic.

The pool has an 8" cast iron pipe that routes water from the two (2) main drains back to the filter via static pressure head. An 8" cast iron equalizer line also routes water from the surge tank to the filter tank. It is industry standard to size gravity piping to flow at 3 fps. Due to the unique design of the pool's perimeter overflow system, there was no gravity piping to take into consideration, rather the perimeter gutter trench flowed via gravity, albeit in a pressurized condition. Washington State Code requires a 1% slope minimum for all gravity piping. In the case that a 1% slope is not provided for gravity piping, a design solution, prepared with a detailed explanation may be sufficient. The Washington State Code requires suction piping to not exceed 6 fps. The max water velocity in the main drain suction lines would be around 4 fps, assuming a flow rate of 597 GPM. The discharge piping, from the effluent end of the pool recirculation pump back to the pool, is 6" PVC, and believed to be Schedule 40 PVC. Again assuming a flow rate of 597 GPM, the discharge velocity is approximately 6.62 fps. Washington State Pool Code does not provide any guidelines on maximum or minimum discharge velocity, as long as the flow rate meets the minimum State required turnover rate. Because the discharge piping velocity falls below the typical industry maximum velocity, it can be assumed that the piping is adequately sized for the current flowrate.

Immediate: A majority of the mechanical room piping is in need of replacement. Industry standard for all exposed pool piping outside of the pool shell is Schedule 80 PVC. All exposed mechanical room piping including, including the recirculation loop, shall be replaced with Schedule 80 PVC.

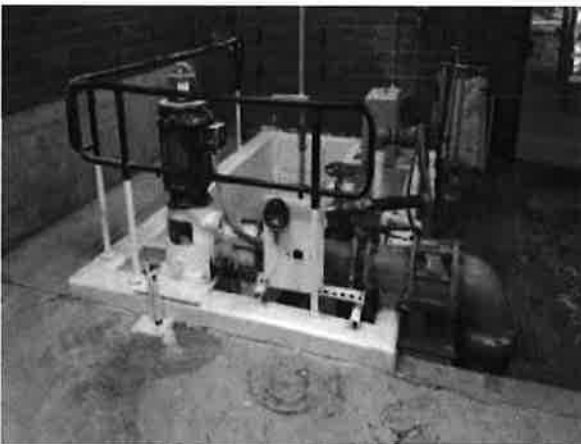
The pool has one recirculation pump, which was recorded as one (1) US Motors pump, model number BF30. The pump was observed to be a 15 HP, 3 phase, 60 Hz, 1770 RPM, vertically mounted recirculation pump. Facility staff noted that the pump motor was last replaced in 2013. Even though the pump was replaced recently, facility staff expressed dissatisfaction with its performance. According to facility staff the pump barely provides enough flow to meet the minimum State required turnover of 6 HRS. During the site visit no flow meters were observed. The pump strainer was in the form of a square stainless steel screen. A pressure gauge, reading 8 psi, was recorded along with a vacuum gauge reading of 5 Hg (-12.4 psi). As per industry standard, vacuum and pressure gauges are required on the suction and pressure sides of pool pumps. The pump is mounted on brackets that span over the filter tank. The motor did not appear to be bonded and the knife disconnect was not labeled.

A booster pump was observed in the mechanical room by the chemical loop. According to facility staff the booster pump was installed to help circulate water through the chemical feed loop. The flow that the recirculation pump provides does not create enough pressure to simultaneously circulate the secondary chemical loop. It is unknown if the booster pump was needed before the recirculation pump was replaced in 2013. The booster pump was observed to be an Emerson ¾ HP, 1 phase, 60 Hz, 3450 RPM, horizontally mounted pump. At the time of the site visit no flowmeters or gauges were observed on the suction or pressure sides of the pump. As per industry standard, vacuum and pressure gauges are required on the suction and pressure sides of all pumps. The pump appeared to be attached to a housekeeping pad. The motor did not appear to be bonded but a labeled knife disconnect switch was observed.

Three (3) additional booster pumps were observed in the mechanical room but were not in operation. One (1) of the three (3) booster pumps was located in the old heat exchanger loop but served no purpose due to the heat exchanger being inoperable.

Immediate: Replace the recirculation pump with a pump that can adequately surpass the state required turnover as well as power the chemical feed loop. To meet a 4 HR turnover the new recirculation pump will need to provide a flowrate of 895 GPM. Provide vacuum gauges on the intake suction side of all pumps and pressure gauges on the discharge side. Provide labels for the knife disconnects and ensure they are working properly. Ensure all pumps are properly bonded as per NEC 680.

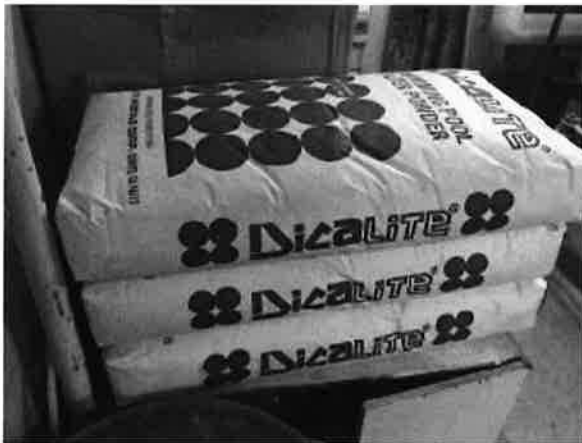
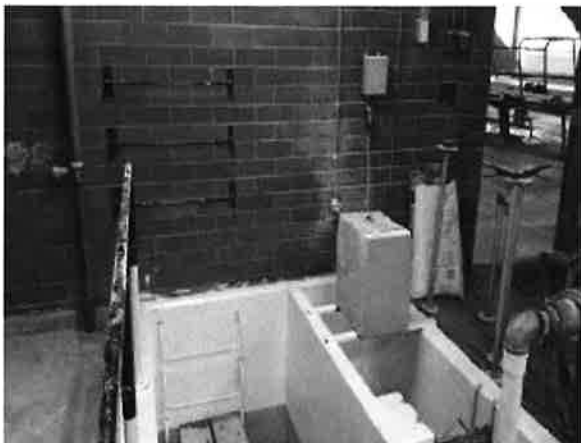
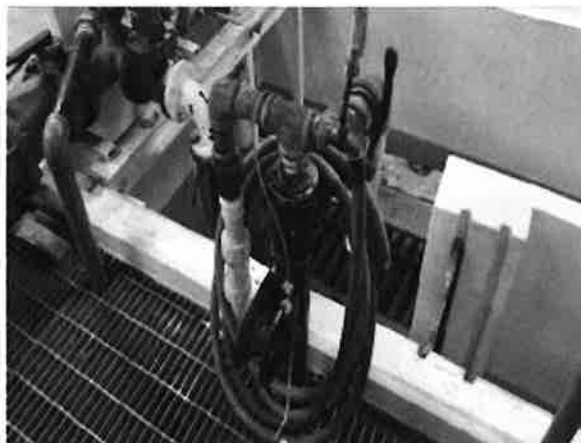
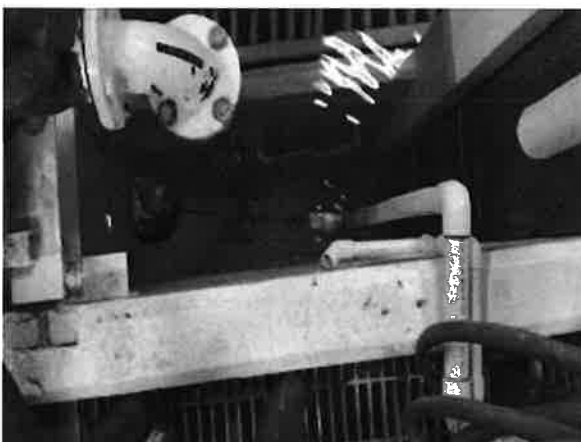
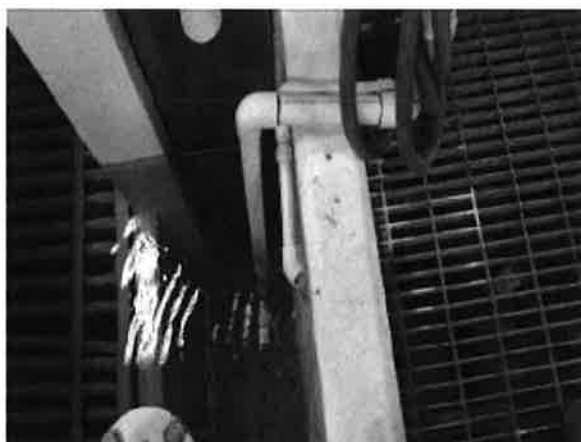
Currently, the pool utilizes a vacuum diatomaceous earth filtration system. The system is composed of a filter tank which houses twenty (20) 32" square diatomaceous earth cartridges. The cartridges provide 142 SF of filter area. At the current assumed flow rate of 597 GPM, the approximate filtration rate is 4.20 GPM/SF of Filter Area. This is significantly higher than the usual standard of 1.5 GPM/SF. Higher filtration rates typically result in more backwashing, as well as deterioration of overall filtration performance. Typically Facility staff noted that the cartridges are generally bumped every two (2) weeks and the filter media is replaced every 2½ months.

The Lions Pool does not have a backwash catch basin resulting in a direct conveyance of filter backwash water to the pool sanitary sewer. Many jurisdictional authorities require a reclamation tank between the D.E. filter tank and the backwash outfall so that the spent D.E. is captured and not discharged into the sanitary sewer. The captured D.E. is then hauled to an approved dump site.

The filter tank itself is open to atmosphere which is convenient for maintenance and monitoring. Two (2) wooden planks were observed to serve as a walking bridge over the filter tank. The floating planks were dangerous due to the fact that they began to sink when stepped on.

Immediate: Confirm that diatomaceous earth can continually be drained directly to sewer during backwash cycles.

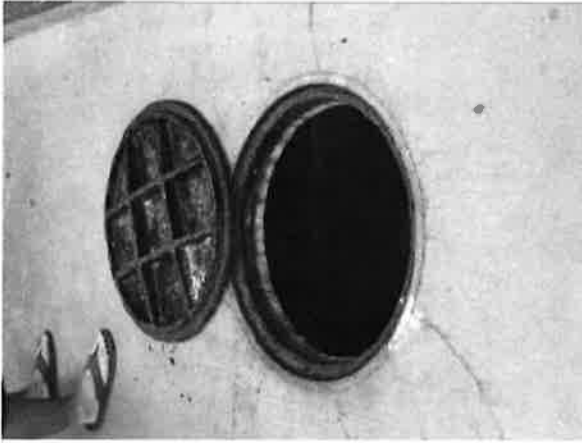
Currently, there is one (1) surge tank at the facility. A circular manhole located in the deck serves as the main access point into the surge tank. The surge tank is located directly under the deck behind the diving boards. Water is conveyed to the surge tank via the pool's perimeter gutter and main drains. The perimeter trench drain appears to drop at a constant slope on all sides of the pool until it empties into the surge tank. At the floor of the surge tank there is a drain which sends the perimeter overflow water directly into the filter tank. The surge tank drain is noted to have some form of screen covering the opening. The '72 construction drawings indicate that the surge tank is 22'-5" x 7'-4" x 7'-5", which provides a surge capacity over 9000 gallons. It is common practice in the aquatics industry to size surge tanks for one (1) gallon of surge capacity for every square foot of pool surface area. (Note: this is in addition to the normal operating level of the water in the surge tank which is typically 36" above finish floor.) Currently, the perimeter overflow trench flows via gravity to the surge tank and the main drain lines flow via static pressure head to the filter tank.

At the time of the site visit, the operating water level in the surge tank could not be confirmed in relation to the operating water level in the pool. However, based upon visual observation the operating level appeared to be at an expected level with several feet of surge capacity.

It was not clear if there was waterproofing provided on the interior surfaces of the surge tank. Due to the configuration of the surge tank it seems that the only way for air to evacuate the inside of the surge tank is back out through the perimeter overflow gutter. If this isn't providing adequate ventilation, the chloramine concentration within the surge tank is most likely high. Because chloramines can attack metals contributing to corrosion, the cast iron piping located in the surge tank appeared to be in poor condition.

Immediate: Replace all piping within the surge tank with Sch. 80 PVC. All piping supports found within the surge tank shall be stainless steel.

No ventilation system was observed for the surge tank during the site visit. Install a ventilation system for the surge tank and vent all air to the exterior of the building. Completely waterproof the interior surfaces of the surge tank and conduct a water tightness test.

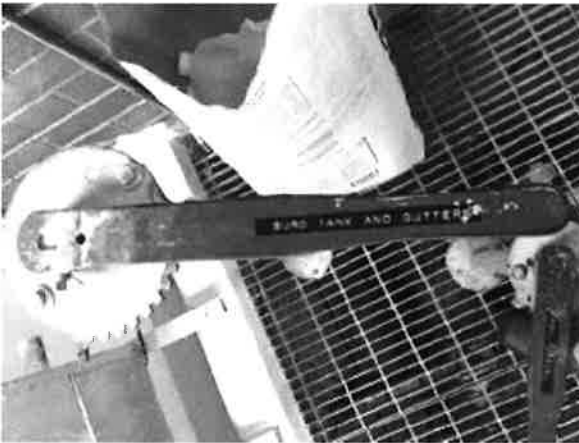
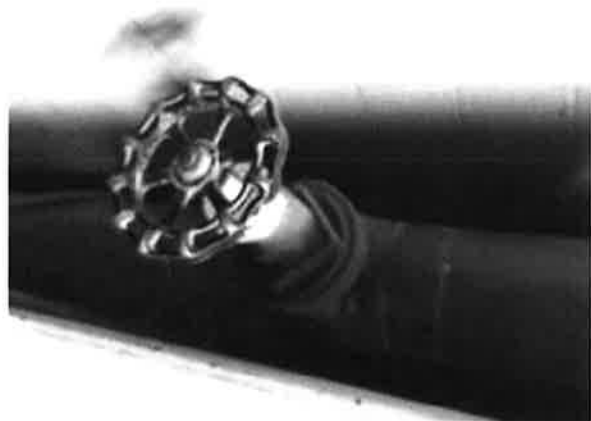
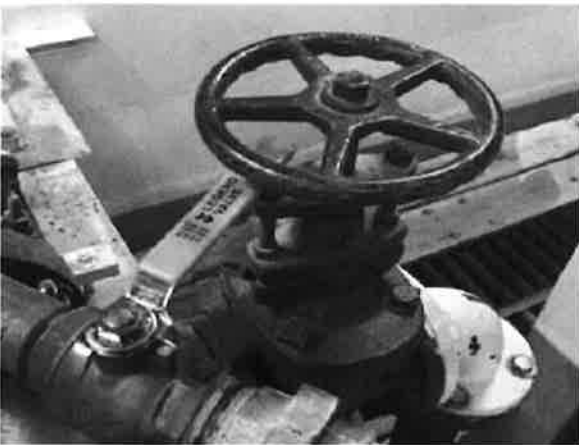
The valves in the mechanical room are a mix of cast iron gate and ball valves, PVC ball valves, and butterfly valves. The industry standard is to use true union ball valves to allow the valve to be accessed without having to cut the connecting PVC piping for valves smaller than 3". All valves greater than 3" shall be butterfly valves. Some of the valves in the mechanical room have identification tags, but there is no posted piping and valve schematic.

Immediate: Provide valve tags for each valve and post a piping and valve chart system schematic in the pool mechanical room.

Future: Replace all valves with Schedule 80 PVC true union style ball valves and butterfly valves. This upgrade would make the most sense to complete when the pool mechanical room piping is upgraded to Schedule 80 PVC. Ensure each piece of mechanical room pool equipment (e.g. pumps, filter systems, heater, etc.) has isolation valves to assist with maintenance and cleaning.

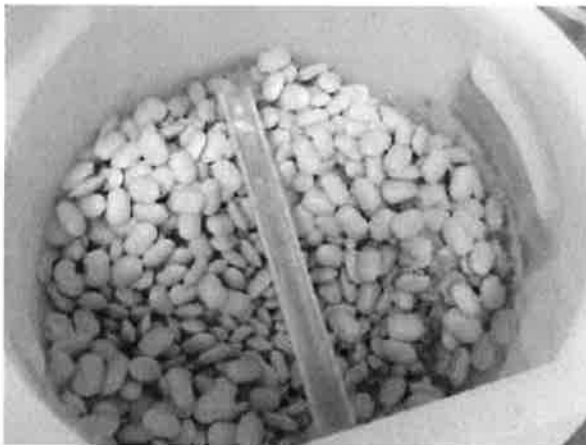
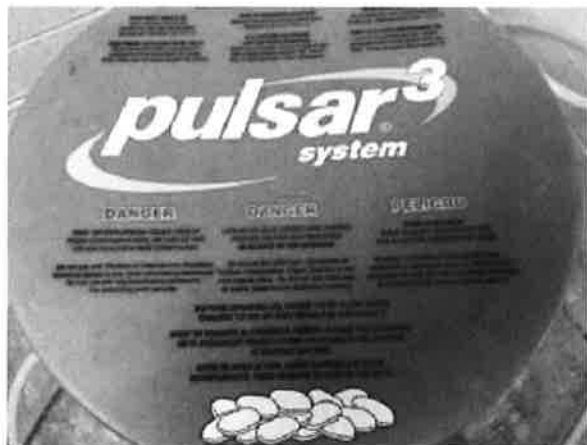
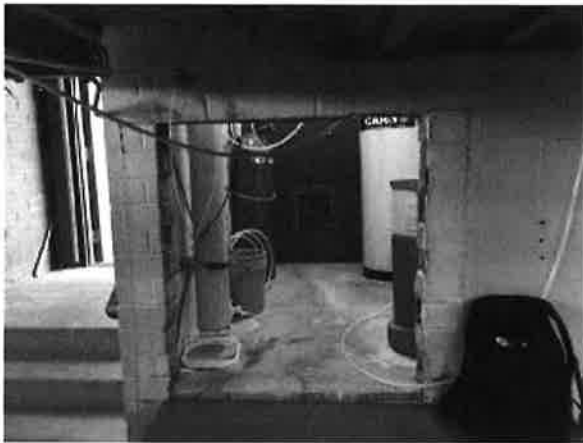
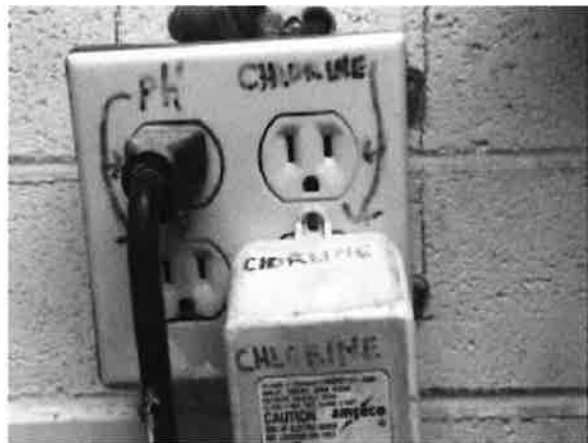
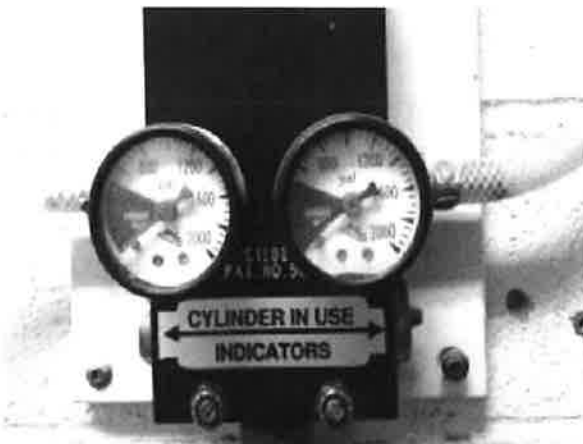
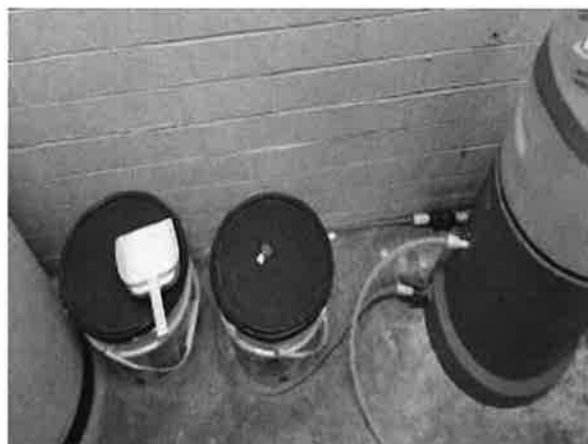
The Lions Pool facility contains a chemical room located inside of the mechanical room. The chemical room contains all chemical treatment operating equipment for all the pool chemicals. The chemical room also serves as storage for all chemicals. Minimal signage was observed and the room was lacking a proper ventilation system. One large portion of the chemical room wall was cut out allowing the air to equalize with the air within the mechanical room.

Currently, the pool is utilizing CO₂ as the pH buffer. There is a bulk tank stored in a small chemical room near the backdoor of the mechanical room. The bulk tank has a filling point located inside a lockbox on the outside wall of the natatorium building. There are also 3 additional smaller cylinders that are located in the small chemical room. The extra cylinders appeared to be connected and ready to use in the circumstance that the bulk cylinder tank runs out of CO₂. One (1) Strantrol CO₂ feed system was observed in the mechanical room. Pressure gauges were observed on all cylinders in the chemical room. Gauge readings varied during the time of inspection from “order gas” seen on the small tank gauge to “120 psi” seen on the bulk tank. The only chemical signage observed indicating the presence of carbon dioxide gas was on the outside of the chemical room door. From inspection it appeared that chemicals are injected after the heating loop.

Currently, the facility uses calcium hypochlorite as a sanitizer. Calcium hypochlorite is the solid form of chlorine which comes in varying sizes from small puck shaped pellets to briquettes. The calcium hypochlorite pellets and the chlorination system are stored in the same chemical room that houses the CO₂. Minimal HAZMAT signage was observed in or around the chemical room. The outside of the chemical room door had a “Danger Chlorine” sign posted. Inside the chemical room a poster was observed that described how to properly handle and store the calcium hypochlorite. The facility uses one (1) Pulsar 3 Chlorination System and small oval calcium hypochlorite pellets about the size of a quarter. The injection line which supplies the Pulsar 3 system with water is located directly after the booster pump and has a small red paddle wheel flow sensor. An additional line was observed right after the Pulsar 3 injection line. The second line is shown going from the chemical loop up to the chemical controller. Because this line is on the pressure side of the pump we can tell that water is flowing from the chemical loop to the chemical controller where the water quality is read, allowing the chemical controller to make needed adjustments. A third line was observed running from the chemical controller to a location under the deck grating. It is assumed that this line is then injected into the main recirculation line or the main chemical loop right before it ties into the recirculation line. Both the CO₂ and chlorine lines leave the chemical room together and fall below the deck grating at the same location.

There is one (1) chemical controller secured to the wall directly outside the chemical room opening. The chemical controller is a Becsys 5 which was installed in 2013. At the time of the site visit, the pool had a pH reading of 7.48, an ORP of 819 mV, and a temperature of 87 °F.

Immediate: Washington State Pool code has no specific requirements for calcium hypochlorite and CO₂ being stored separately. However the International Building Code does pose restrictions on the varying amounts of chemicals that are allowed to be stored in a space based on the room's hazard rating. If less than 200lbs of Calcium Hypochlorite is to be stored at the Lion's Pool Facility the room will not need to be classified as a high hazard space and will therefore incur less restrictions. However Washington State Pool code still requires certain measures be taken for any room that will house chlorine. According to Washington State Code (WAC 246-260-031 Section 17.e), "*Chlorine rooms must have mechanical exhausting ventilation that includes: Air inlets located as far as possible from fan intakes to promote good air circulation patterns; A minimum of one air change per minute in the chlorine room when fan is operating; A remote switch outside the room or a door-activated switch to turn on fan before entering; Suction for fan near the floor; Exhaust vents located to prevent chlorine contaminated air from being drawn into supply air; Screened chlorinator vents.*" Because the chemical room is open to the mechanical room they may both require exhausting ventilation.

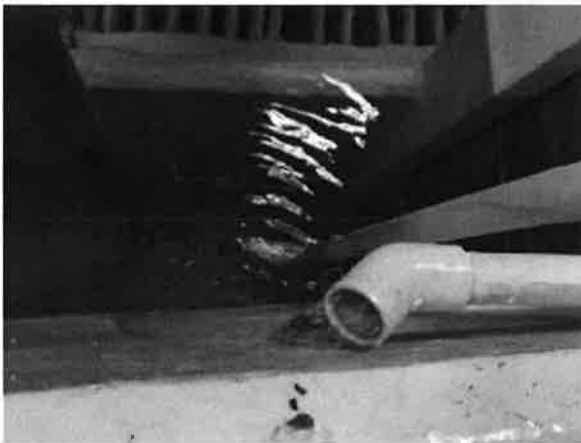
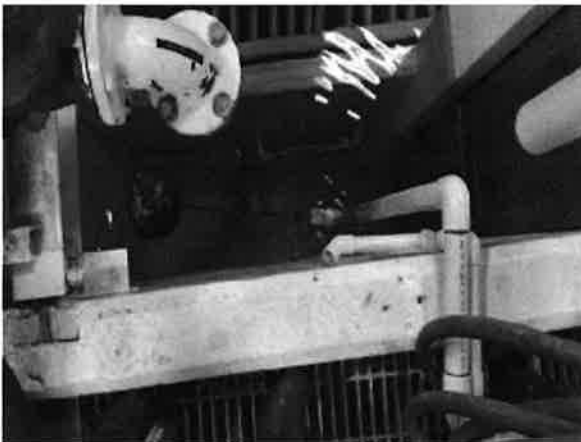
The water level control system for the pool uses a modulating float valve located within the d.e. filter tank. When the water drops to a certain height in the filter tank, the float triggers the valve to open which adds water to the filter tank. The valve will begin to close as the float rises to the desired height from the added fill water. There is also a manual fill valve located by the auto fill line. This valve can be actuated by a facility operator at any time.

Future: Because there appears to be no high level water sensor, it is recommended to provide an automatic water level control system complete with a monitor located in the pool mechanical room, one (1) surge tank mounted wet cell with normal and high level sensor probes, and an automatic solenoid valve on the fill line. System to be similar to an ELC-810 by Aquicontrol Technology. Provide a water totalizer meter for the domestic fill water for the pool system with a digital readout similar to those manufactured by Sensus. It would make the most sense to complete these upgrades when the surge tanks is repaired, replaced, or even cleaned.
